JTBO0595NAS1

**TECHNICAL BULLETIN**

501-08: Exterior Trim and Ornamentation

Windshield Finisher Loose

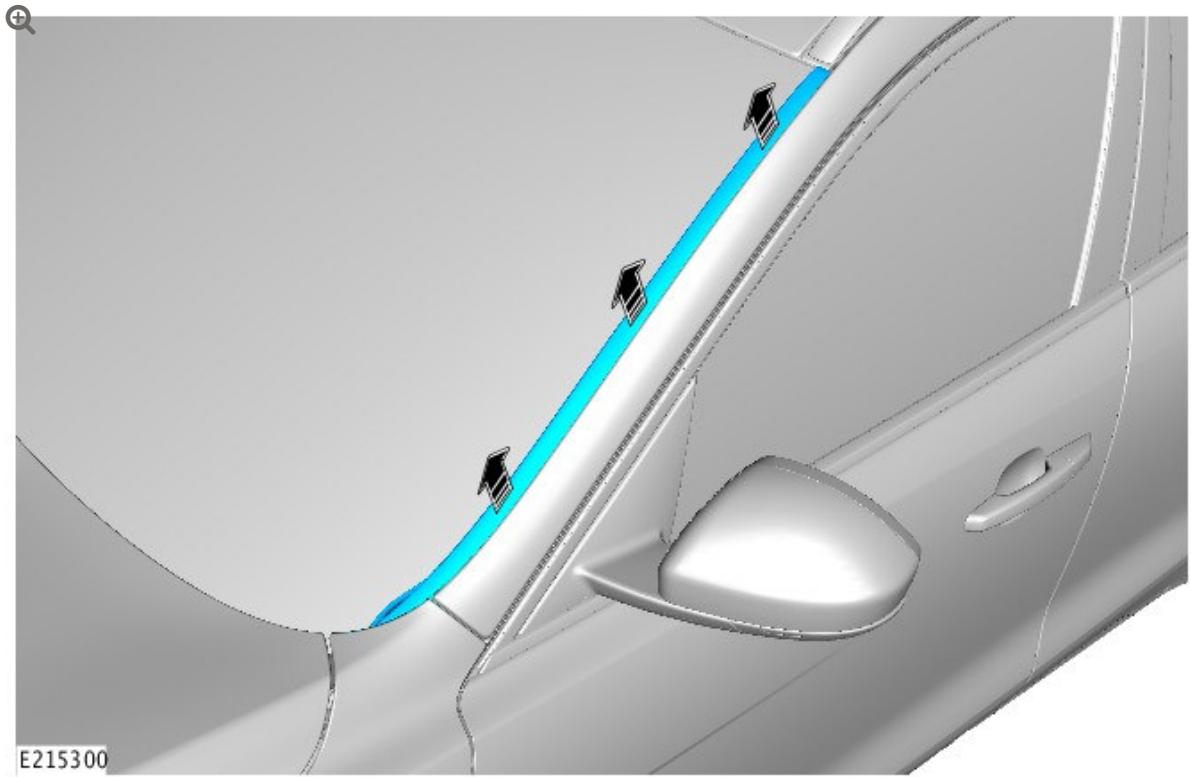
The windshield finisher may be loose and/or wind noise may be evident from the A-pillar area.

This may be caused by the windshield finisher retaining channel not retaining the windshield finisher correctly.

Remove the windshield finisher.
