REVISION [État]: THIS WARRANTY BULLETIN SUPERSEDES PREVIOUS VERSION.
First release

MCM SERVICE SWITCH FUNCTIONALITY- CORRECTIVE MEASURE ON I-START EQUIPPED VEHICLES 9700 (B13R)

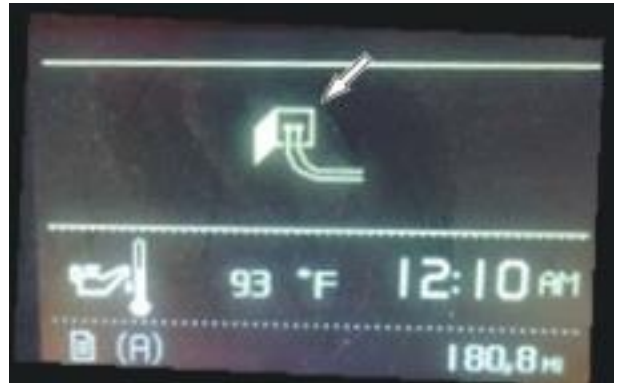
This symbol must pop up when the switch is activated and it should not be possible to crank the engine.

15) Perform a functionality test:
