Park Brake Cable Service Bulletin

Situation: Inner fender placement may affect parking brake cable routing

Corrective Action Summary: Reposition driver's side inner fender and reattach parking brake cable

Range of Units Affected: Aeromaster on the Ford E350 and E450 chassis manufactured between February 2016 and February 2017. Contact Utilimaster Warranty Department to verify chassis VIN.

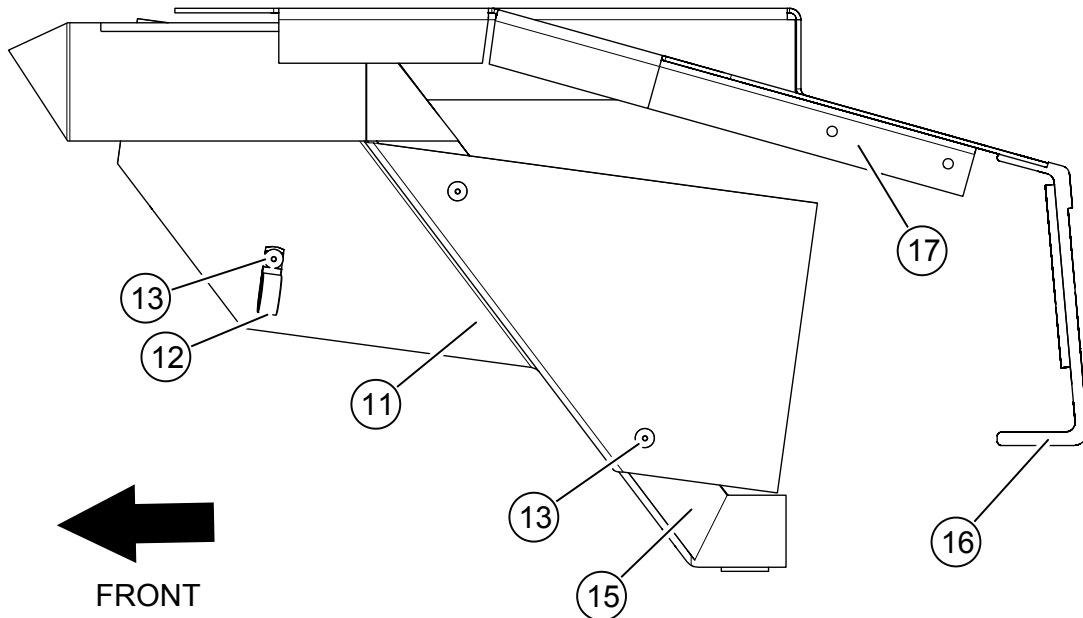
Correct placement of LH inner fender (see page 3)

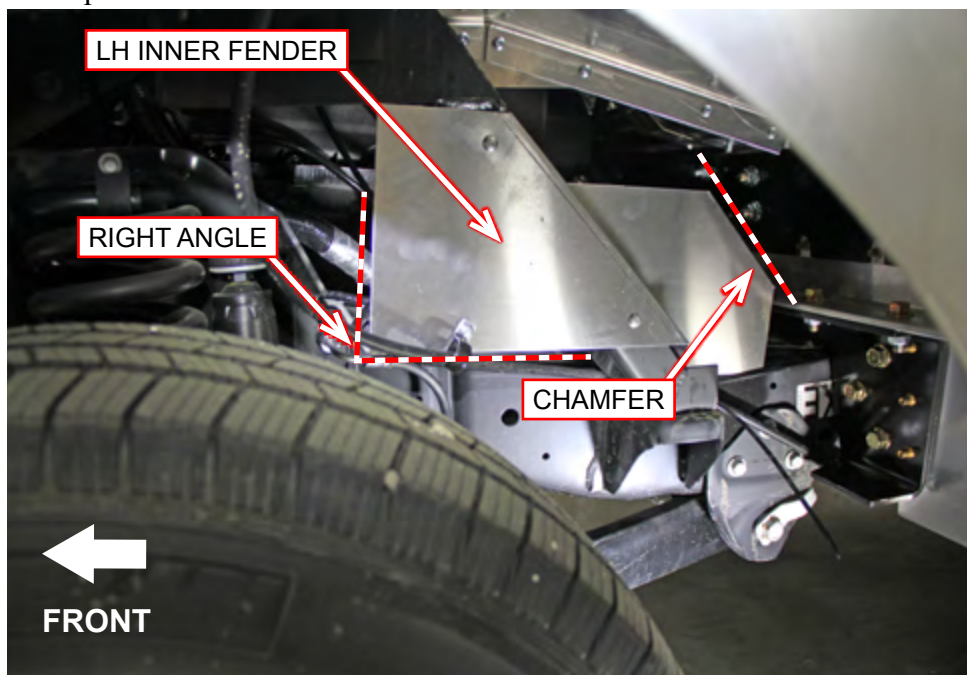
1. Read and understand all the instructions before starting the repair.
2. Turn steering wheel to the right hand lock position.
3. If inner fender chamfer is facing rear toward cross member and the right angle faces forward, proceed with repair.

Incorrect placement of LH inner fender (Driver's side view)

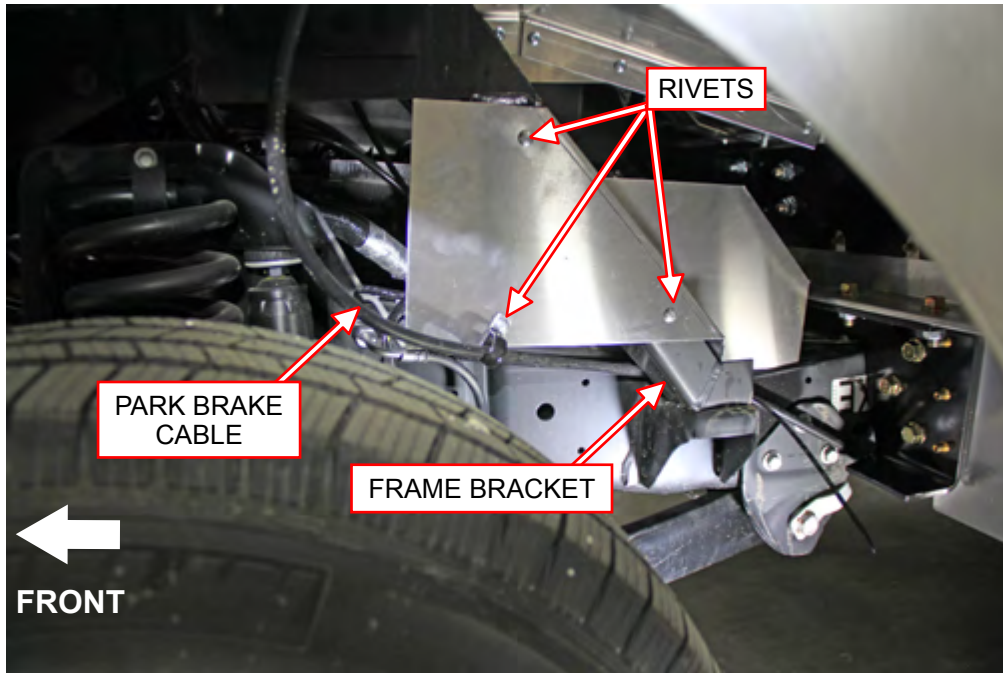
Incorrect placement of LH inner fender (Driver's side view)

1. Remove fastener securing the parking brake P-clamp and set clamp aside.
2. Use an #11 (or 3/16") bit to drill off the heads of rivets securing the inner fender to the frame bracket. Use a center punch to knock out stem.
