## Liftgate Subframe Interference Service Bulletin

**Situation:** Liftgate interference may cause fissures in long sills

**Corrective Action Summary:** Weld plates to long sills

**Document Part Number:** 03102101-B013EN

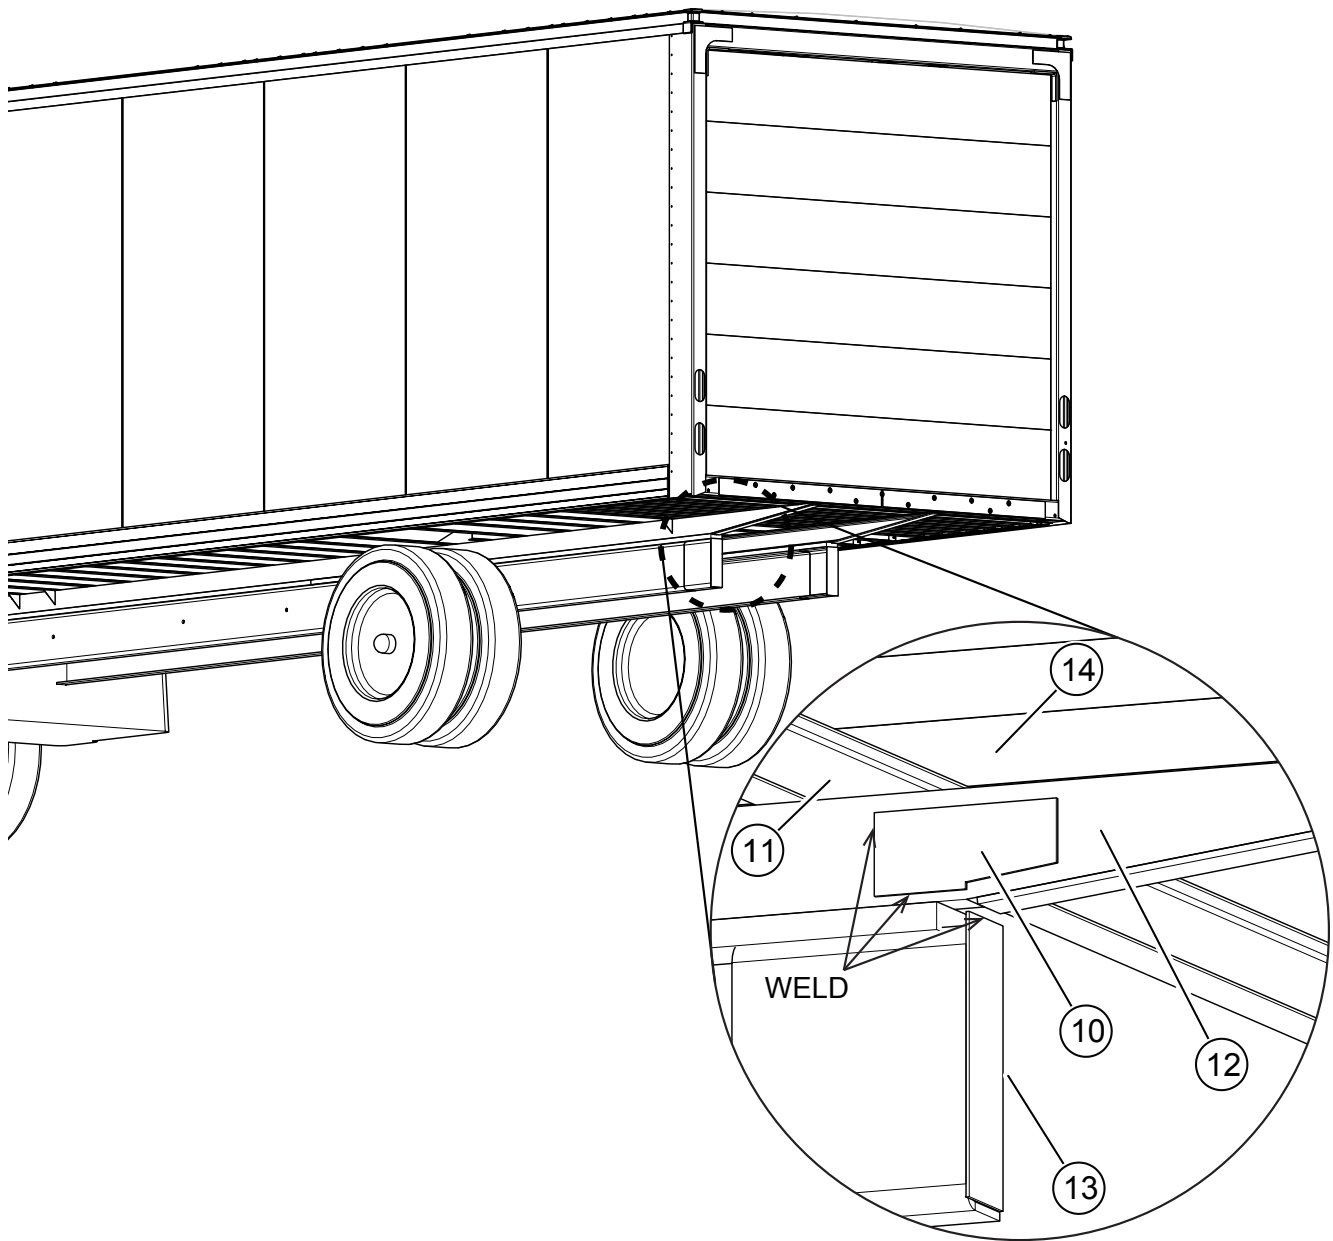
*Overview of subframe long sills (liftgate omitted for clarity)*

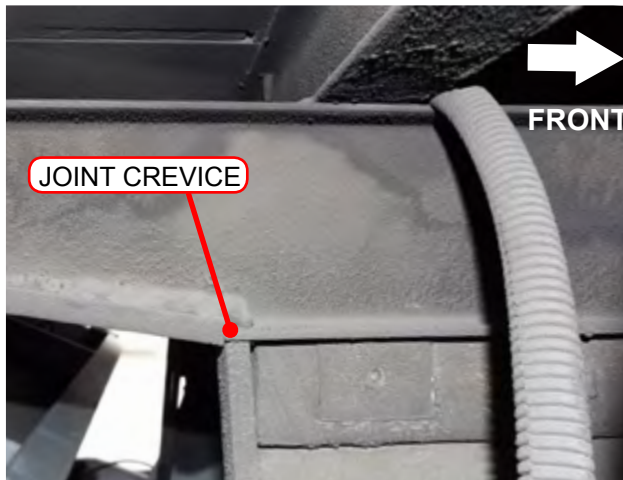
*Correct weld and no joint at flange*

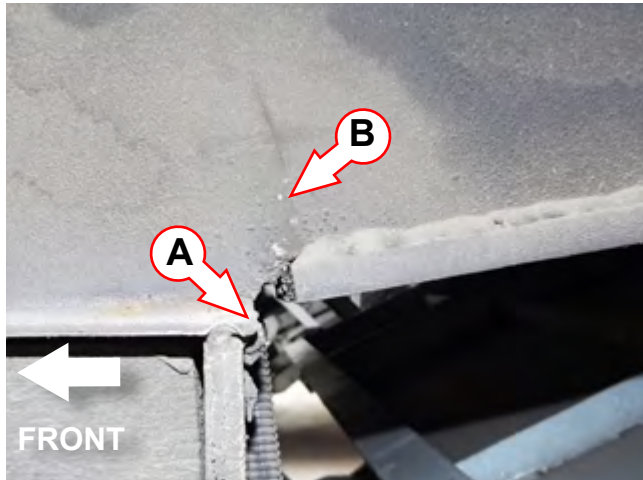
*Damaged weld (A) and fissure (B) at RH long sill*

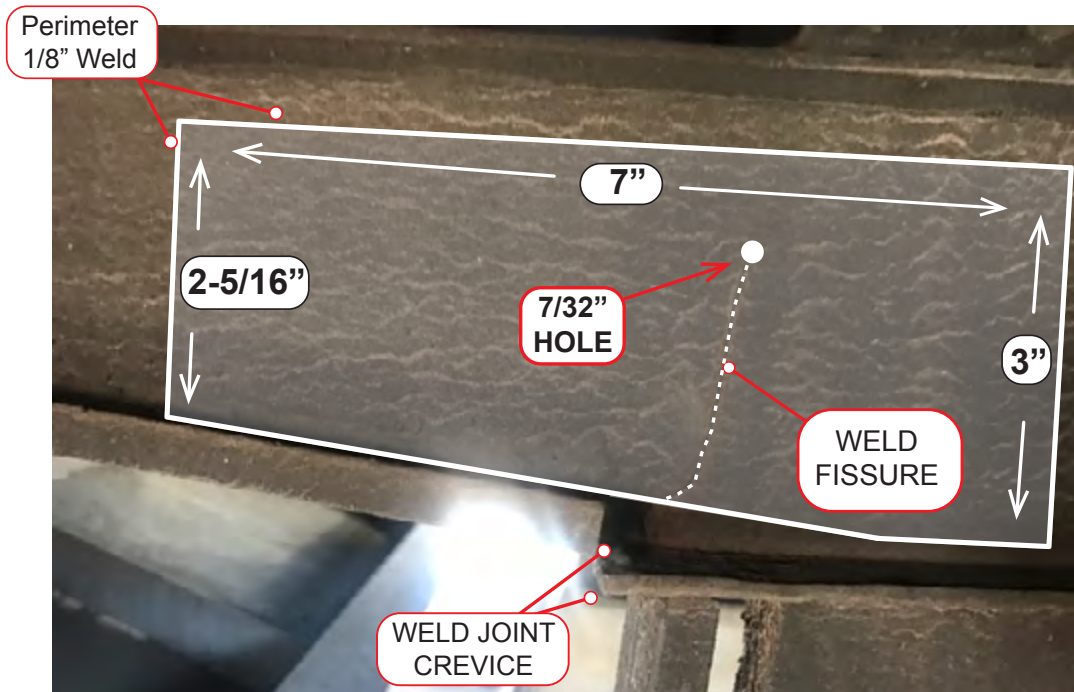
*Overview of plate reinforcement and fissure repair*

Regardless of which side of the truck the fissure is located, reinforcement plates will be welded onto both long sills

1. Drill 7/32" relief hole at top end of crack to stop crack growth.
2. Use a die grinder to create channel in fissure.
3. Remove undercoating around sill flange welding areas.
4. Weld fissure gap to join sides of crack.
5. Use a clamp to secure plate on outboard side of long sill at the taper point.
6. Perimeter weld reinforcement plate to web of long sill using 1/8" fillet-style continuous weld around edges.
7. Weld any gaps on bottom flange and angled steel plate joints at the long sill. Weld a continuous bead with no gaps between lower flange and angled plate. Fill in joint crevice with 1/8" weld between long sill flange and angled plate.
