November 29, 2017

07786 Version 2

Power Tailgate Won't Open from the Outside in Cold Weather

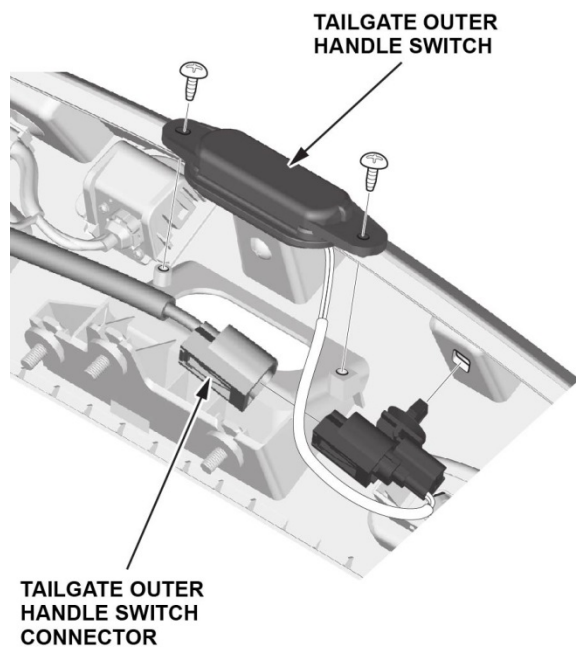
The power tailgate outer handle switch is inoperative in cold weather.

1. Remove the rear license trim.
2. Disconnect the tailgate outer handle switch connector.

3. Remove the tailgate outer handle switch.
 4. Install the new tailgate outer handle switch.
 5. Connect the connector.
 6. Install the rear license trim.
- END
