SIL 22-EP-17  
November, 2017  
Page 1 of 2

**SUBJECT:** Release of Allison Transmission 5th Generation Controls

**MODELS AFFECTED:** H 40/50 EP™ System

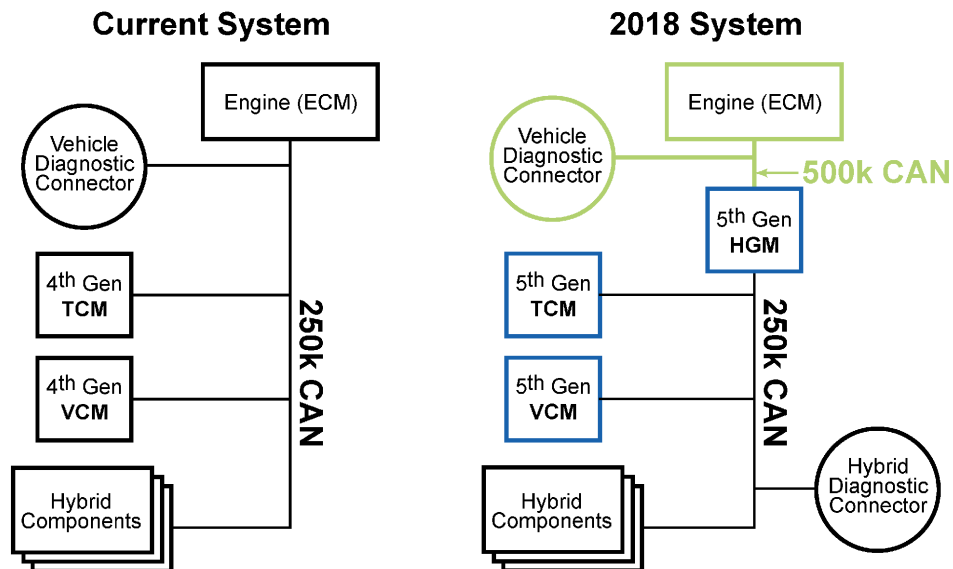
Figure 1. Current System vs. 2018 System

The new HGM will bridge the 500k baud vehicle CAN and the 250k baud H 40/50 EP™ CAN (refer to [Figure 1](#)).

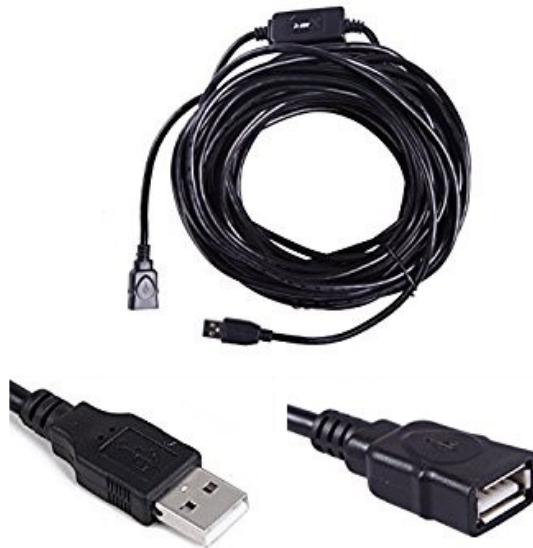
Figure 2. Example of USB Extender

**NOTE:** The green 500k baud diagnostic connector located in the driver's compartment cannot be used for Allison DOC® or Reflash Programming. Allison diagnostics and programming tools must use a black 250k baud diagnostic connector located on the rear panel of the bus. A 50-foot high speed Universal Serial Bus (USB) extender may be needed to work with a translator at the rear diagnostic connector and a laptop located near the driver's compartment (refer to [Figure 2](#)).
