TT7994EN, Rev. A  
November, 2017  
Page 1 of 4

SUBJECT: P2789 Code in IC Bus School Buses with PSI 8.8L Propane (LPG) Engine

MODELS AFFECTED: 1000/2000 Series Product Family Pupil Transport Series (PTS) Transmissions in IC  
Bus School Buses

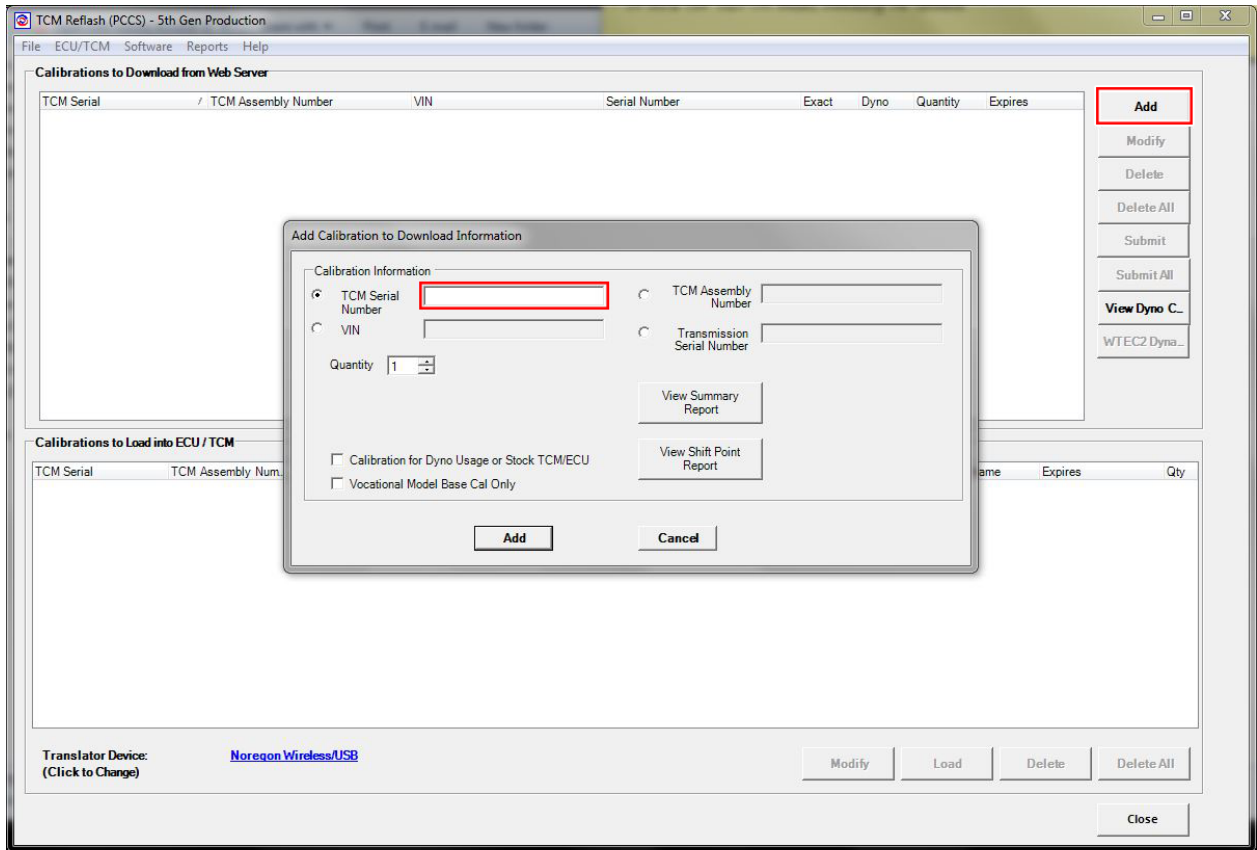
**Figure 1. Enter TCM Serial Number to Download Updated Calibration**

recorded. Add and submit to download the calibration. The downloaded calibration will contain new settings for the specific TCM. Flash the TCM with the updated calibration (refer to [Figure 1](#)).

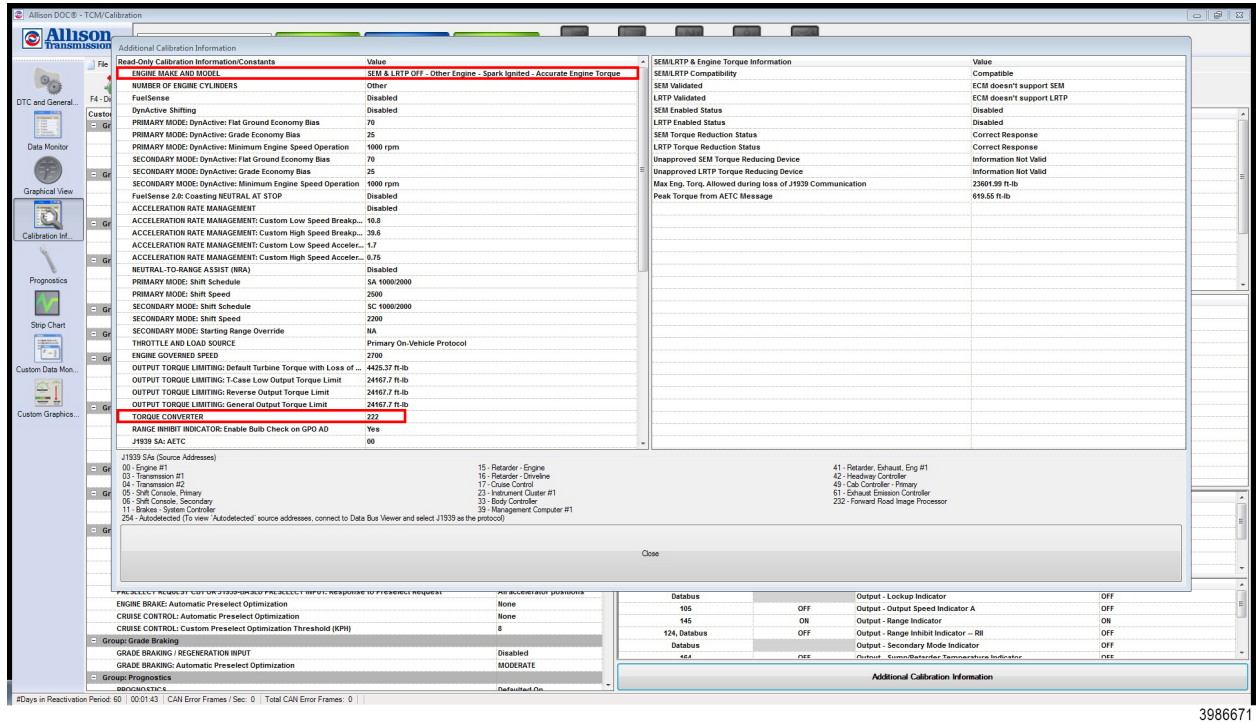
Figure 2. Example of Updated Settings After Reflashing

After flashing the TCM in Allison TCM Reflash™, connect to the TCM using Allison DOC® Premium. Once connected to the TCM, select Calibration Information from the left tool bar. Select Additional Calibration Information in the bottom right corner of Allison DOC® Premium. In the left side of the Additional Calibration Information screen, verify that the value for **ENGINE MAKE AND MODEL** at the top is set to "**SEM & LRTP OFF - Other Engine - Spark Ignited - Accurate Engine Torque**". Further down in the list, verify that the value for **TORQUE CONVERTER** is set to one of the following values: **211**, **221**, or **222** (refer to [Figure 2](#)).

After recalibration, if the calibration parameters are not set as listed above, call the Allison Technical Assistance Center (TAC) at 800-252-5283.
