**17-2208**16 October  
2017

## TECHNICAL SERVICE BULLETIN

### Floor Console Cup Holder Door - Unable To Operate

Lincoln 2017 Continental
-----------------------------

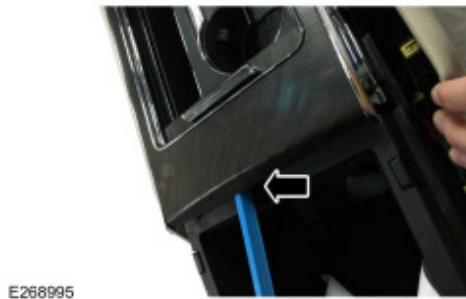
Figure 2

**4.** Inspect the louver right and left side tracks for the louver out of the track. (Figure 2)
