Michael A. Berardi
 Director
 Service Engineering Operations
 Ford Customer Service Division

Supercedes 17N03

October 26, 2017

SUBJECT: **Customer Satisfaction Program 17N03 – Supplement #1**
 Certain 2011-2017 Model Year Explorer Vehicles
 Carbon Monoxide Concerns

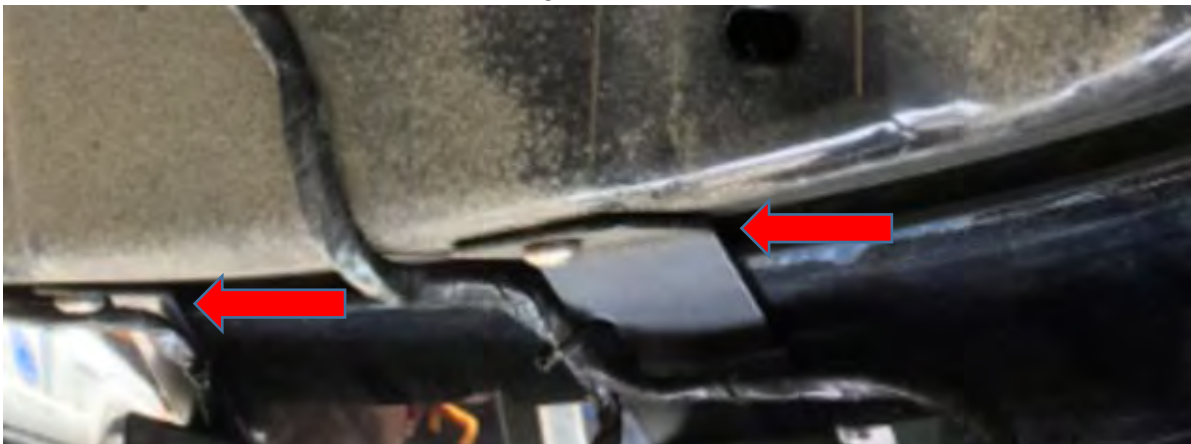
Figure 1

- Brackets positioned between the spoiler and the liftgate (See Figure 1)
- Lighting and/or equipment that forces the spoiler out of position creates a gap between the spoiler and the liftgate (See Figure 2)
- Unsealed holes drilled in the spoiler or liftgate (See Figures 3 and 4)
- Wiring for lighting and/or equipment routed from the spoiler to the vehicle in a manner that damages the seals between the spoiler and the vehicle (See Figures 5 and 6)
- When the spoiler is removed to install aftermarket lights and/or equipment, the spoiler attachment clips and seals may be damaged. If the spoiler was removed from the vehicle, the spoiler attachment clips and seals should be replaced. Use part number HB5Z-78442K03-A

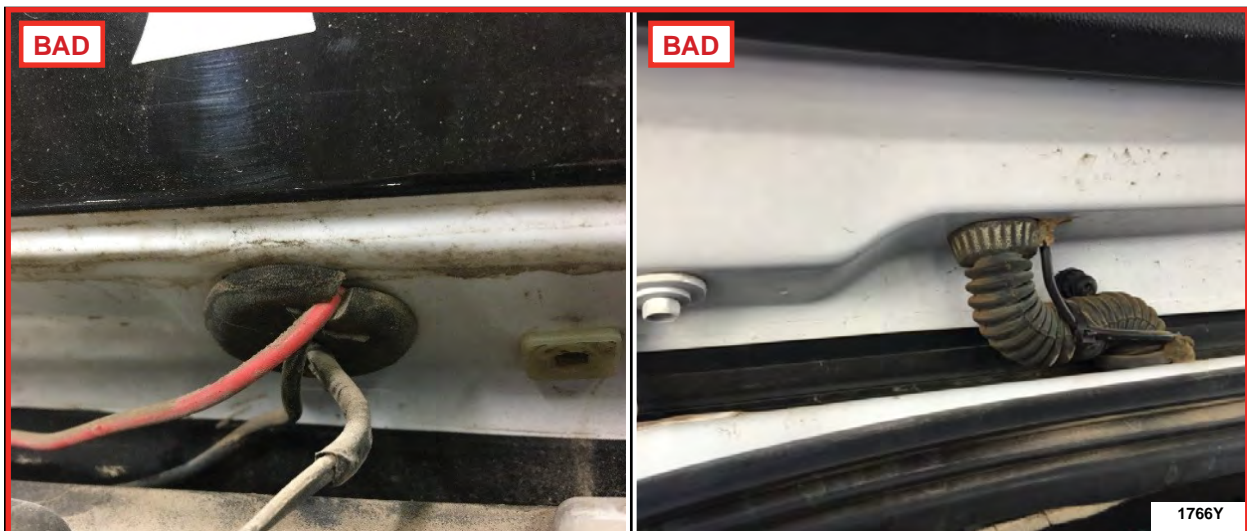
2. Inspect for any aftermarket wiring pass throughs/holes that could affect the sealing ability of the spoiler. See Figures 9a and 9b.

3. Seal any leak paths created by the aftermarket wiring pass throughs/holes in the spoiler area with Motorcraft® TA-2 seam sealer or equivalent.
4. Remove the liftgate spoiler tower foam seal. See Figure 10.
