# Tech Article

## TA0019: TA0019: Oil Spinner Retention

| <b>Models</b> | 2017: FXSB, FXSE<br>2018: FLFB, FLFBS, FLFBS ANV, FLFBS ANX, FXBR, FXBRS, FXBRS ANX |
| <b>Category</b> | Primary Drive |

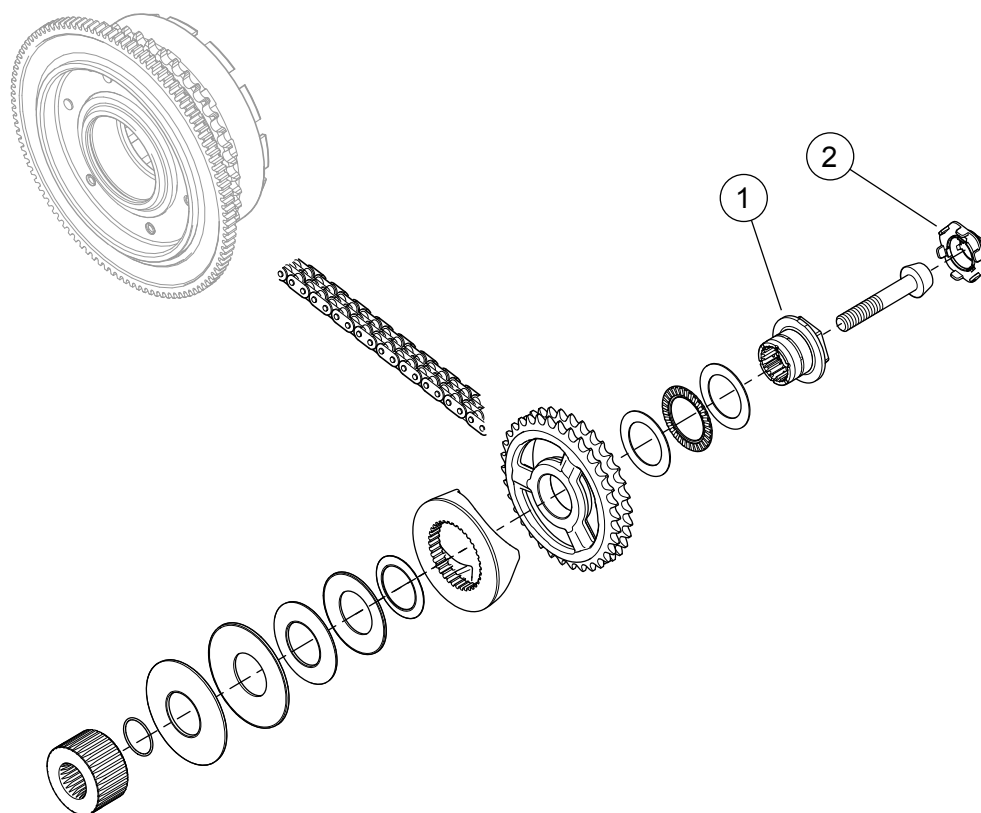
**Figure 1. Primary Drive Components**

| <b>ISSUE</b> | We have identified the potential for the oil spinner to become detached from the sprocket retainer on some 2017 and 2018 Softail motorcycles. A quality issue with the sprocket retainer has been identified as the cause. |

See Figure 1. The oil spinner (2) may be partially secured or separated from the sprocket retainer (1).

- 1. Sprocket retainer (Part No. 40100041)      2. Oil spinner (Part No. 62700062)**

If you determine that an oil spinner has lost retention, inspect the compensator assembly for wear and service as needed. Upon reassembly, replace both the oil spinner and sprocket retainer.
