Technical Service Bulletin

GROUP CAMPAIGN	NUMBER 17-01-057-1
DATE NOVEMBER, 2017	MODEL IONIQ HYBRID (AE HEV)

SUBJECT: TRACTION MOTOR INSPECTION AND REPLACEMENT
(SERVICE CAMPAIGN T2J)

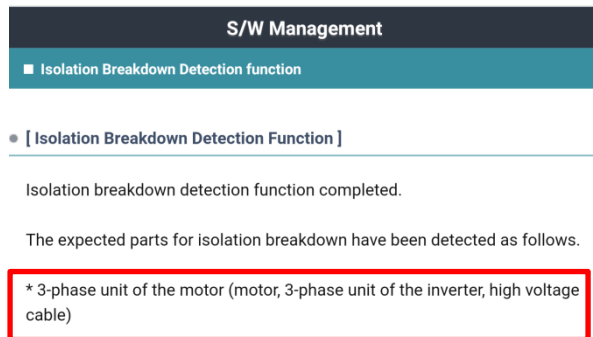
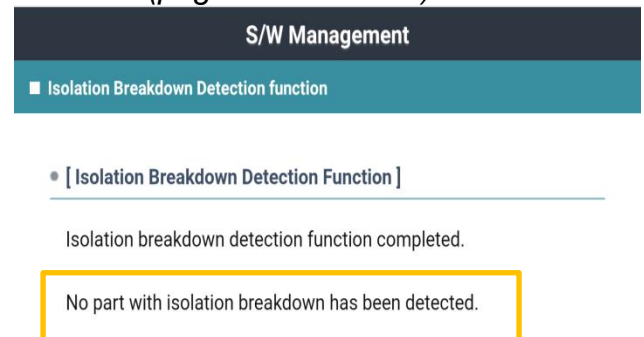
FAILED MOTOR is confirmed by below result:
 -> Go to section-D “Replace Traction Motor.”
 (page 13 of this TSB)

PASSED - No issue confirmed by this test:
 -> Go to the next section-B “Traction Motor Coolant Leakage Inspection”
 (page 6 of this TSB)

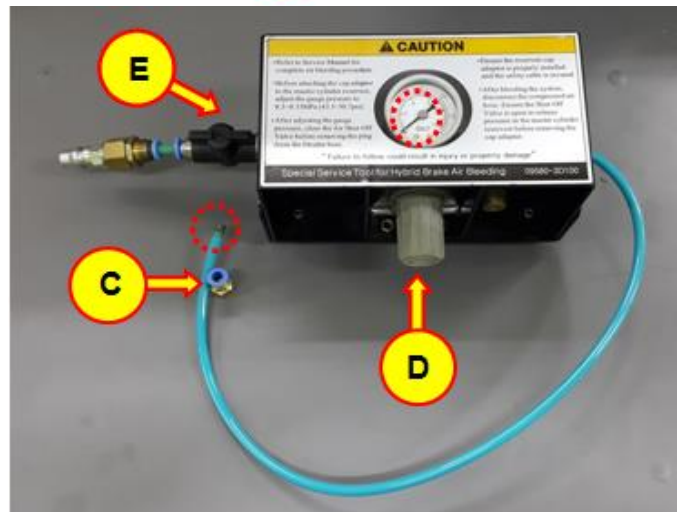
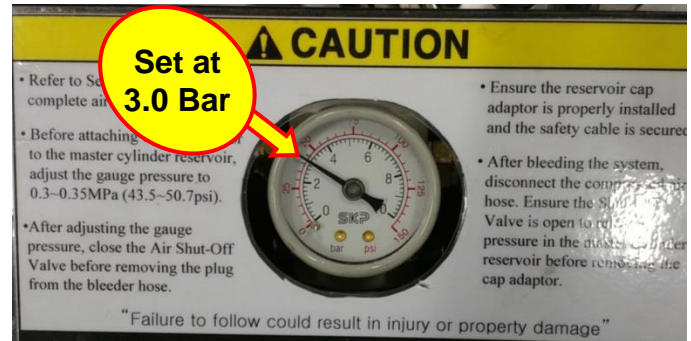
Air Leak Test Result:

- **GOOD:** *Holds pressure after 5 minutes within 0.2 Bar of the original setting.:*
 - Traction Motor is OK.
 - Proceed to step 11.

- **FAILED:** *Pressure falls more than 0.2 Bar and ends up dropping below 2.8 Bar after 5 minutes:*
 - Traction Motor has an internal coolant leak failure and must be replaced per section-D. (page 13 of this TSB)
 - Complete Step-11 then replace the Traction Motor per Shop Manual procedure.

In event of FAILED result confirm that the adapter tool connections were tight fitting and recheck the Air Leak test result if necessary.
