GROUP	NUMBER
CAMPAIGN	17-01-062
DATE	MODEL(S)
NOVEMBER, 2017	SANTA FE SPORT (AN) SANTA FE (NC)

SANTA FE SPORT (AN) AND SANTA FE (NC) CONSOLE UPPER COVER 'PRND' INDICATOR REPLACEMENT (SERVICE CAMPAIGN T2L)

SANTA FE (AN / NC) CONSOLE 'PRND' INDICATOR REPLACEMENT (SERVICE CAMPAIGN T2L)

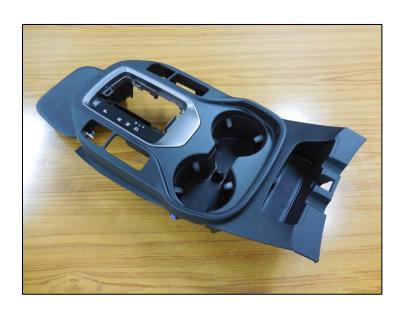
Description: On certain 2017-2018 Santa Fe Sport (AN) and Santa Fe (NC) vehicles, the face plate on the "PRND" indicator may exhibit peeling. This bulletin provides the procedure to replace the console upper cover 'PRND' indicator.
