GROUP
BODY ELECTRICAL

NUMBER
17-BE-002-G

Technical Service Bulletin

SUBJECT: 2017MY-2018MY GENESIS G80 STANDARD NAVIGATION
VARIANT CODING

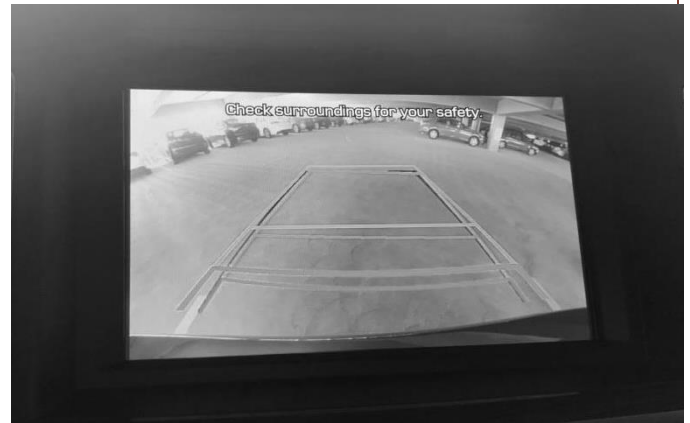
Description: This bulletin describes the procedure to variant code the Genesis G80 (DH) navigation system. A black/blank screen or black and white image may be displayed from the rear view camera after the navigation unit is replaced without performing this variant coding procedure.

Black and White Image

Use this information bulletin to variant code the standard navigation system after replacement.
