## Advanced Technical Information

### Cayenne (92A), Panamera (970) Rear Lid FC 00001E

Vehicle Type: **Cayenne (92A), Panamera (970)**

Model Year: **2010 - 2013**

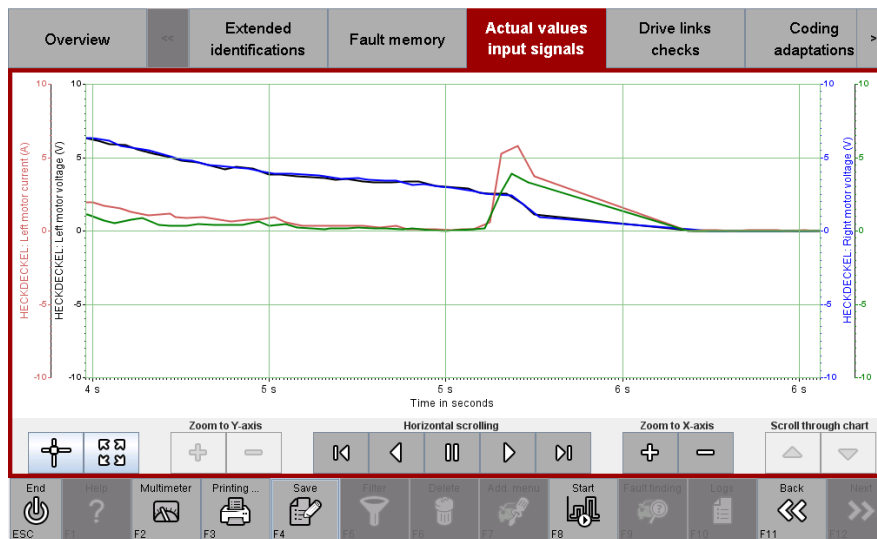
The graph above shows the voltage in the blue and black lines. It is very consistent for both struts.

The current is shown in the green and red lines. Notice how the red line has a larger current spike than the green line does.

This could be due to some mechanical resistance that is causing that strut to work a bit harder (it needs more energy). The lid adjustment or a binding strut would be good places to check for that.

Note that the green current line could be from an electrical resistance accumulating in a strut, as it progressively fails, (the red line could be the normal one).
