<b>Reference</b>	SSM73469
<b>Models</b>	Discovery Sport / L550
<b>Title</b>	L550 Discovery Sport - Rear Screen replacements
<b>Category</b>	Body
<b>Last modified</b>	14-Jul-2017 00:00:00
<b>Symptom</b>	102000 Window/Glass
<b>Attachments</b>	Fig 11.pdf (Fig 11.pdf) Fig 21.pdf (Fig 21.pdf)

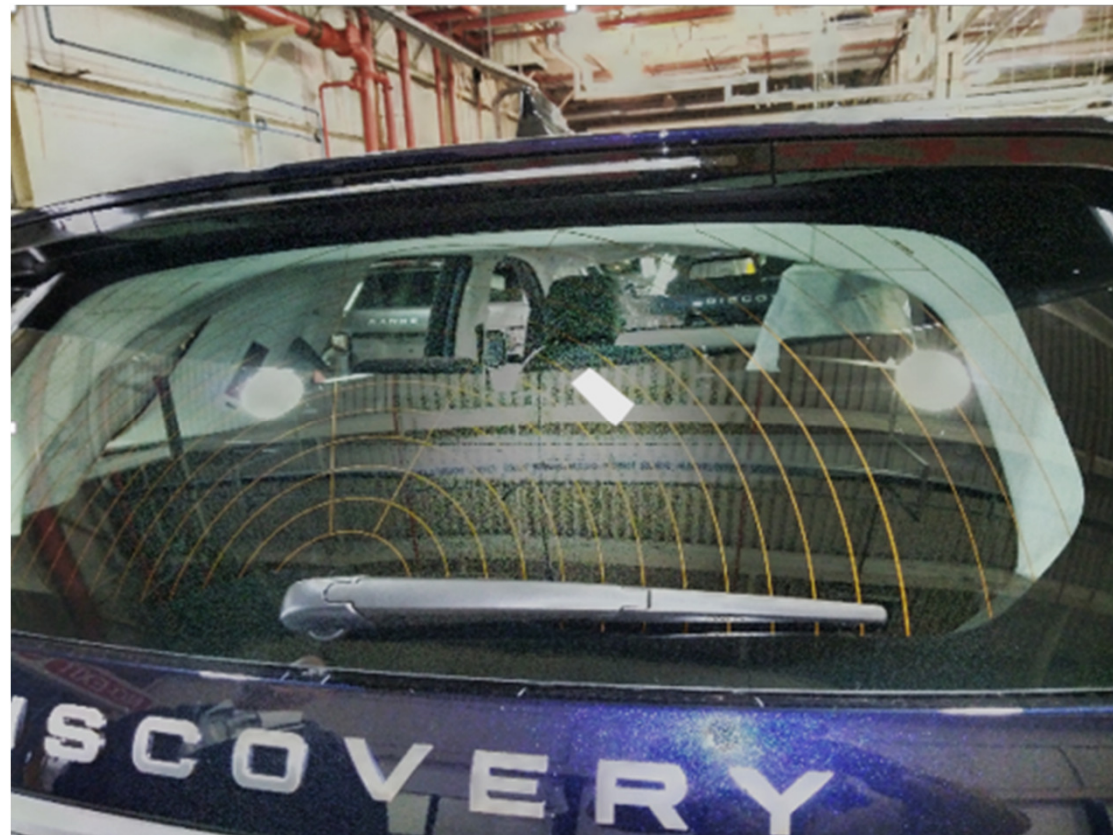
Fig. 1

Fig 1. – Full screen with tape in place.

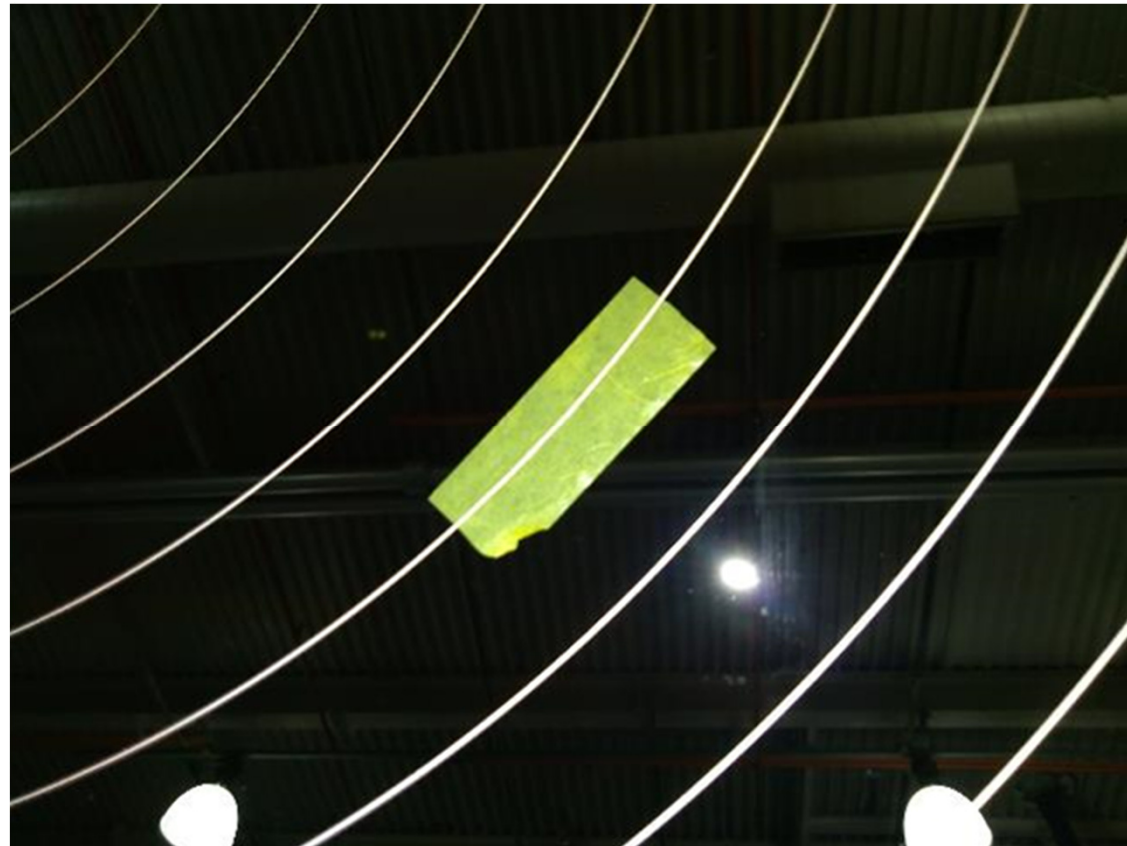
Fig. 2

Fig 2. – A clear, close up photograph of the defect.
