N039NAS1

TECHNICAL BULLETIN

309-00A: Exhaust System - TDV6 3.0L Diesel

Service Action: Engine Heatshield Fixings Loose

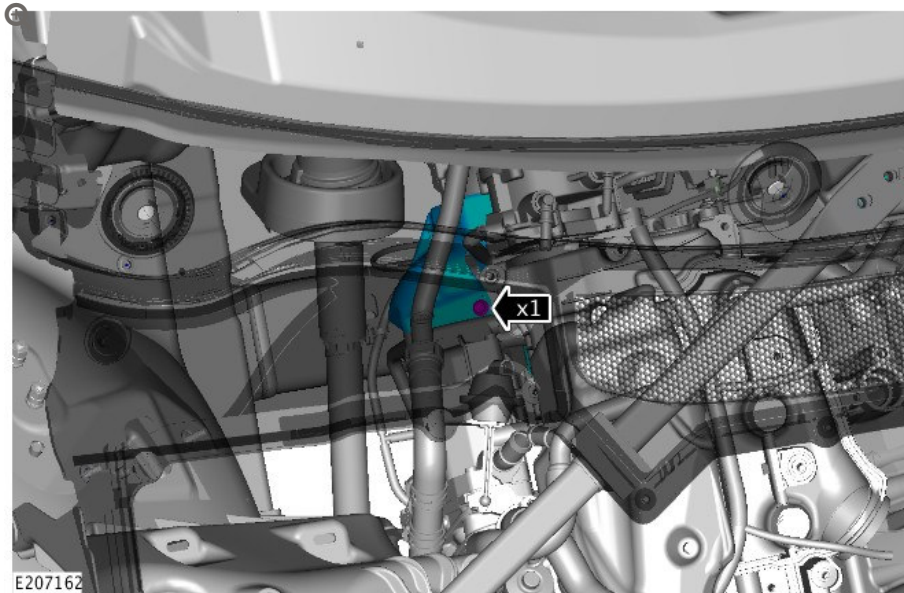
An issue has been identified on certain vehicles within the listed Affected Vehicle Range which may have been manufactured with engine heatshield fasteners not tightened to the correct torque value. In cases where fasteners are not to the correct torque value, a heatshield may: become loose, leading to an audible noise; or dislodge from its location and drop down onto the engine undershield. In an instance where the heatshield dislodges, any component within 150mm/6in that is not metallic or ceramic that would have been protected will be at risk of heat damage.

Tighten the heatshield fastener.

- Torque: **10 Nm**
