N057 UPS4717-1BNAS1

TECHNICAL BULLETIN

501-08: Exterior Trim and Ornamentation

Update Prior to Sale: Hood Finisher Detaching

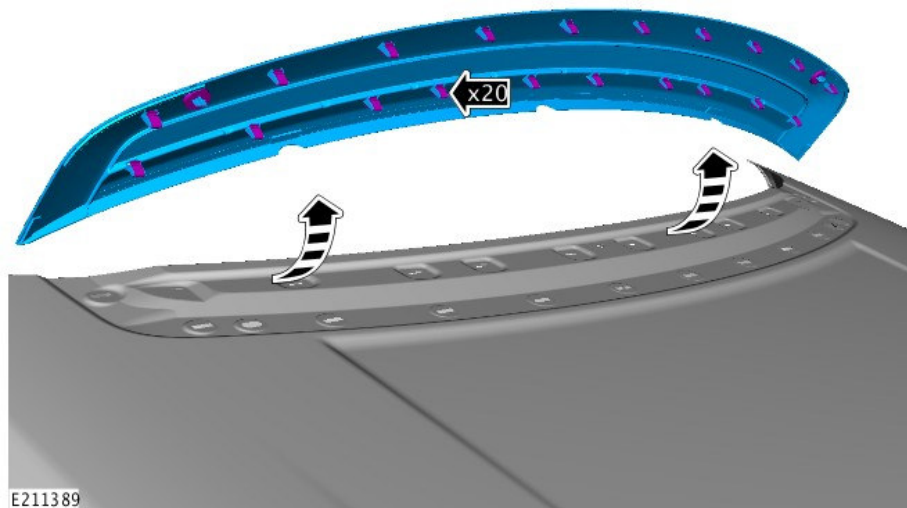
1

The hood finisher trim clips must be replaced.

Remove the hood finisher.

- 2 Remove and discard the 20 trim clips from the hood finisher.
- 3 Install 20 new trim clips to the hood finisher.
