LTB00628NAS2

# TECHNICAL BULLETIN

501-28B: Roof Sheet Metal Repairs

Roof Panel Damaged By 'A' Pillar Trim

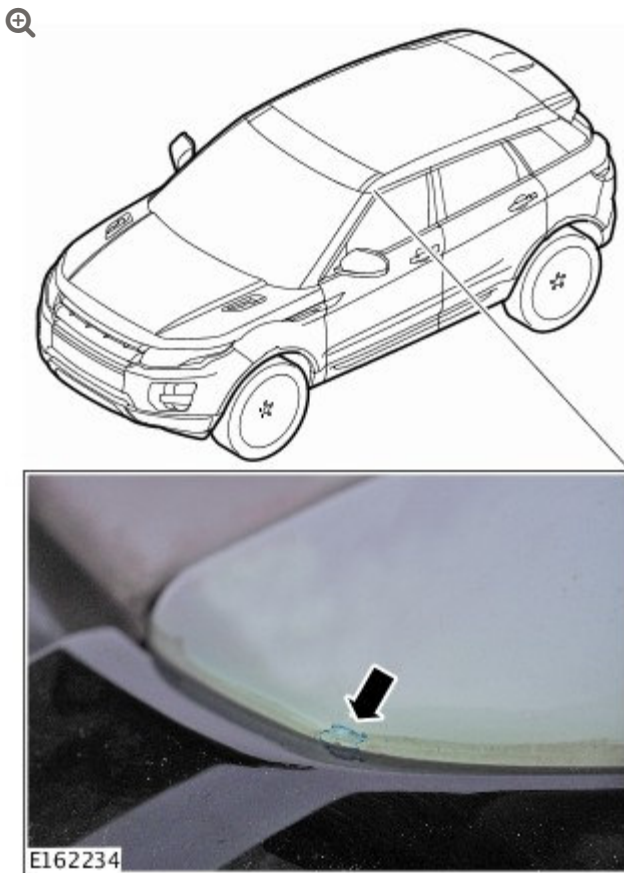
1

Paint damage to the roof panel at the 'A' pillar area may be evident.

This may be caused by contact between the 'A' pillar trim and roof panel.

Inspect both sides of the vehicle roof panel for damage in the area shown.

- If paint damage is not evident, do not continue with this Technical Bulletin.
- If paint damage is evident, go to Step 2.

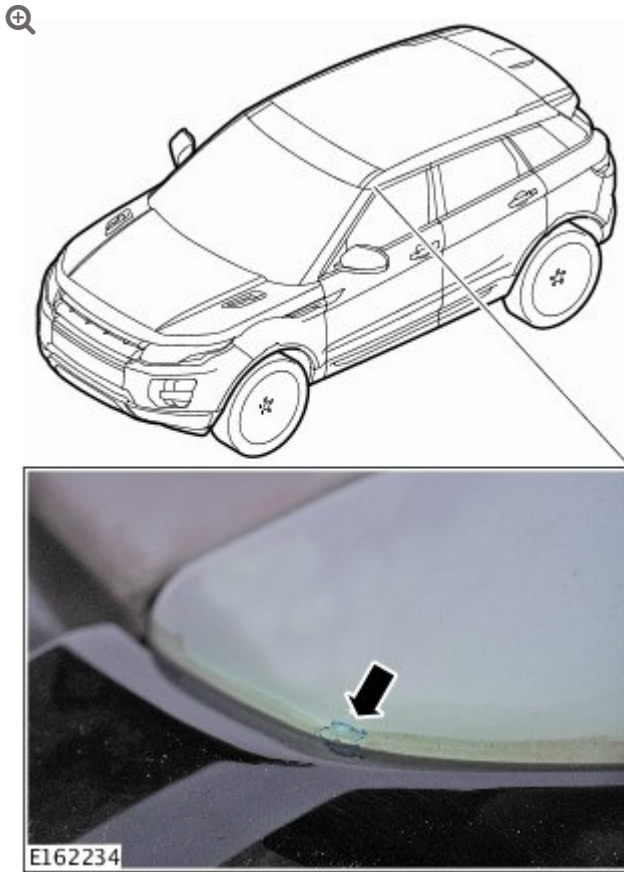
4

Primer undercoat is only required if the paint has worn through to the bare metal.

Repair and touch-up the paint in the affected area (see TOPIx Workshop Manual section 501-25: Body Repairs - Corrosion Protection).
