LTB01094NAS1

TECHNICAL BULLETIN

501-10: Seating

Third Row Left Seatback Does Not Fold

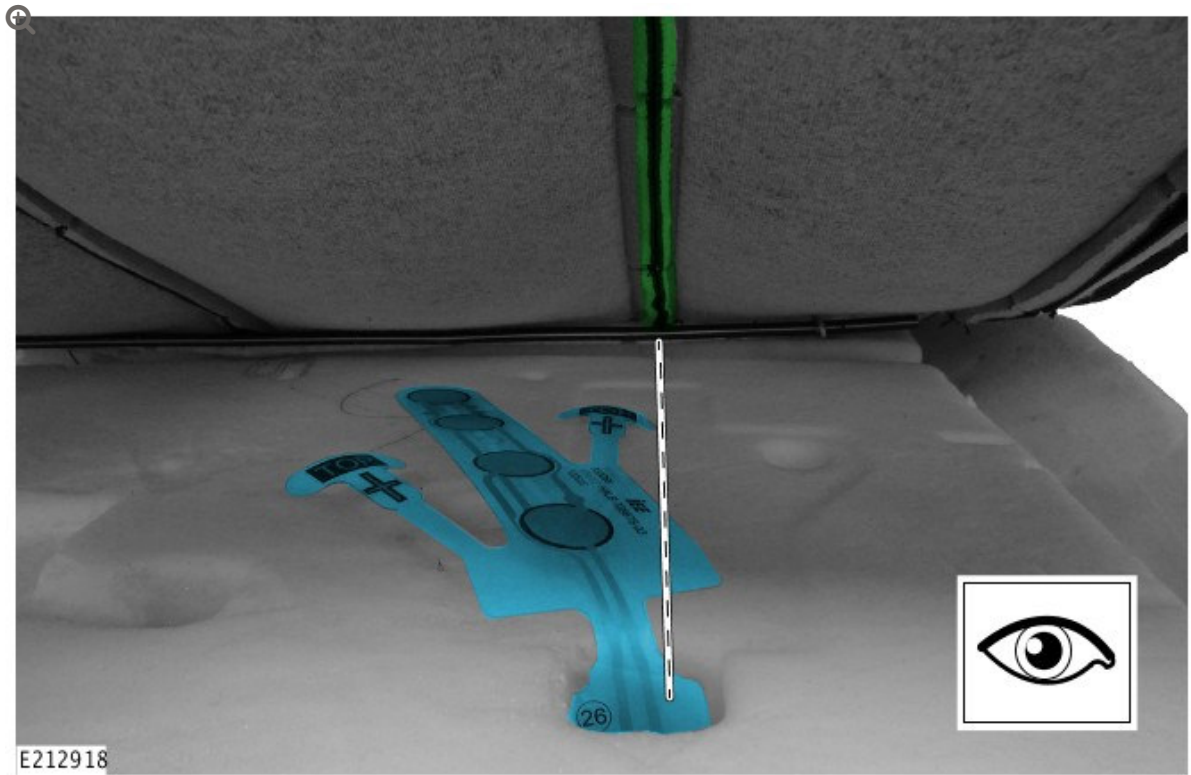
Make sure the anti-trap sensor does not contact the seat cushion cover seam.

Install the third row left seat cushion cover (see TOPIx Workshop Manual section 501-10: Seating - Removal and Installation - Third row seat cushion cover).
