Reference	SSM73531
Models	Range Rover Evoque / L538
Title	Range Rover Evoque (L538) Dynamic Suspension damper lower retention nut
Category	Chassis
Last modified	04-Sep-2017 00:00:00
Symptom	304000 Suspension System
Attachments	JLR Dynamic Suspension Damper Build code identification.png (JLR Dynamic Suspension Damper Build code identification.png)

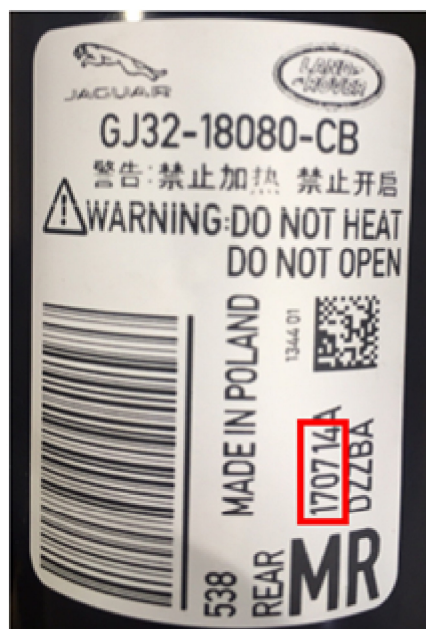
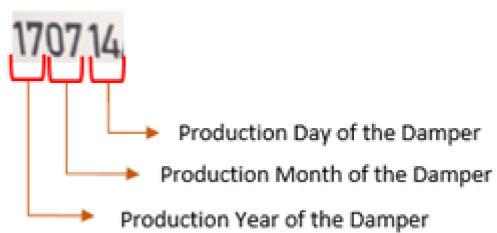
An automatic nut torque application machine in the build process intermittently did not apply the correct assembly torque to the damper lower retention nut. This was observed to have occurred on only two dates, 3rd July 2017 and 7th July 2017.

**Affected Production Codes are 170707 and 170703
for LR079421, LR070932 and LR079420.**

As per the attached instruction, retailers are requested to check any components they have received during this period and identify the build date from the damper. Should the dates be either '**170707**' or '**170703**', then retailers are advised to return the parts to Neovia and request replacements. All components supplied and available from Neovia since 16th August 2017 have been verified and are not subject to this reported defect.

In the instance of such reports, retailers are first requested to confirm whether the damper build code is within the affected range. If so, retailers are requested to replace the damper and return with reference to this SSM.
