# LTB00631NAS5 TECHNICAL BULLETIN 22 SEP 2017

501-14: Handles, Locks, Latches and Entry Systems

Smart Key Handset - Lower-Level Service Repair

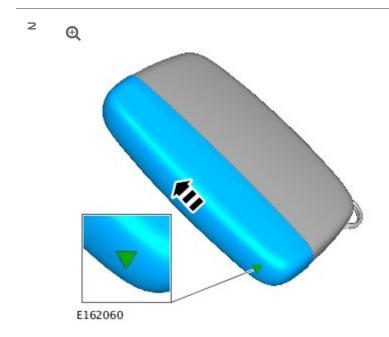
Identify the type of Smart key handset currently fitted -- 'matte' or 'gloss' -- to the vehicle to ensure a like-for-like replacement handset is fitted.

- Left = matte finish
- Right = gloss finish
