LTB01065NAS1

TECHNICAL BULLETIN

501-03: Body Closures

Tailgate Does Not Open

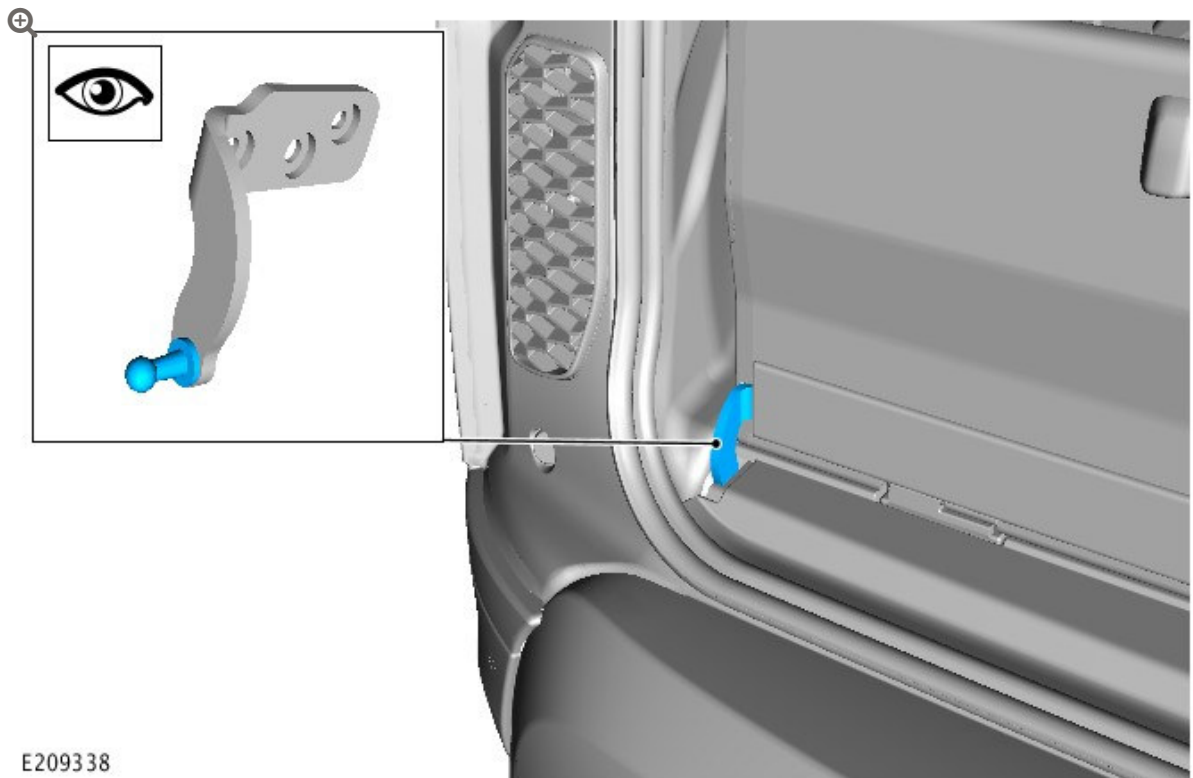
1

Deployable luggage compartment floor operating arm location.

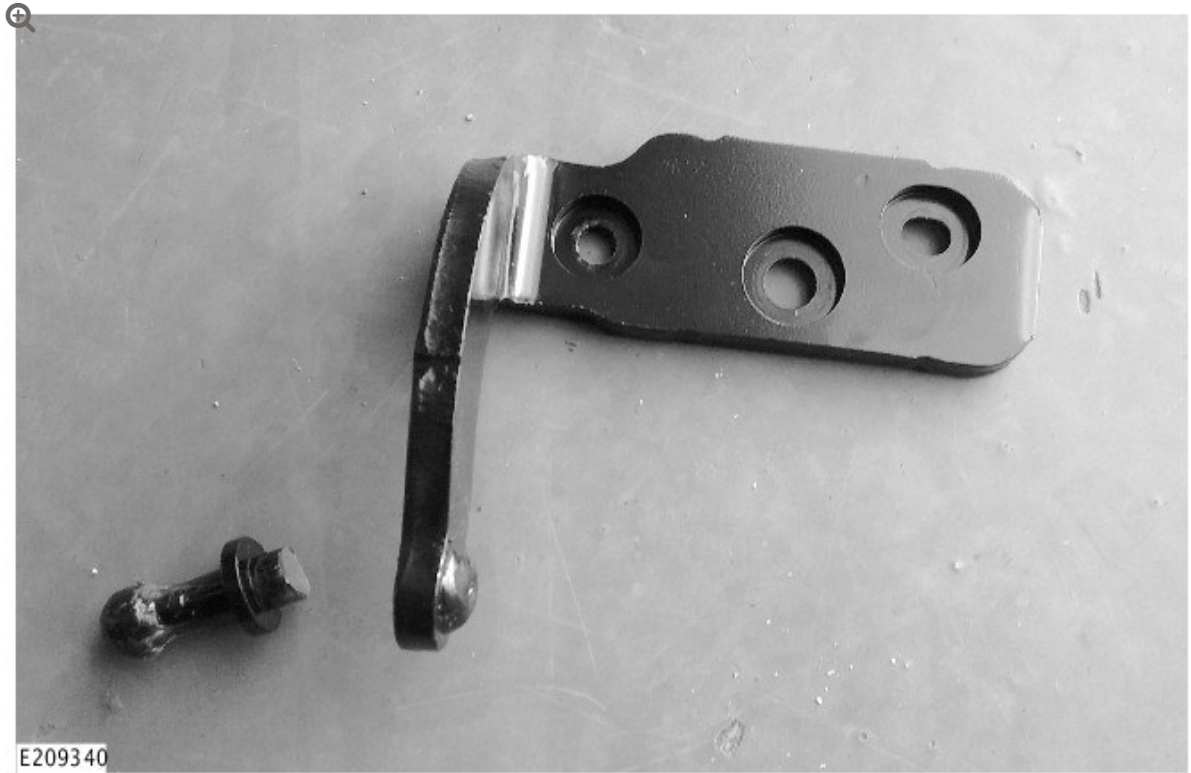
Failed condition shown; the deployable luggage compartment floor operating arm may not be as shown.

Example: deployable luggage compartment floor operating arm damage.

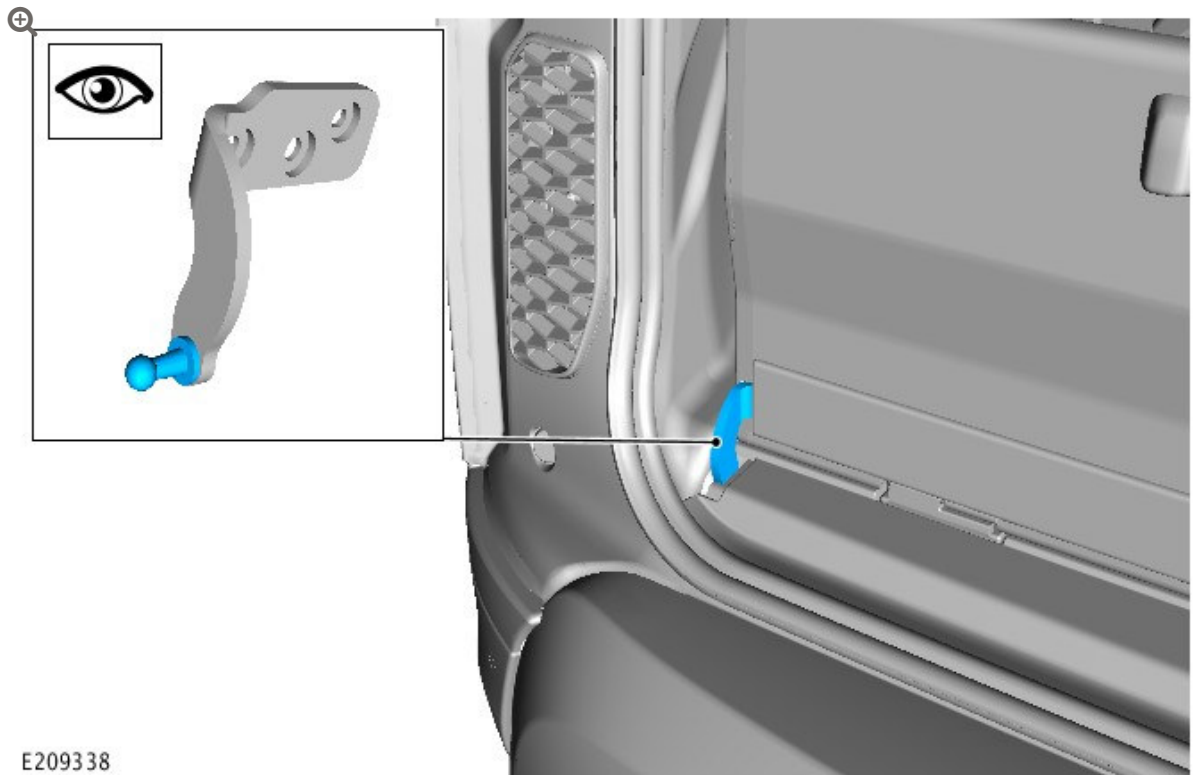
Inspect the deployable luggage compartment floor operating arm for damage (cracks/fractures).

- If the arm is not damaged, go to:
 - **VIN 011189-017814** - No further action required.
 - **VIN 000127-011188** - WORKSHOP PROCEDURE 'B'.
- If the arm is damaged, go to the next Step.

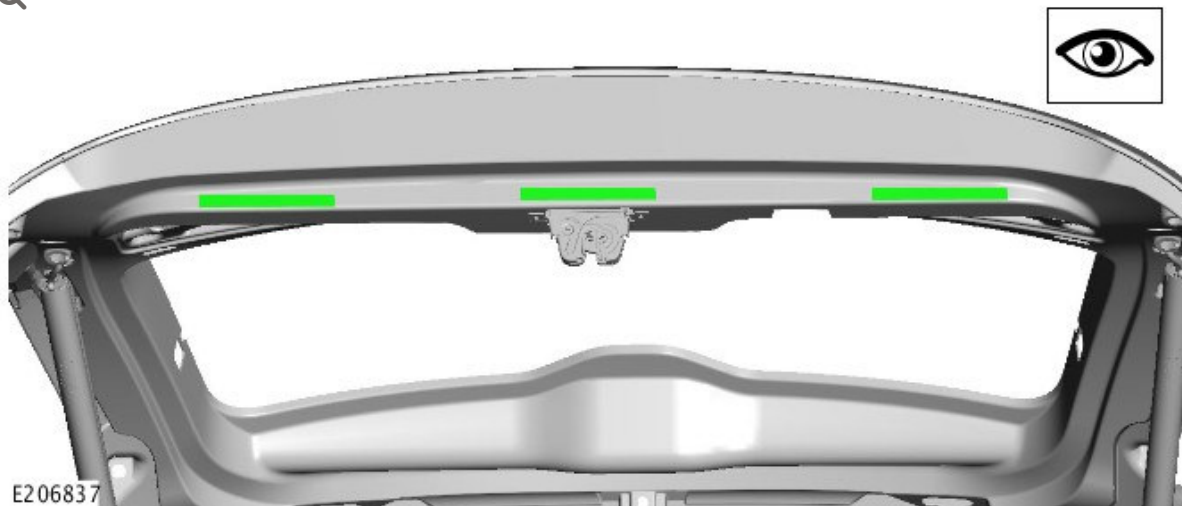
Visually inspect the tailgate.

- If chalk is not visible on the tailgate, go to Step 17.
- If chalk is visible on the tailgate, clean the chalk from the tailgate and go to Step 8.

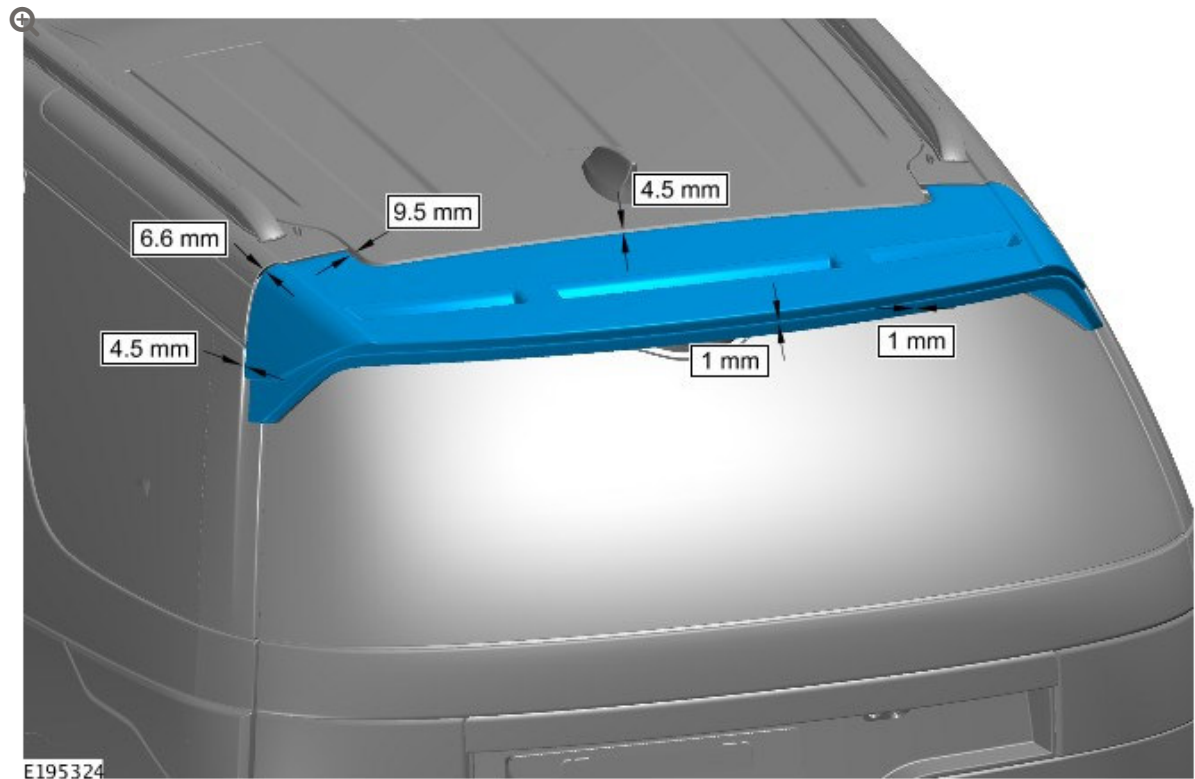
Visually check the rear spoiler alignment.

- If the rear spoiler alignment is correct, go to Step 19.
- If the rear spoiler alignment is not correct, adjust the rear spoiler alignment (see TOPIx Workshop Manual section 501-03: Exterior Trim and Ornamentation - Rear Spoiler [steps 5-9 of the installation procedure]).
