**JAGUAR LAND ROVER SHOP FOREMAN CONFERENCE CALL
SEPTEMBER 14TH 2017**

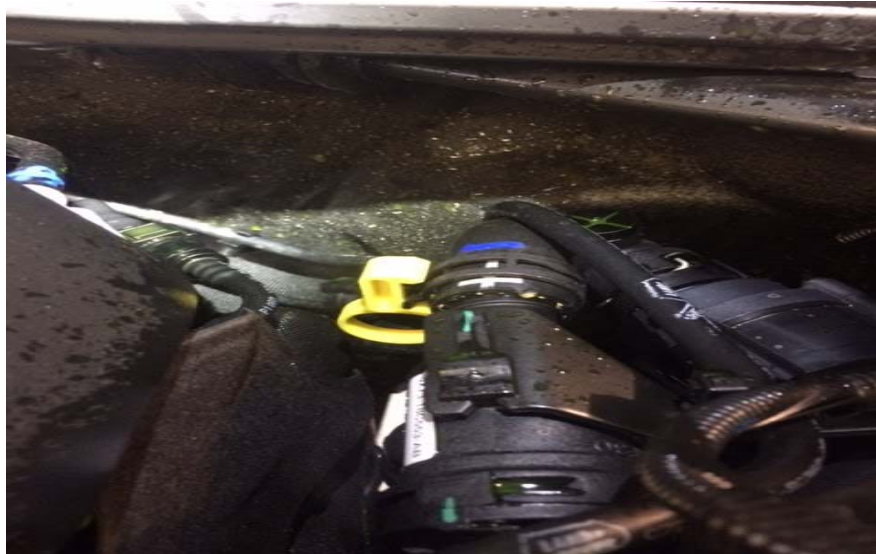
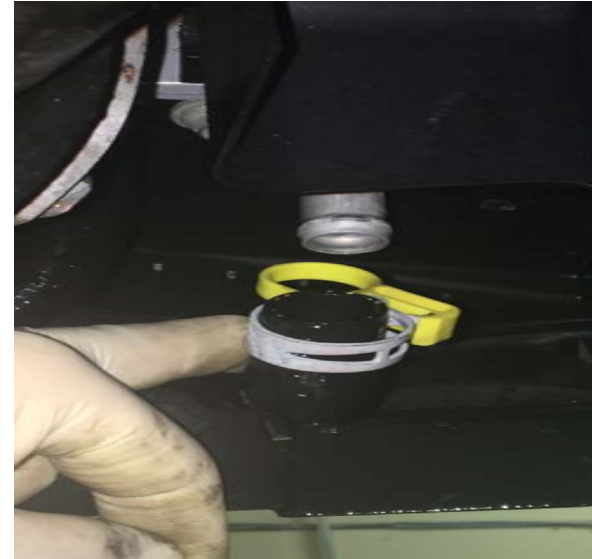
Vehicle	Customer Concern	Details and Status	Publication
XCL	Coolant leaking from the vehicle.	A customer may report a coolant leak from the vehicle shortly after vehicle delivery. It is possible the assembly clip used to hold the coolant hose clamp open remains on a cooling system hose clamp. If an assembly clip is found still installed, please report the vehicle by raising an EPQR. Please include pictures of the assembly clip in place.	TBD

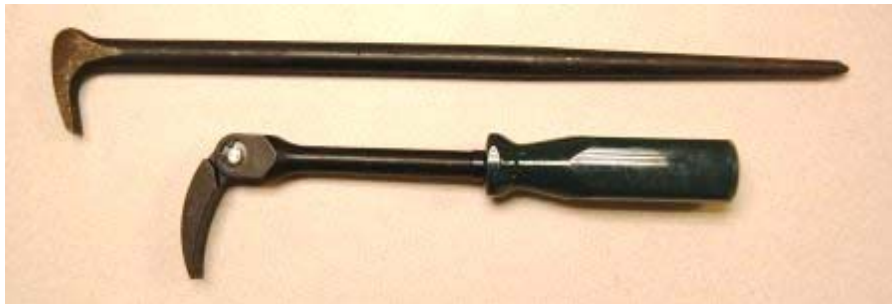
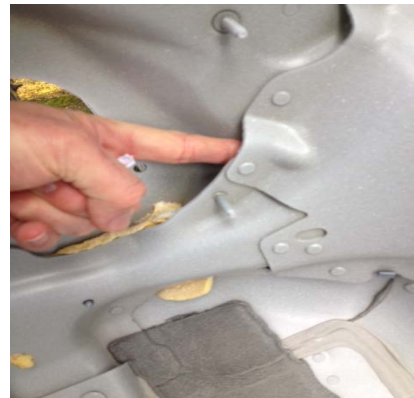
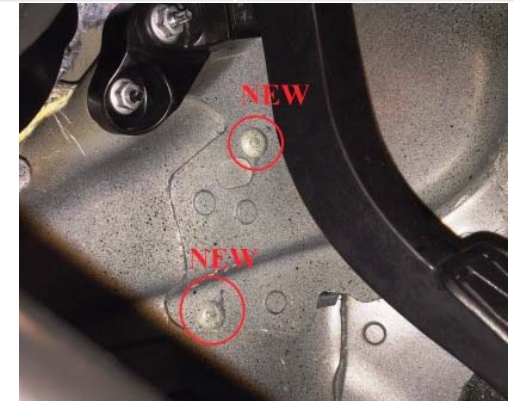
Example of a suitable tool to create panel separation & install foam padding

Vehicle	Customer Concern	Details and Status	Publication
Range Rover 13 – 16MY RR Sport 14 – 16MY	A Customer may report the under hood NVH pads have become torn.	This is most likely caused by the NVH pads absorbing moisture and freezing to the hood panel, then becoming torn when the hood is open while frozen. TSB LTB00814 is being updated to include replacing the dirty air duct guides to address this concern.	LTB00814NAS4 On Sign-off
F-PACE XE	Customers may report a creaking/ ticking type noise from the accelerator pedal or steering column area.	This may be caused by the bulkhead panel moving against the reinforcement panel. Should a customer express a concern, please refer to TSB JTB00567NAS1 to repair the concern by increasing the clearance between the bulkhead panel and the reinforcement panel and add two additional body rivets. Note: DO NOT add any more rivets to the vehicle other than those specified in the TSB. If after performing the TSB procedure exactly as written the noise concern is not resolved, please submit a TA case for assistance.	JTB00567NAS1
