Service Bulletin 551 Issue 1

Subject: Coolant Tee Piece Torque Change				
Bulletin Number	Models Affected	VIN Range		Markets Affected
551	Street Triple 660cc A2 Restricted Licence Version	From	823373	All Markets
		Up to	853473	
	Street Triple S	From	803572	All Markets
		Up to	853473	
	Street Triple R	From	806646	All Markets
		Up to	853473	
	Street Triple S 660cc	From	818083	All Markets
		Up to	853473	
	Street Triple R LRH	From	822626	All Markets
		Up to	853473	
	Street Triple RS	From	800262	All Markets
		Up to	853473

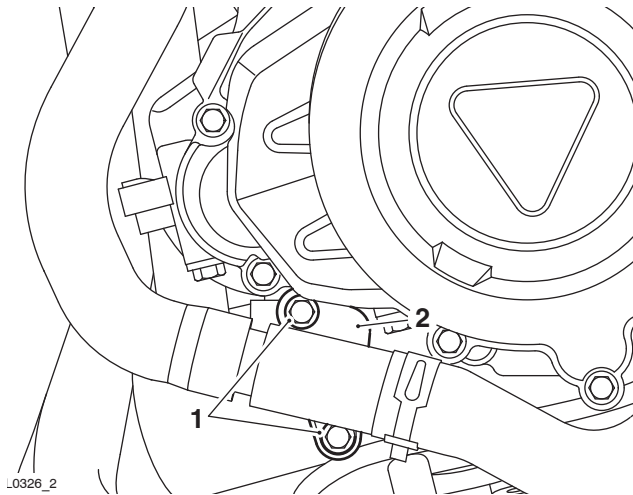
1. Locate the coolant tee piece on the left hand side of the lower crankcase.

1. Fixings
2. Coolant tee piece

2. Torque the fixings to 10 Nm.
