RECREATIONAL VEHICLE SERVICE CAMPAIGN

SERVICE ADVISORY 17-298

Springdale 38BH Bunk Support

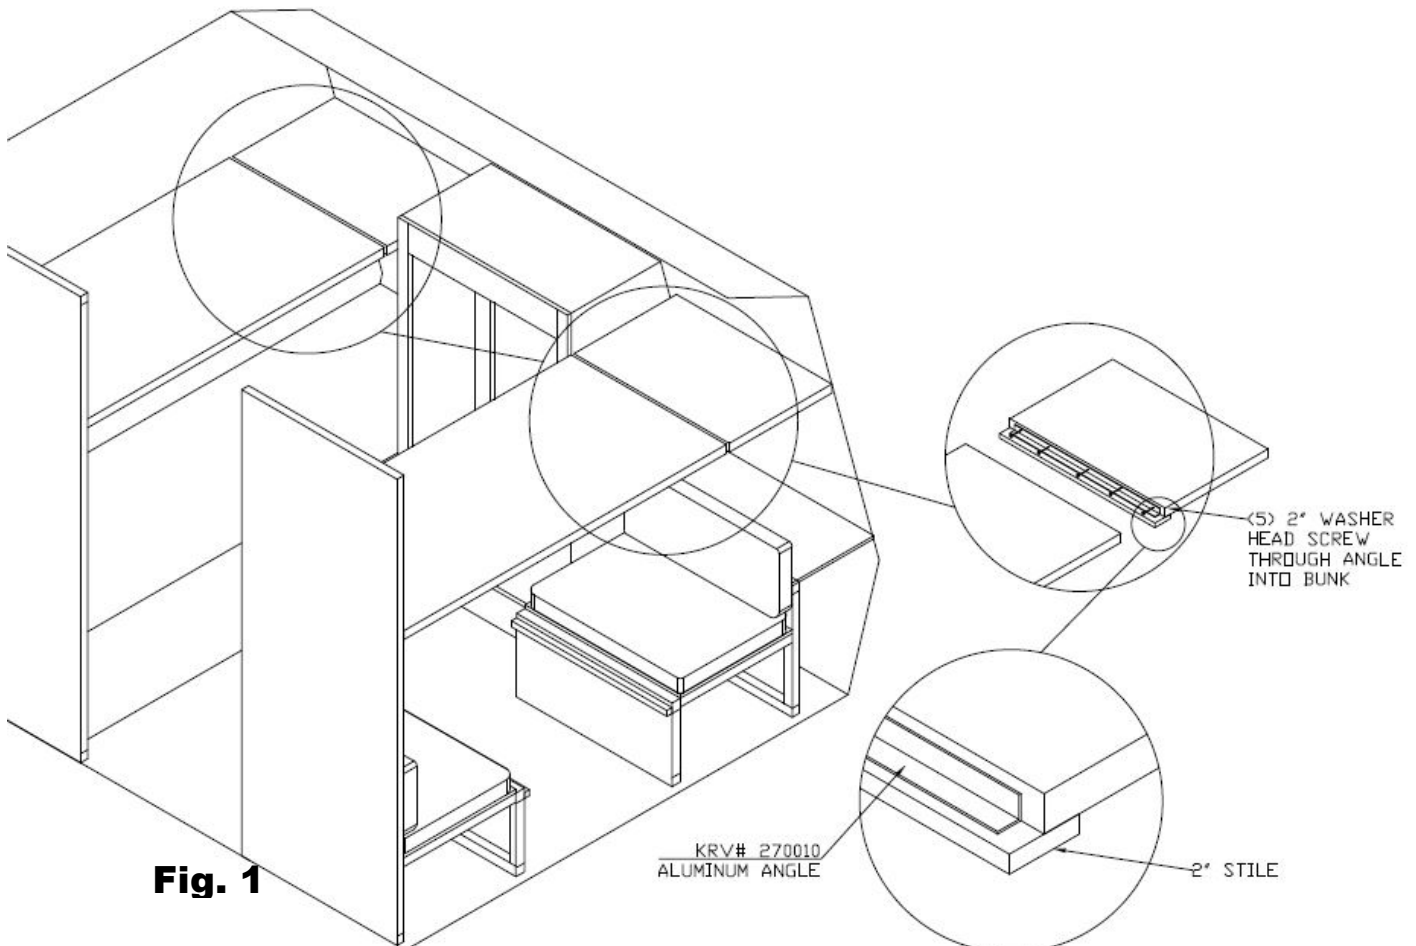
It has been determined some 2018 Springdale 38BH models were built with support that may be inadequate for the rear upper bunks, additional support must be added. This service advisory explains how to add additional fasteners.

Locate the support for the upper bunks in the rear of the unit, Figure 1.

Cut aluminum angle (270010) to fit existing support and install according to Figure 1, using 5 screws in each support as indicated.
