Authorized Field Change

AFC 17904

Subject: Update Instrument Cluster, Body Control Module (BCM), Light Control Module (LCM), Switch Pack Modules, and Stalk Shifter Module

Model: Certain International® LT™ Series and RH™ Series model trucks built 01 June 2015 through 14 August 2017.

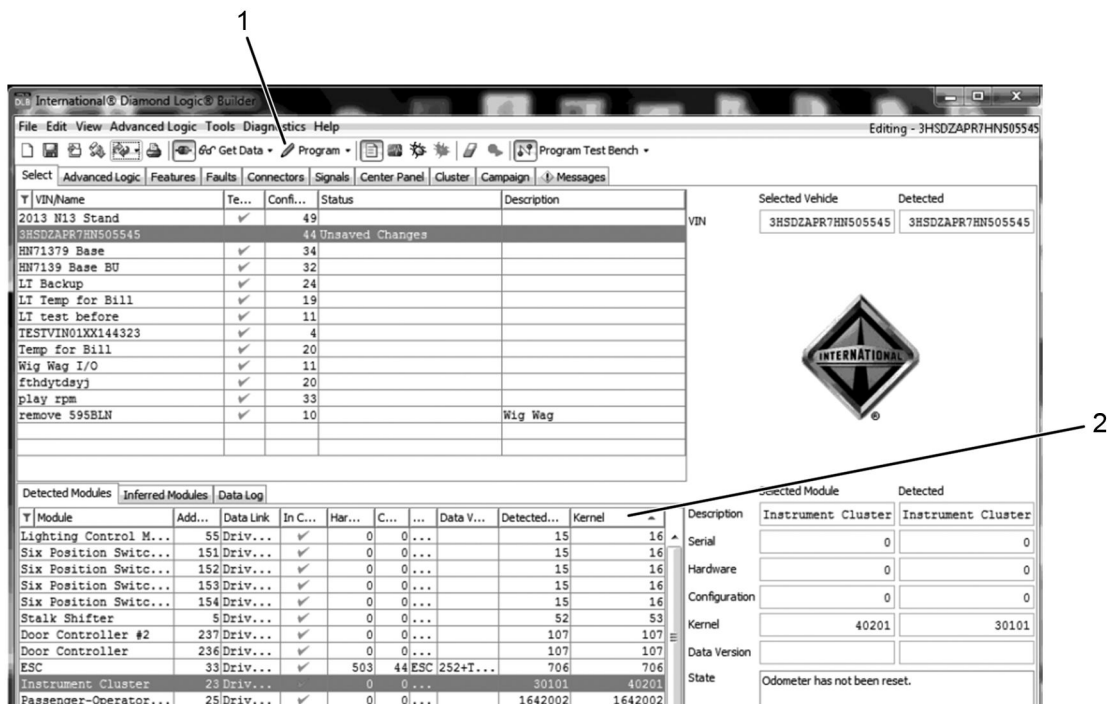
Figure 3. Detected Modules: After Update

1. Program icon
2. Kernel column

10. Once the versions in the Kernel column (Figure 3, Item 2) have been updated, click the Program icon (Figure 3, Item 1) in the toolbar.
11. At this point, several messages regarding programming of the body controller may be displayed. Respond to these prompts in the same way you would during normal body controller programming.
12. Once programming begins, DLB will indicate programming status in the status bar at the bottom of the window. Programming may take up to 60 minutes, depending on how many modules are being updated.

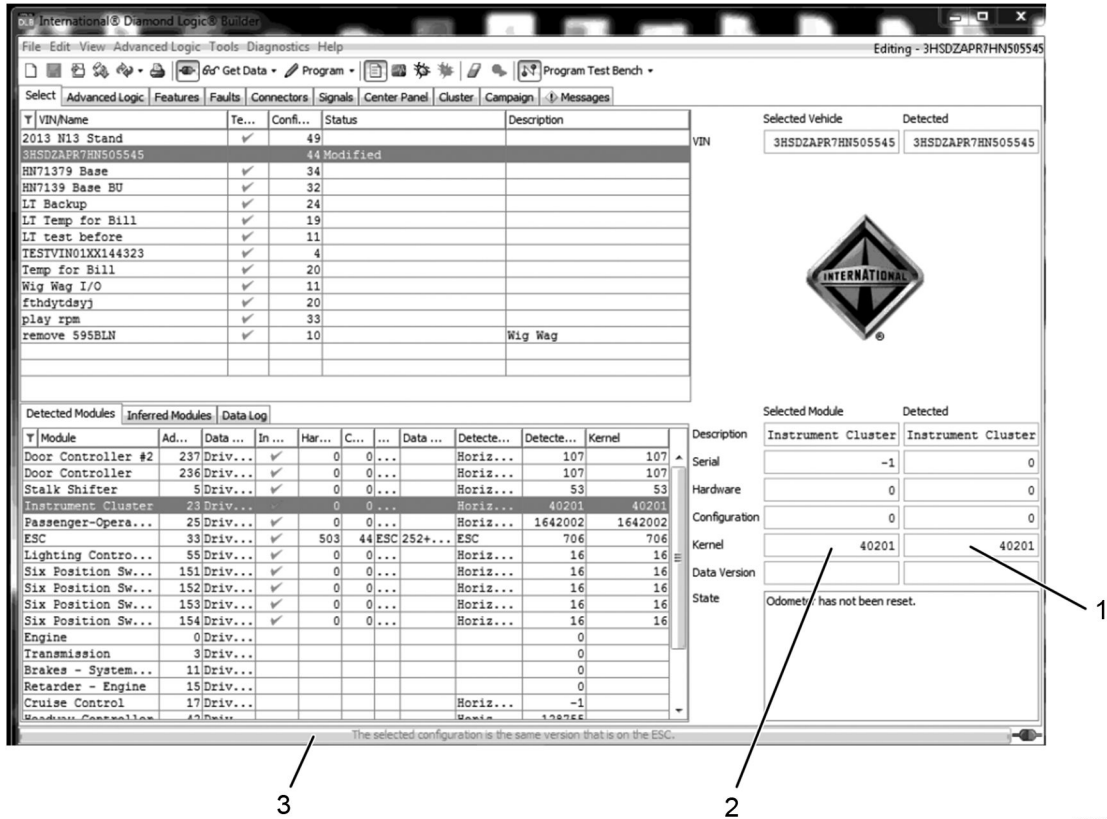
Figure 4. Programming Complete

1. Detected kernel version
2. Selected Module kernel version
3. Status bar

13. Verify that programming is complete by selecting each updated module. If the update has been finished for the selected module, the kernel version listed in the Selected Module column (Figure 4, Item 2) will match the version listed in the Detected column (Figure 4, Item 1). Additionally, the status bar at the bottom of the window (Figure 4, Item 3) will display “The selected configuration is the same that is on the ESC.”
