Authorized Field Change

AFC 17905

Subject: Update Instrument Cluster, Body Control Module (BCM), Light Control Module (LCM), Switch Pack Modules, Stalk Shifter Module and Aero Bumper Rock Screen.

Model: Certain International® LT™ and International® RH™ model trucks.
Start Date: 17 May 2016 End Date: 22 July 2017

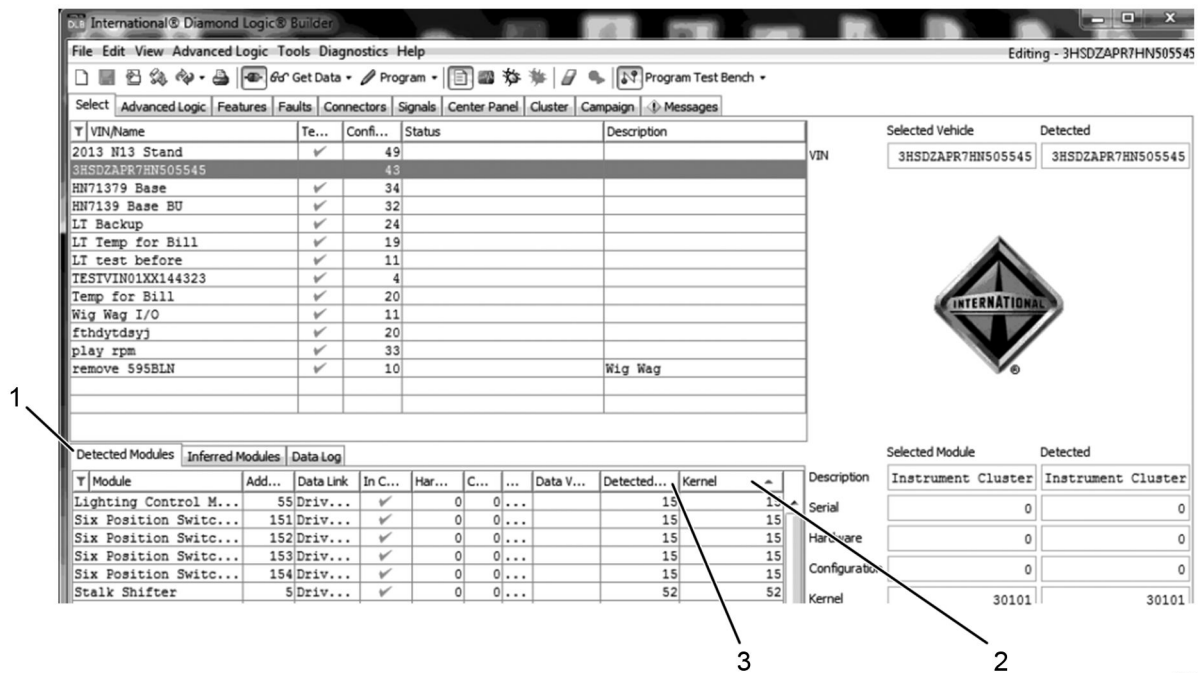
Figure 1. Detected Modules: Before Update

1. Detected Modules tab
2. Column headings
3. Detected and Kernel columns

7. Select the Detected Modules tab (Figure 1, Item 1) to see the kernel information for this vehicle.
8. If the Detected Kernel and Kernel columns are not displayed, enable their display by right clicking on any column heading (Figure 1, Item 2) and then selecting these columns in the right-click menu.

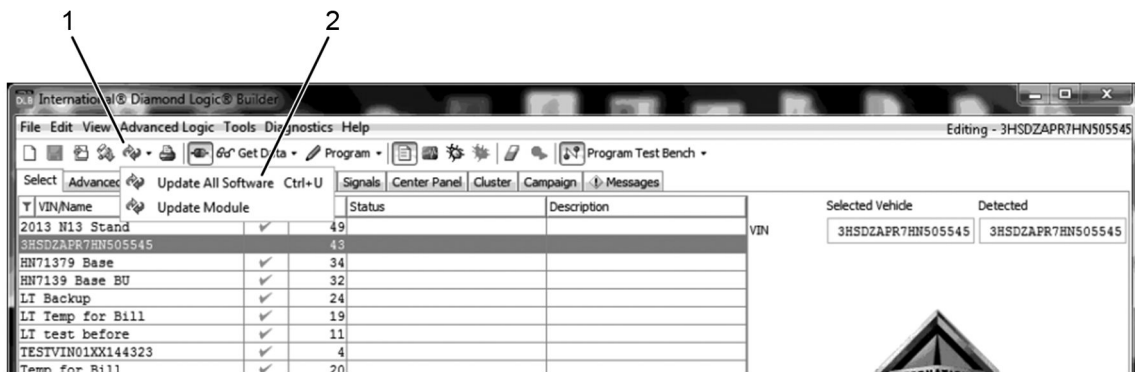
Figure 2. Update All

1. Update All icon
2. Update All Software

9. Click the Update All icon in the toolbar (Figure 2, Item 1) and select the Update All Software option (Figure 2, Item 2). DLB will update the versions displayed in the Kernel column to the latest versions available.

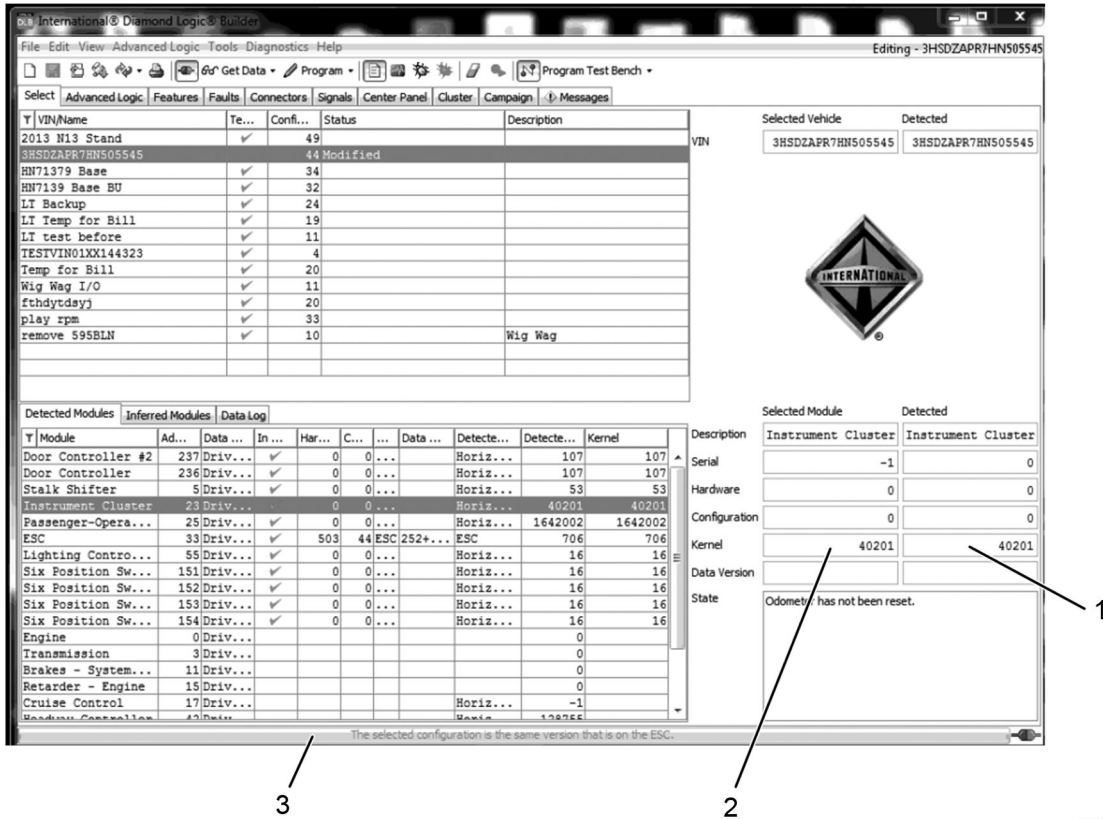
Figure 4. Programming Complete

1. Detected kernel version
2. Selected Module kernel version
3. Status bar

13. Verify that programming is complete by selecting each updated module. If the update has been finished for the selected module, the kernel version listed in the Selected Module column (Figure 4, Item 2) will match the version listed in the Detected column (Figure 4, Item 1). Additionally, the status bar at the bottom of the window (Figure 4, Item 3) will display “The selected configuration is the same that is on the ESC.”
14. Disconnect DLB from vehicle by clicking on Disconnect icon, switching vehicle ignition to Key OFF, Engine OFF position, and disconnecting the interface connector from the diagnostic port.
15. Reconnect interface connector to diagnostic port, switch vehicle ignition to Key ON, Engine OFF position and click DLB’s connect icon.

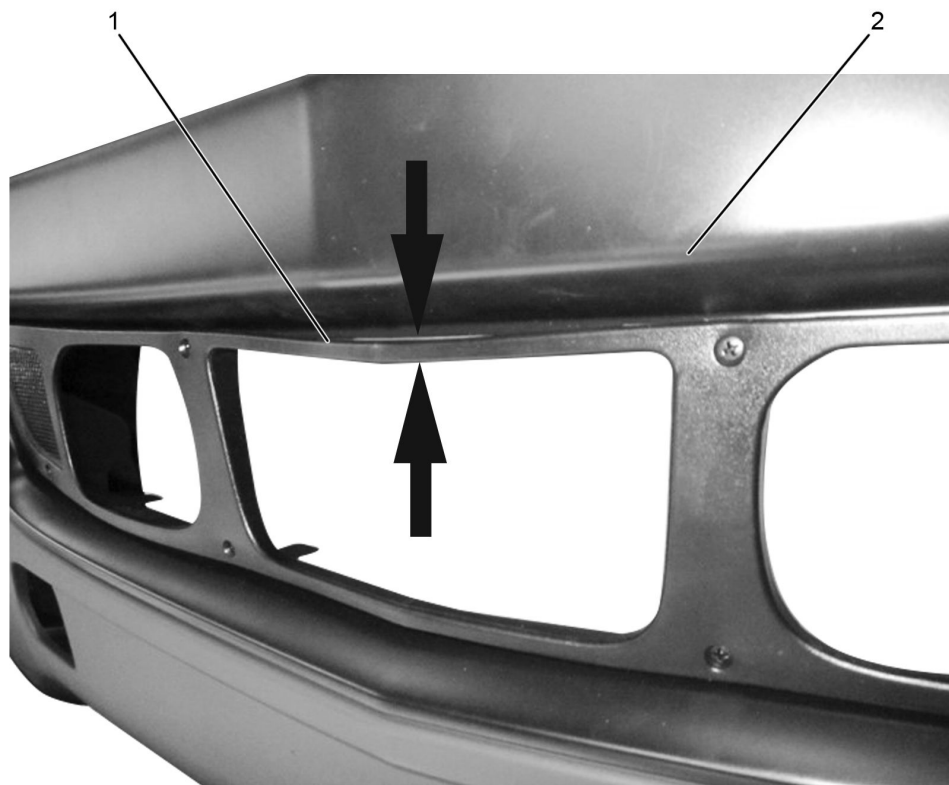
Figure 5. Rock Screen Radar Frame (Bumper Exterior)

1. Bumper rock screen radar frame
2. Bumper applique

NOTE: Collision avoidance radar may malfunction or cause fault codes if rock screen radar frame blocks the radar signal.

20. Locate center of rock screen radar frame (Figure 5, Item 1) and bumper applique (Figure 5, Item 2).

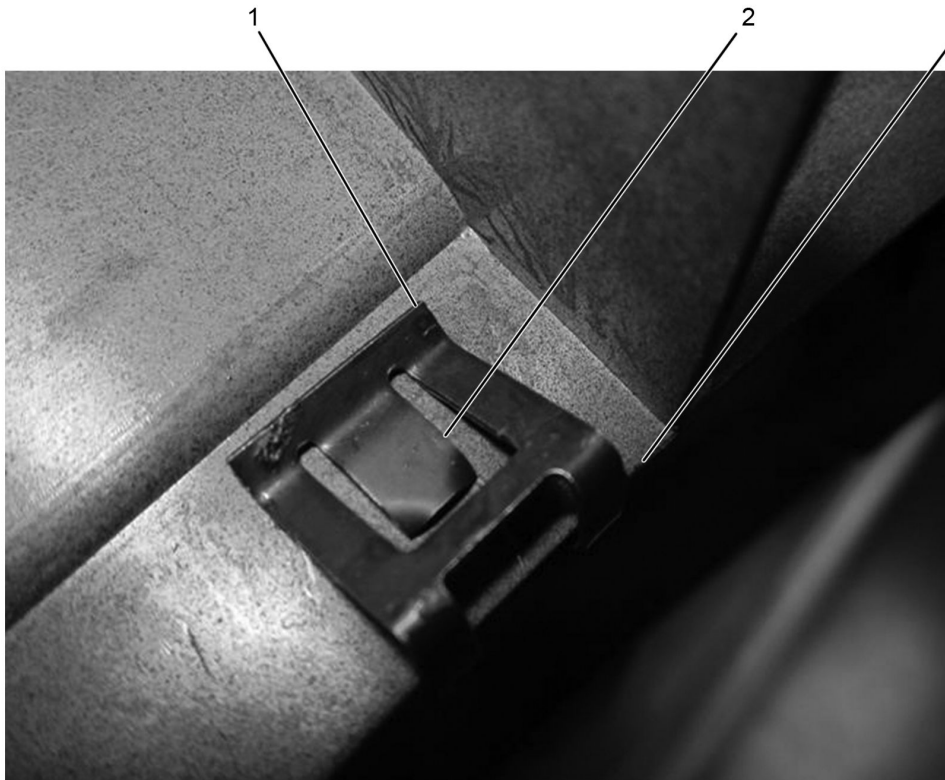
Figure 7. U-Clip Fastener

1. U-clip fastener
2. Retaining tab
3. Bumper applique

23. Visually inspect the inside bumper to ensure U-clip fastener (Figure 7, Item 1) is oriented with retaining tab (Figure 7, Item 2) face up onto bumper applique (Figure 7, Item 3) and seated fully.
