Authorized Field Change

AFC 17908

Subject: Update Instrument Cluster, Body Control Module (BCM), Light Control Module (LCM), Switch Pack Modules, Stalk Shifter Module, and Inspection of Powertrain Harness Routing.

Model: Certain International® LT™ Series and International® RH™ Series model trucks.
Start Date: 07 July 2017 End Date: 12 August 2017

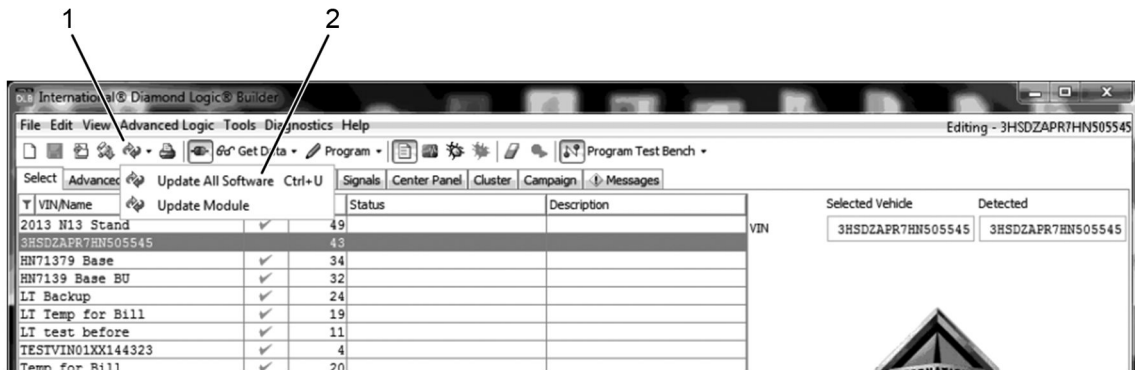
Figure 2. Update All

1. Update All icon
2. Update All Software

9. Click the Update All icon in the toolbar (Figure 2, Item 1) and select the Update All Software option (Figure 2, Item 2). DLB will update the versions displayed in the Kernel column to the latest versions available.

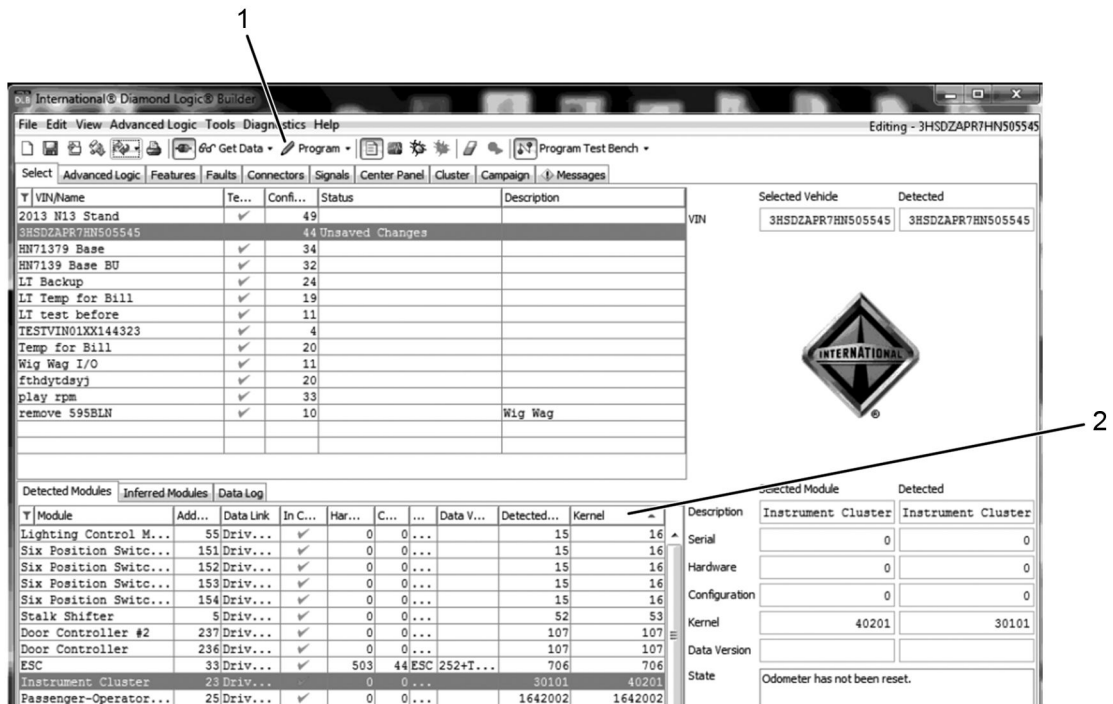
Figure 3. Detected Modules: After Update

1. Program icon
2. Kernel column

10. Once the versions in the Kernel column (Figure 3, Item 2) have been updated, click the Program icon (Figure 3, Item 1) in the toolbar.
11. At this point, several messages regarding programming of the body controller may be displayed. Respond to these prompts in the same way you would during normal body controller programming.
12. Once programming begins, DLB will indicate programming status in the status bar at the bottom of the window. Programming may take up to 60 minutes, depending on how many modules are being updated.

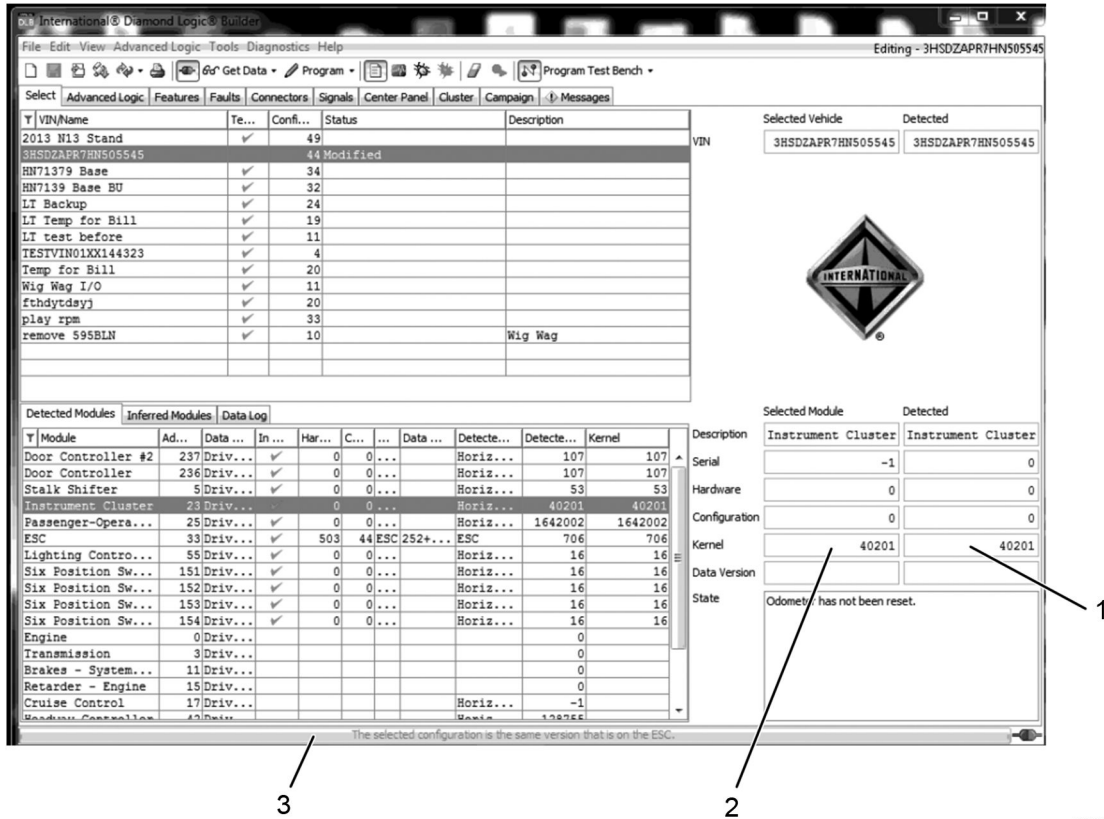
Figure 4. Programming Complete

1. Detected kernel version
2. Selected Module kernel version
3. Status bar

13. Verify that programming is complete by selecting each updated module. If the update has been finished for the selected module, the kernel version listed in the Selected Module column (Figure 4, Item 2) will match the version listed in the Detected column (Figure 4, Item 1). Additionally, the status bar at the bottom of the window (Figure 4, Item 3) will display “The selected configuration is the same that is on the ESC.”
14. Disconnect DLB from vehicle by clicking on Disconnect icon, switching vehicle ignition to Key OFF, Engine OFF position, and disconnecting the interface connector from the diagnostic port.
15. Reconnect interface connector to diagnostic port, switch vehicle ignition to Key ON, Engine OFF position and click DLB’s connect icon.

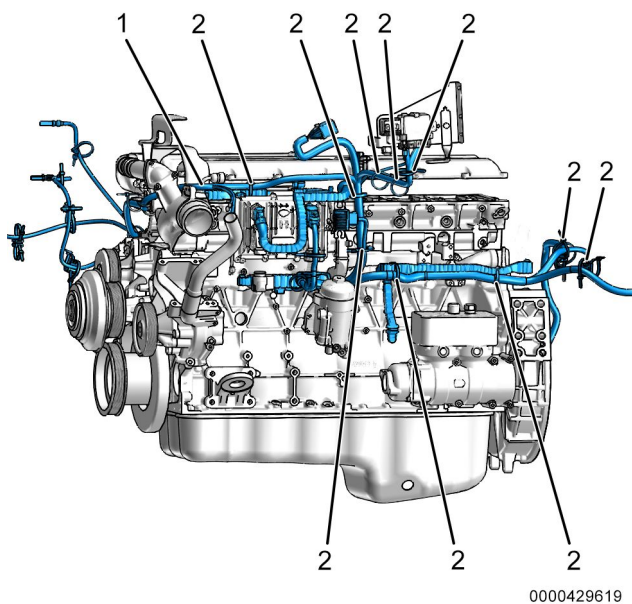
Figure 5. Left-side Tie Strap Locations

20. Unlatch and open hood.
21. Locate powertrain harness near air compressor discharge line and left engine mount.
22. Inspect powertrain harness; if harness is not rubbing or not in contact with mount proceed to Step 27.

1. Harness
2. Tie strap (10)

23. Locate tie strap clips; if tie straps are not installed, adjust harness (Figure 5, Item 1) routing and install tie straps (Figure 5, Item 2). If tie straps are installed, proceed to Step 24.

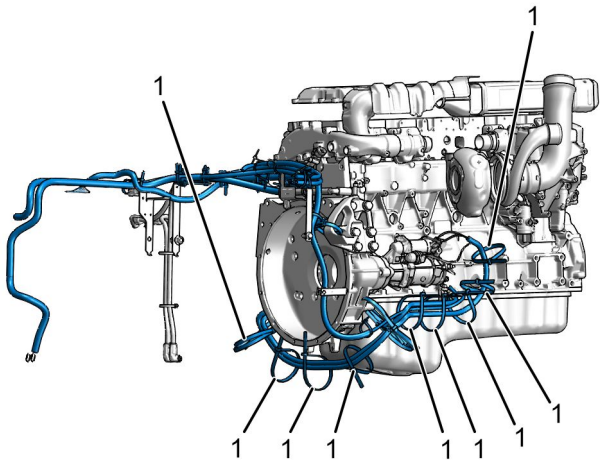
Figure 6. Rear Tie Strap Locations

1. Tie strap clip (9)

24. Locate tie strap clips (Figure 6, Item 1) on harness underneath turbocharger; if tie straps are not installed, adjust harness routing and install tie straps.

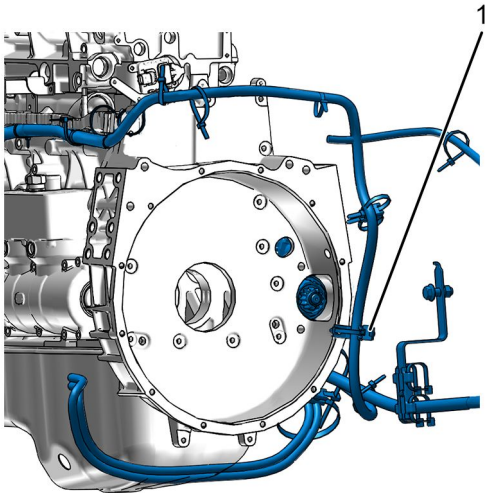
Figure 7. LT Rear Bracket

1. Bracket

25. On LT™ Series vehicle, locate rear bracket (Figure 7, Item 1) and secure harness to bracket.

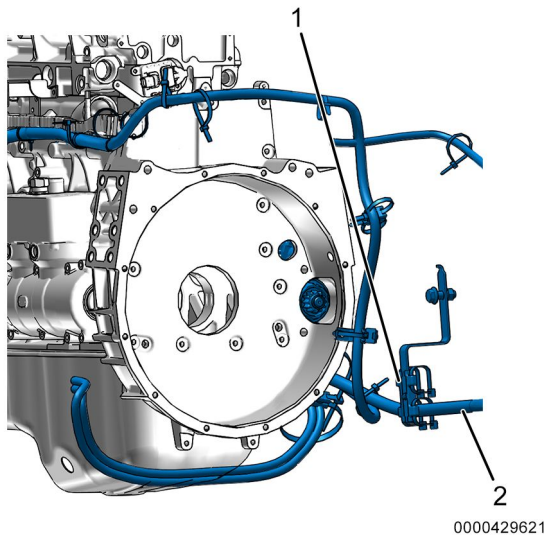
Figure 8. RH Rear Bracket

1. Clip point
2. Starter wire

26. On RH™ Series vehicles or units with frame rail battery boxes, locate clip point (Figure 8, Item 1). If missing, secure powertrain harness to starter wire (Figure 8, Item 2).
