# Authorized Field Change

AFC 17911

**Subject File:** Uptime Improvements

**Subject:** Update Instrument Cluster, Body Control Module (BCM), Light Control Module (LCM), Switch Pack Modules, Stalk Shifter Module, Auxiliary Battery Interconnect cables, and Aero Bumper Rock Screen.

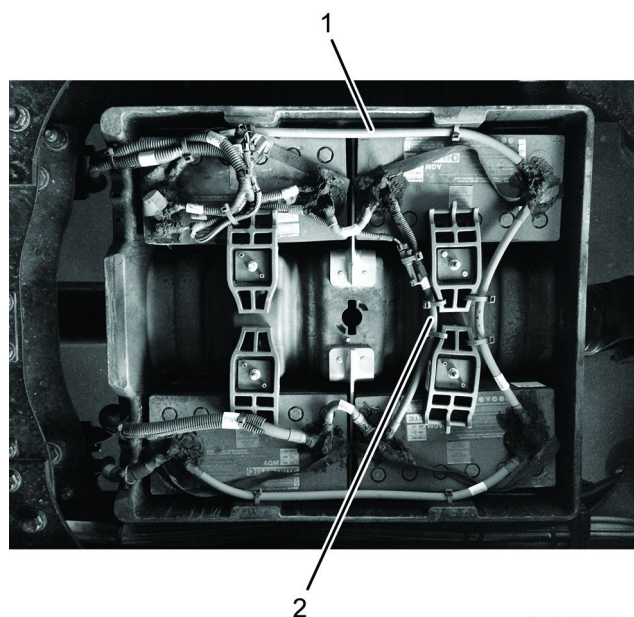
**Figure 5. Battery Interconnect Cables**

## EXCESSIVE VOLTAGE DROP AUXILIARY BATTERY WITH AUTO START

1. Positive interconnect cable
2. Negative interconnect cable

22. Cut tie straps and remove negative battery interconnect cable (Figure 5, Item 2).
23. Cut tie straps and remove positive battery interconnect cable (Figure 5, Item 1).

24. Install new negative battery interconnect cable.
25. Install new positive battery interconnect cable.
26. Using tie straps, secure negative and positive interconnect to same clipping points as cut in Steps 22 and 23.
27. Using a torque wrench, tighten positive battery post nuts to 142 - 177 lb-in (16 - 20 N•m).
28. Using a torque wrench, tighten negative battery post nuts to 142 - 177 lb-in (16 - 20 N•m).
29. Connect ground cable on main vehicle battery.
30. Apply Grafo dielectric grease to positive and negative battery posts.
31. Install battery box cover.
32. Install deck plate if equipped.

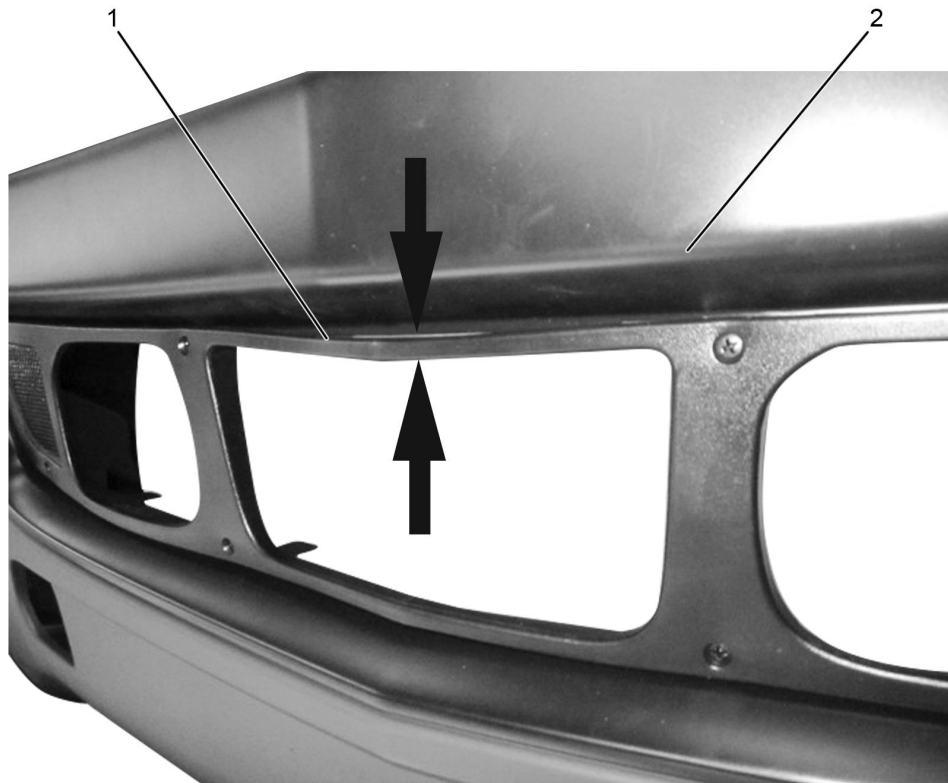
**Figure 6. Rock Screen Radar Frame (Bumper Exterior)**

**NOTE: Collision avoidance radar may malfunction or cause fault codes if rock screen radar frame blocks the radar signal.**

33. Locate center of rock screen radar frame (Figure 6, Item 1) and bumper applique (Figure 6, Item 2).
