# Authorized Field Change

AFC 17916

**Subject:** Update Instrument Cluster, Body Control Module (BCM), Light Control Module (LCM), Switch Pack Modules, Stalk Shifter Module, Aero Bumper Rock Screen and Inspection of Powertrain Harness

Model: Certain International® LT™ Series and International® RH™ Series model trucks.  
Start Date: 06 July 2017 End Date: 22 July 2017

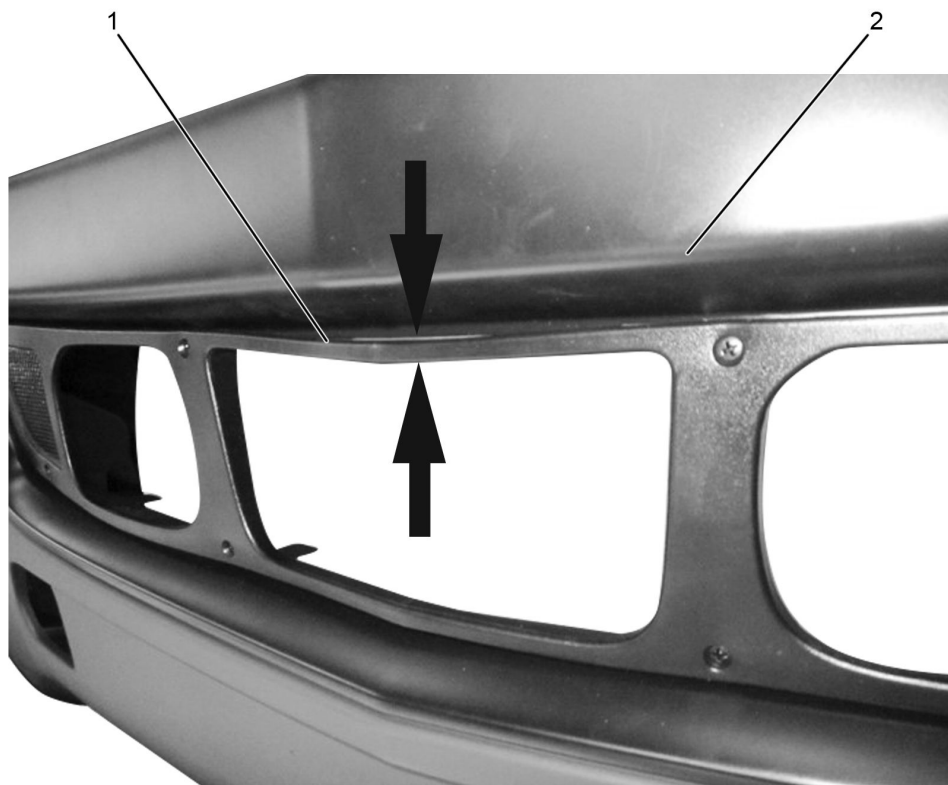
**Figure 5. Rock Screen Radar Frame (Bumper Exterior)**

1. Bumper rock screen radar frame
2. Bumper applique

**NOTE: Collision avoidance radar may malfunction or cause fault codes if rock screen radar frame blocks the radar signal.**

20. Locate center of rock screen radar frame (Figure 5, Item 1) and bumper applique (Figure 5, Item 2).

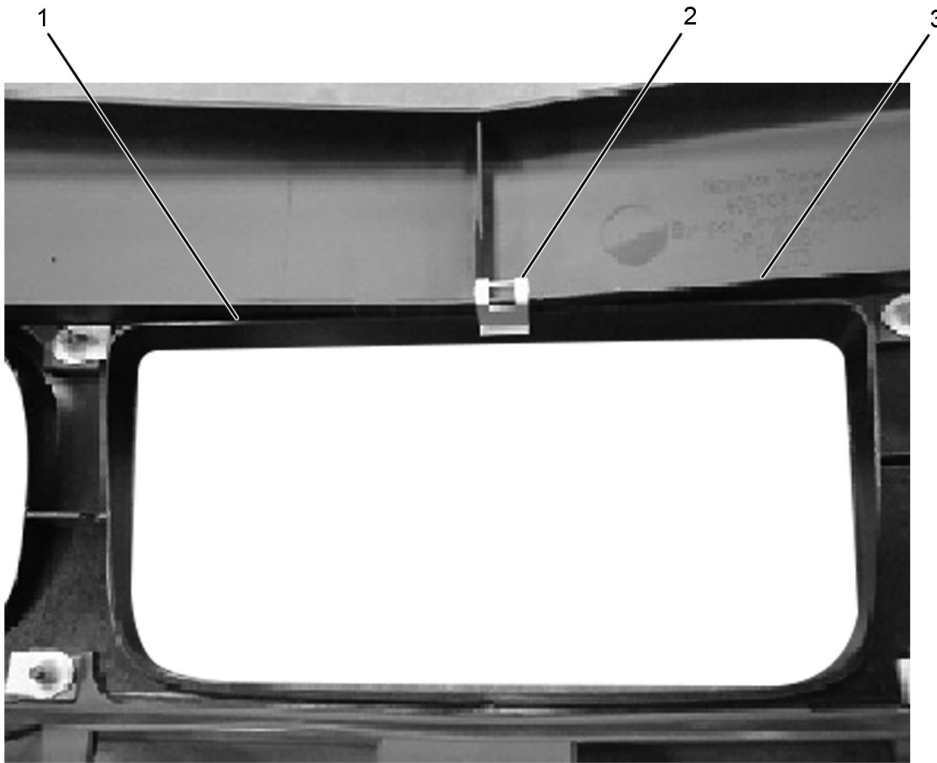
**Figure 6. Rock Screen Radar Frame with U-Clip Fastener (Bumper Interior)**

1. Rock screen radar frame
2. U-clip fastener
3. Bumper applique

21. Align and install U-clip fastener (Figure 6, Item 2) with retaining tab face up to top center area of rock screen radar frame (Figure 6, Item 1), securing radar frame to inside edge of bumper applique (Figure 6, Item 3).

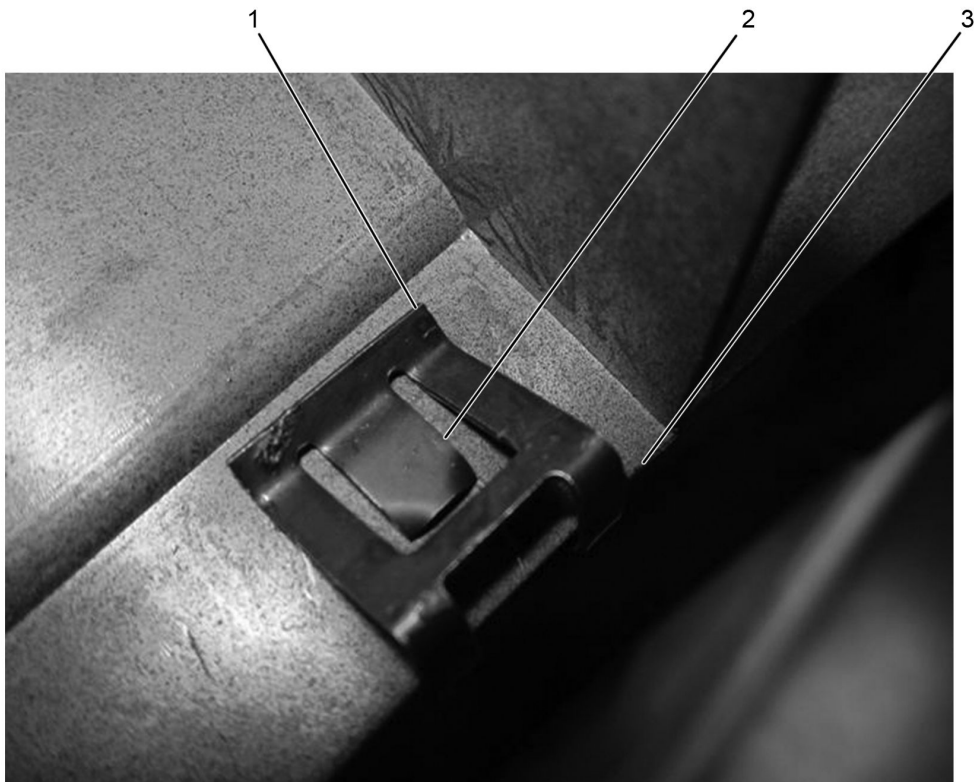
**Figure 7. U-Clip Fastener**

1. U-clip fastener
2. Retaining tab
2. Bumper applique

23. Visually inspect the inside bumper to ensure U-clip fastener (Figure 7, Item 1) is oriented with retaining tab (Figure 7, Item 2) face up onto bumper applique (Figure 7, Item 3) and seated fully.

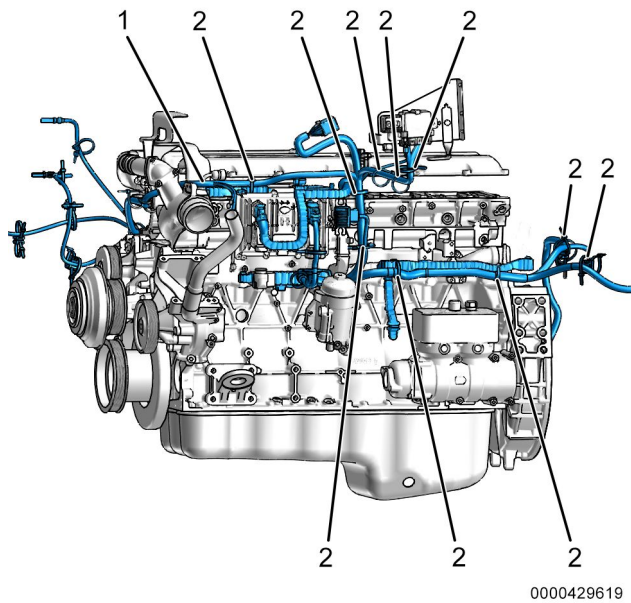
**Figure 8. Left-Side Tie Strap Locations**

24. Locate powertrain harness near air compressor discharge line and left engine mount.
25. Inspect powertrain harness; if harness is not rubbing or not in contact with mount proceed to Step 30.

1. Harness
2. Tie strap (10)

26. Locate tie strap clips; if tie straps are not installed, adjust harness (Figure 8, Item 1) routing and install tie straps (Figure 8, Item 2). If tie straps are installed, proceed to Step 27.

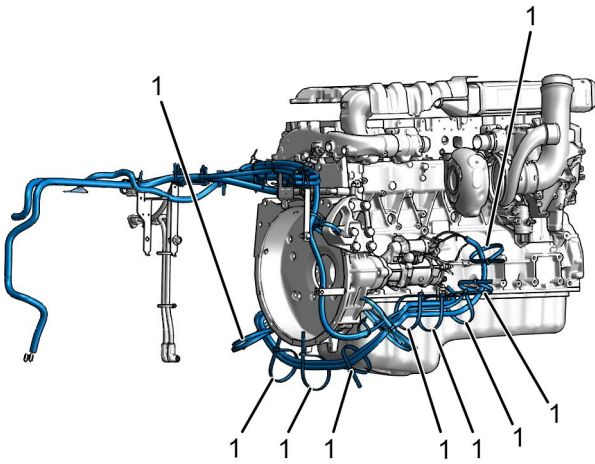
**Figure 9. Rear Tie Strap Locations**

1. Tie strap clip (9)

27. Locate tie strap clips (Figure 9, Item 1) on harness underneath turbocharger; if tie straps are not installed, adjust harness routing and install tie straps.

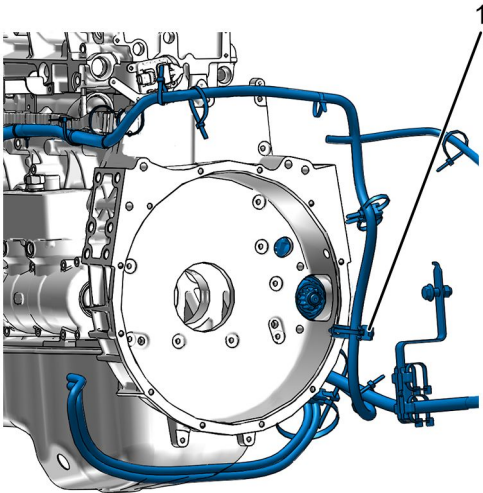
**Figure 10. LT Rear Bracket**

1. Bracket

28. On LT™ Series vehicles, locate rear bracket (Figure 10, Item 1) and secure harness to bracket.

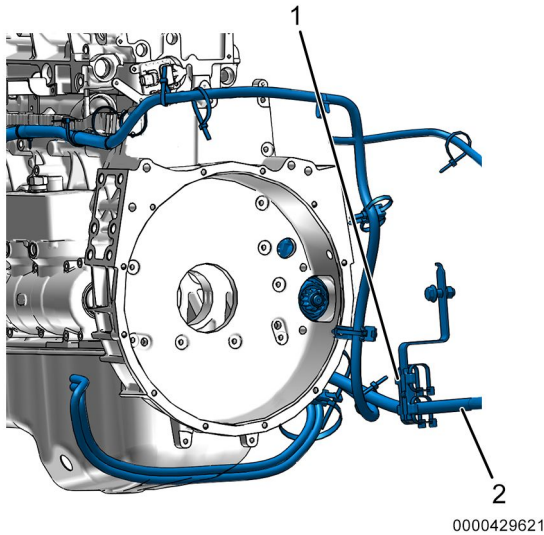
**Figure 11. RH Rear Bracket**

1. Clip point
2. Starter wire

29. On RH™ Series vehicles or units with frame rail battery boxes, locate clip point (Figure 11, Item 1). If missing, secure powertrain harness to starter wire (Figure 11, Item 2).
