**Countries:** CANADA, UNITED STATES **Document ID:** IK0700096  
**Availability:** ISIS, FleetISIS, IsSIR **Revision:** 16  
**Major System:** EXHAUST **Created:** 5/19/2017  
**Current Language:** English **Last Modified:** 11/13/2017  
**Other Languages:** NONE **Author:** Josh Bowman  
**Viewed:** 22118

**Title:** Urea Quality Sensor (UQS) Supplemental Diagnostic and Service Information

**Applies To:** Navistar N9, N10, N13, A26 and Cummins ISB, ISL, ISX built from January 2016 to present

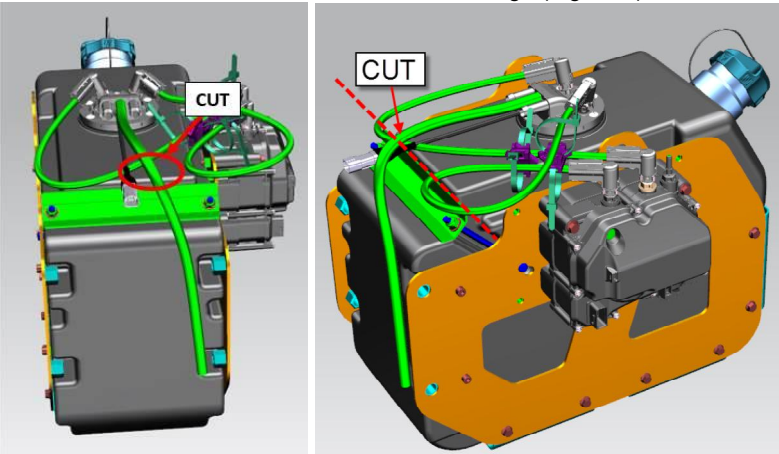
| Step | Action | Decision |
|---|---|---|
| 6 | <b>DIAGNOSTIC:</b><br>Install UQS boot and retest for faults. Refer to Service Parts Information section below for UQS boot kit part number and repair instructions.<br><br>Also, locate the vent tube on the DEF sensor head and cut as shown below. The tube should be cut at the end of the DEF tank edge (Figure 1) :<br><br><br><b>Figure 1: DEF Tank Vent Hose</b><br><br>Are any faults active after boot installation?<br><br>*Fault code monitors may take several minutes to come active. Refer to appropriate manual to locate the conditions for setting the fault code. | <b>Yes.</b> Go to Step 7. |

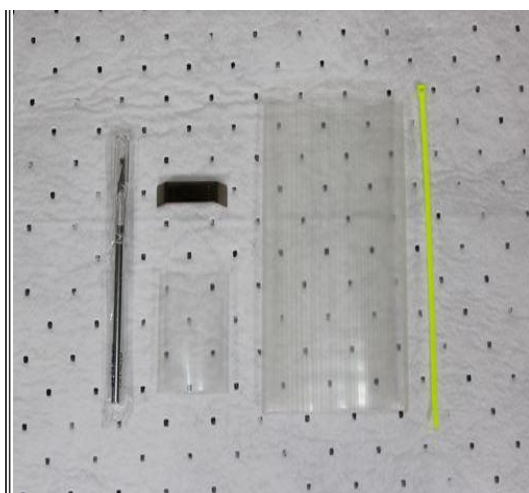
Figure 2: Heat Shrink Kit

- If you have a UQS Boot Kit with only heat shrink boots and a green zip tie as pictured in **Figure 2** below, use the installation instructions found here: [UQS - Urea Quality Sensor Heat Shrink Boot Installation](#)
- If you have a UQS Boot Kit with the plastic boot and blue zip tie as pictured in **Figure 3** below, use the instructions found here: [UQS - Urea Quality Sensor Plastic Boot Installation](#)
