Title: LT and RH Auxiliary Switch Not Working 08XBN

Applies To: LT RH

This document will guide the user through the repair when the auxiliary switch does not function for feature 08XBN because the relay is missing.

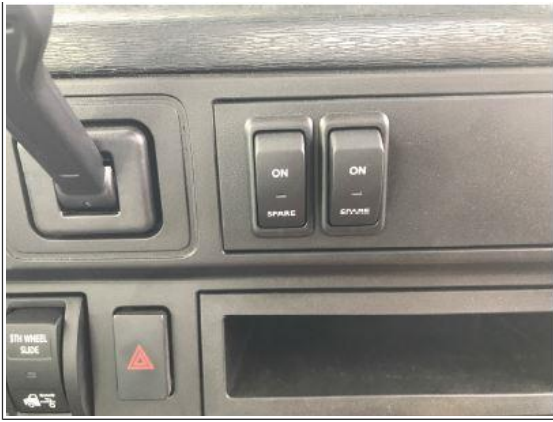
Figure 1: Switches, including Auxiliary Switch

Customer Observations or Concerns: Auxiliary switch does not function. Reference Figure. 1

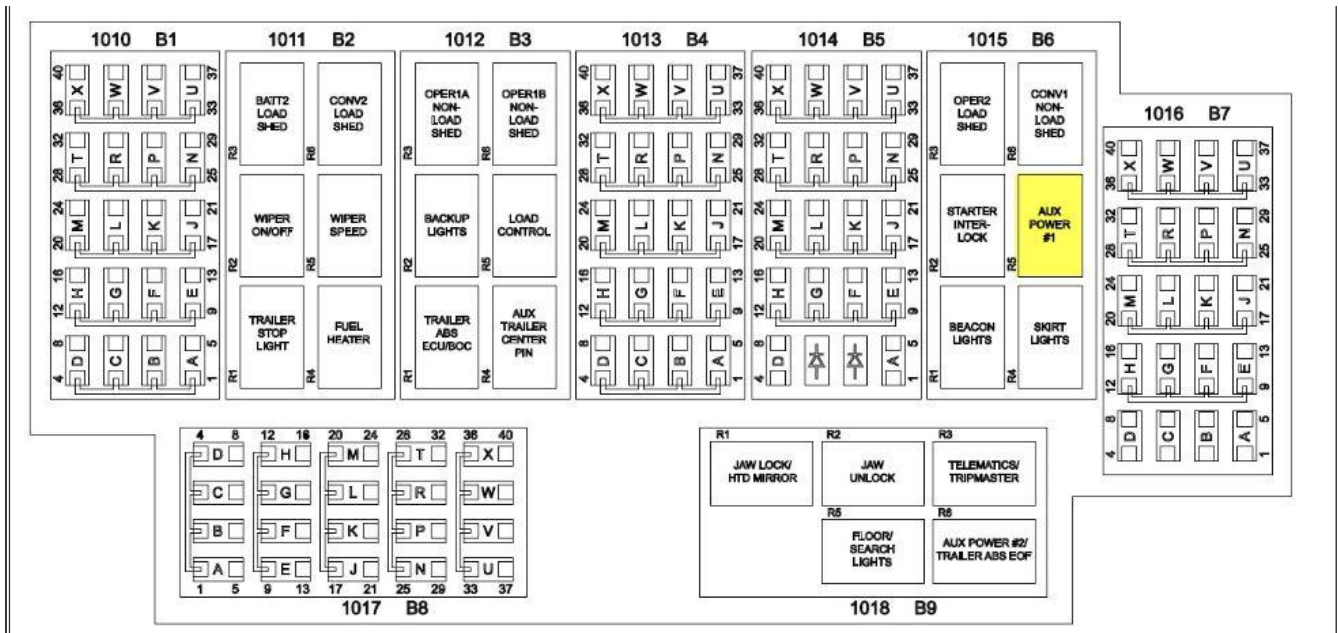
Figure 3: Cab PDM location of Relay 5 in 1015 B6

1. Bring vehicle into shop and park on a flat surface.
2. Shift transmission into park or neutral, set parking brake, and install wheel chocks.
3. Verify that relay is missing for Aux Power #1 in Cab PDM location 1015 B6 R5. See Figure 2 and 3.

4. Install relay .
5. If desired, install customer accessory that will be associated with the switch. Return unit to operating condition.
6. Once complete remove wheel chocks.
