**Document ID:** IK0900122  
**Revision:** 2  
**Created:** 8/3/2017  
**Last Modified:** 11/27/2017  
**Author:** Greg Scheff

**Title:** Loose or Missing Charge Air Cooler Clamps and Possible DPF Plugging

**Applies To:** Chassis Equipped with Cummins B6.7

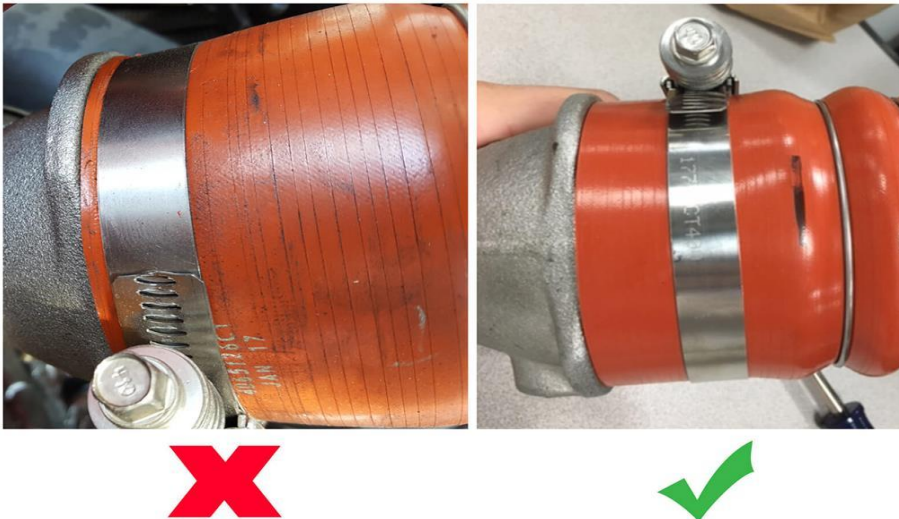
If after inspection any of the CAC clamps are found to be loose or missing, perform the following steps.

1. Inspect the CAC boots, and piping for any damage. Replace boots as needed if any damage is found.
2. Install and torque all missing or loose CAC clamps (Figure #1), and torque to 11 Nm (8 ft. lbs.). Ensure clamp is positioned correctly while torquing. See image below:
