**Title:** IC Bus with ISB Frequent Regeneration

**Applies To:** IC Bus ISB

This document will guide the user through resolving Frequent Regen issues on IC Bus with ISB 6.7.

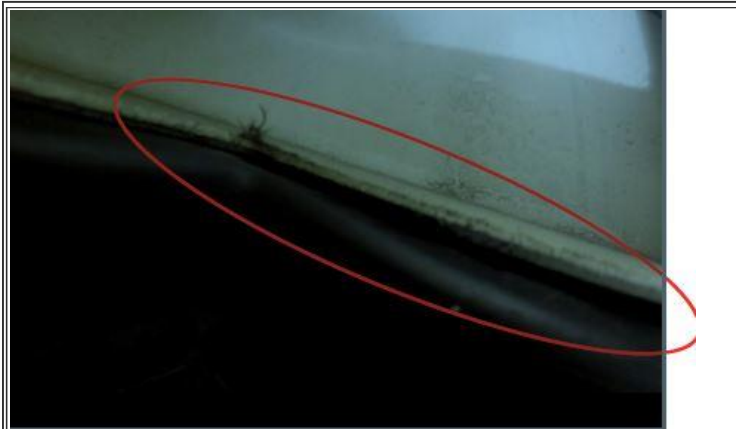
1. Airbox boot seal to the hood compromised. Middle section may appear bent or folded in. The seal position looks off-centered from the hood.

**Figure 1: Gap between Boot seal and Hood**

Step	Action	Decision
3	<p><b>DIAGNOSTIC:</b></p> <p>With the hood in the fully latched position, inspect the accordion boot seal to hood. See Figure 1 and 2</p> <p>Is a gap present between the seal and hood?</p>	<p><b>Yes.</b> Replace the cover assembly.</p> <hr/> <p><b>No.</b> Return to Fault Codes Diagnostics</p>

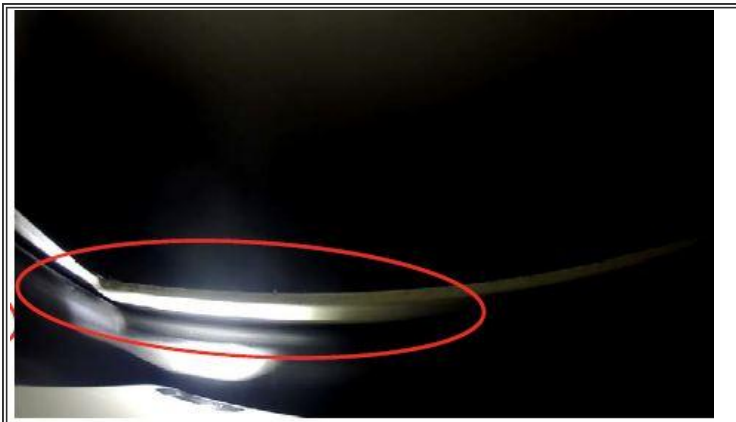
**Figure 2: Hood misaligned with respect to Boot seal**
