SERVICE PROCEDURE

17507
November, 2017

SUBJECT: SAFETY RECALL
Tie Rod Castellated Nut on certain 9900i, DuraStar[®], LoneStar[®], PayStar[®], ProStar[®], TerraStar[®], TranStar[®], and WorkStar[®] model trucks built 04 March 2015 thru 18 June 2015 and FBC bus, SFC bus, and FE bus chassis built 09 March 2015 thru 21 July 2015 with Spicer D or E series steer axles.

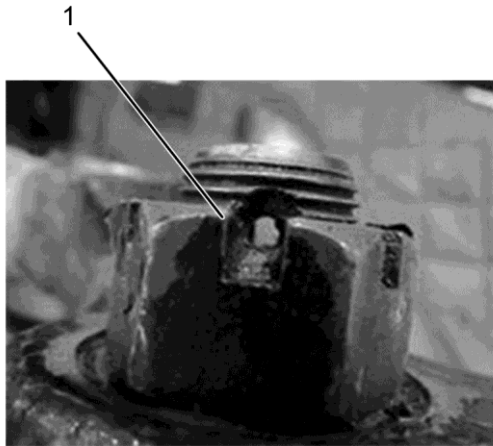
Figure 5. Unacceptable Cotter Pin Hole Position

NOTE: Any tie rod stud with movement after proper nut torque and alignment and / or the cotter pin hole is above the top of the nut surface will require the authorization from Dana to replace the components and will be sent to you.

14. After nut has been aligned with cotter pin hole in stud, check to see if cotter pin hole is above top of castellated nut (Figure 6, Item 1):
 - a. If top of cotter pin hole is even with or less than top of nut, continue to Step 22.
 - b. If cotter pin hole is above top of nut surface, continue to Step 15.
15. If no tie rod and knuckle require replacement, proceed to Step 22. If one or both tie rods and knuckles require replacement, proceed to Step 16.
16. For each tie rod and knuckle require replacement, fill out document at end of letter before calling Dana's Real Time Warranty Center.
17. After completing form and taking required photos, email information to Spicer.rtw@dana.com with repair order number in subject line.
