## TECH TIP

### TT-17-015 TURBOCHARGER REPLACEMENT GUIDELINES

REFERENCE: HMM-170951-J1

**SUBJECT VEHICLES:** 05MY-18MY Conventional Trucks equipped with a J05 or J08 engine.

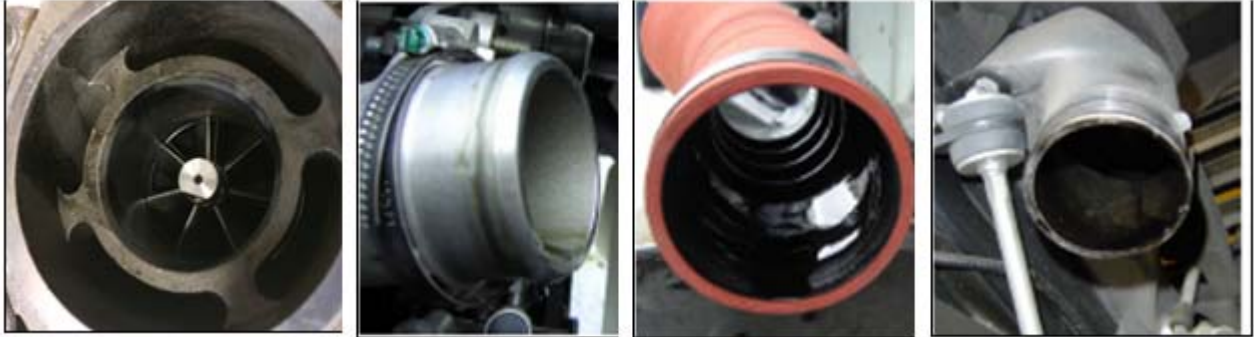
The images below represent a normal condition with some oil in the CAC piping

It is normal to find some engine oil at the turbocharger outlet, within the CAC (charge air cooler) piping, or inside of the CAC. Seeing oil in these areas is not a cause for concern unless the amount of oil is grossly excessive. If excessive amounts of oil are found, do not suspect a faulty turbo without first inspecting the following:

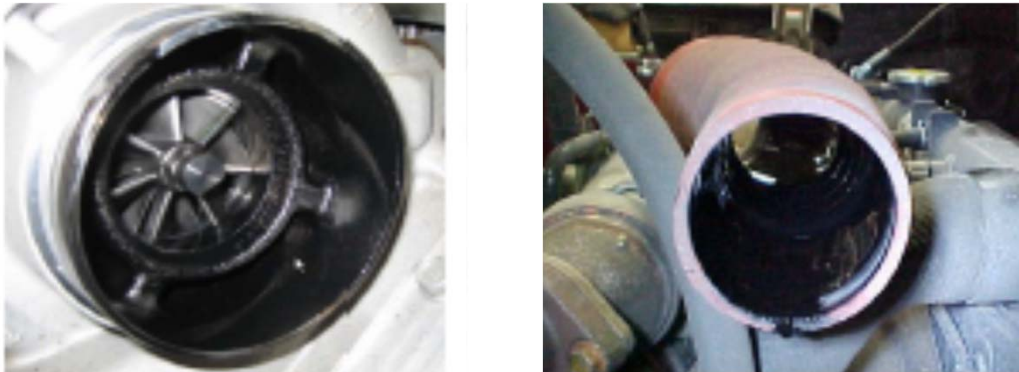
The following images represent heavy oil saturation.  
This is not usually caused by a faulty turbocharger and further inspection is required.

- The engine air filter is not restricted (verify that the filter minder has not triggered, and remove the air filter to inspect its condition).
- The CCV (closed crankcase ventilator) system is operating properly and not restricted.

- Engine oil level and condition. Excessive fuel dilution of the engine oil should be considered. Reduced viscosity of the engine oil can result in more oil in the CAC pipes.
- Intercooler hoses. Inspect for loose hoses or leaks. Oil leaking from an intercooler hose is not indicative of a failed turbocharger.
- Engine misfire. Improper engine performance due to a misfire can lead to turbo misdiagnosis. Inspect the fuel injectors –i.e. injection quantity, correction balance, misfire, or knocking. These items, as well as low engine compression can cause the turbo shaft to shudder during operation resulting in excessive oil carryover from the turbocharger. Do not replace the turbo for this condition.

If no issues are identified with the above items and excessive amounts of oil are present within the CAC piping, careful inspection of the turbocharger is necessary before condemning it. Unless the presence of liquid oil is confirmed in combination with a mechanical failure of the turbocharger, the turbocharger should NOT be replaced. Follow the inspection guidelines set forth within the Engine Workshop Manual relevant to the model year vehicle you are inspecting. Also reference the Turbo Inspection section, below.

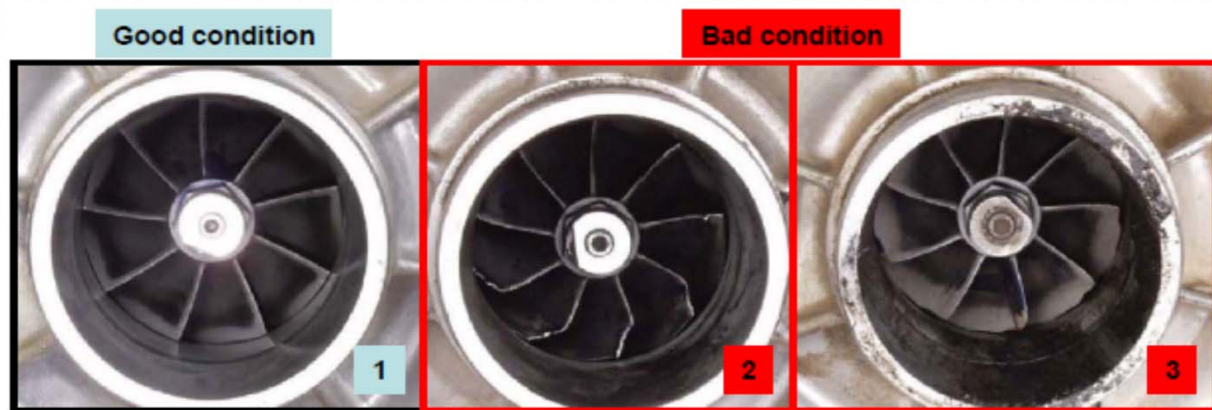
### **Compressor Wheel Inspection**

- **Good condition (1)** - The compressor blades are clean and straight. There are no large gaps between the compressor housing and the wheel. No visible damage to blades.
- **Bad condition (2)** - The compressor wheel has bent and/or broken blades. This turbocharger should be replaced.
- **Bad condition (3)** - The compressor wheel blades have signs of erosion from dirt entering the intake air system. The blades are rounded off and there is dirt accumulation in the compressor inlet. This turbocharger should be replaced and the cause should be corrected. This is caused by dirt intrusion and is not a warrantable failure.
