TECH TIP

**TT-17-017 P0500 DTC AND SPEEDOMETER
INOPERATIVE**

**GROUP: 0-GENERAL
BULLETIN NO: TT-17-017
DATE: 10-31-2017**

SUBJECT VEHICLES: 17MY-Current Conventional Trucks.

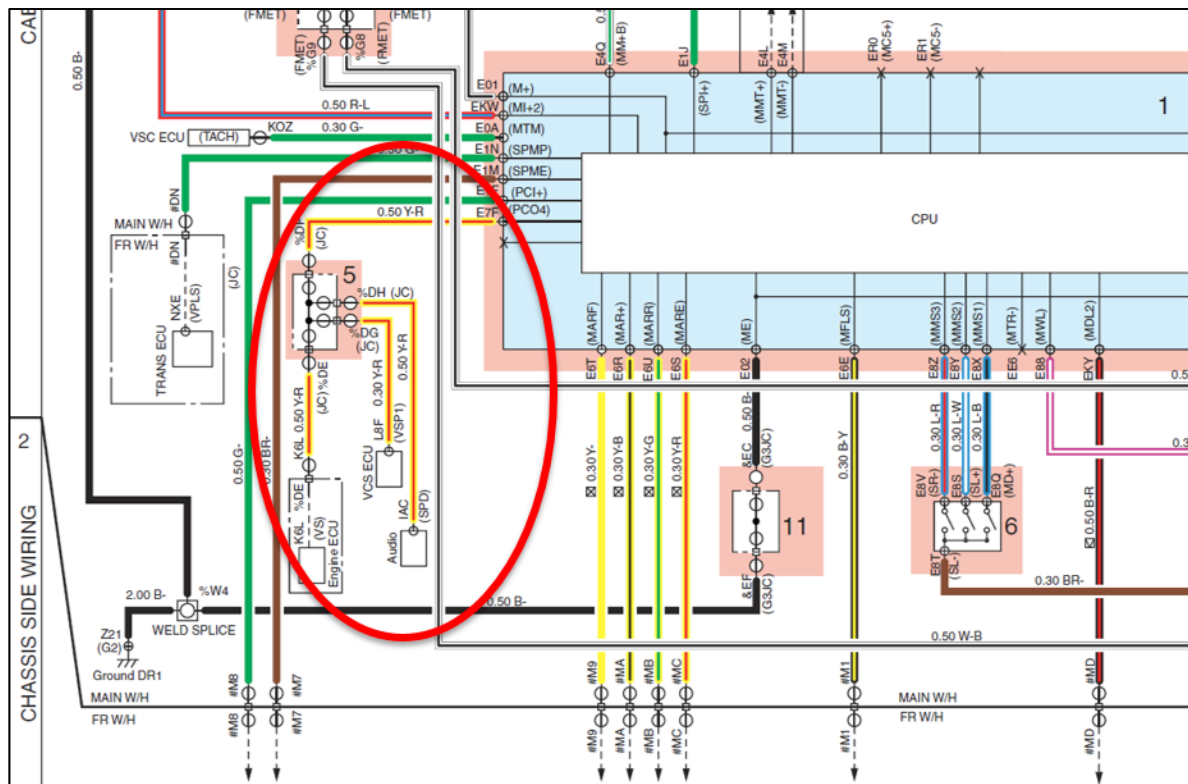
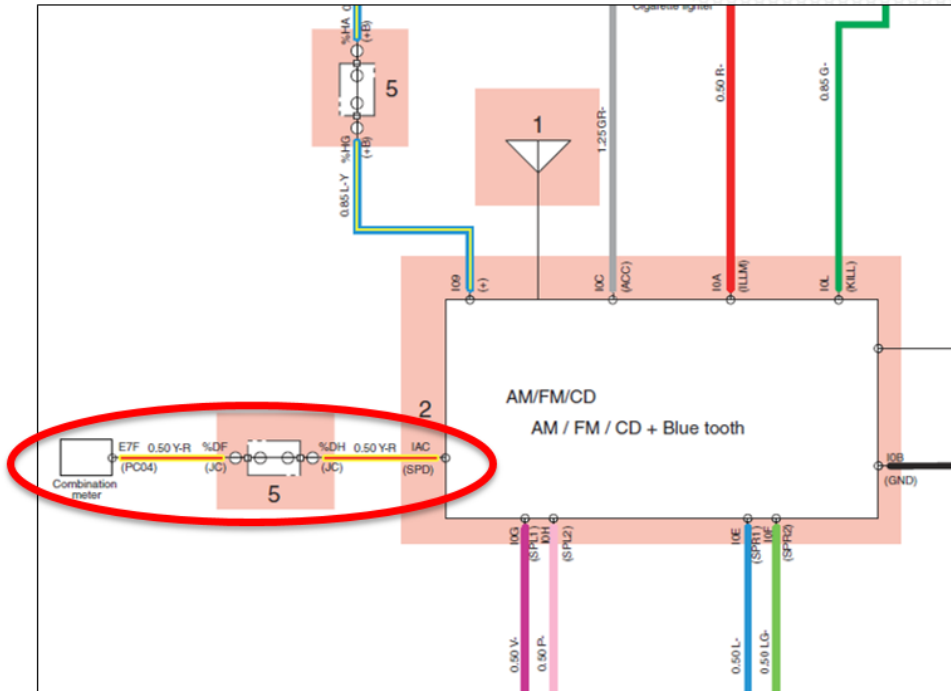
The P0500 typically sets due to a short or sensor concern. Since the speed is sent to the meter then to the ECU, suspect a concern between the meter and engine ECU. If so, unplug the radio and see if the concern changes. A speed wire was added to the radio connectors for speed controlled radio volume. If an aftermarket radio is installed, it will short this wire, set the P0500 and cause the concern experienced. See the below wiring diagrams.

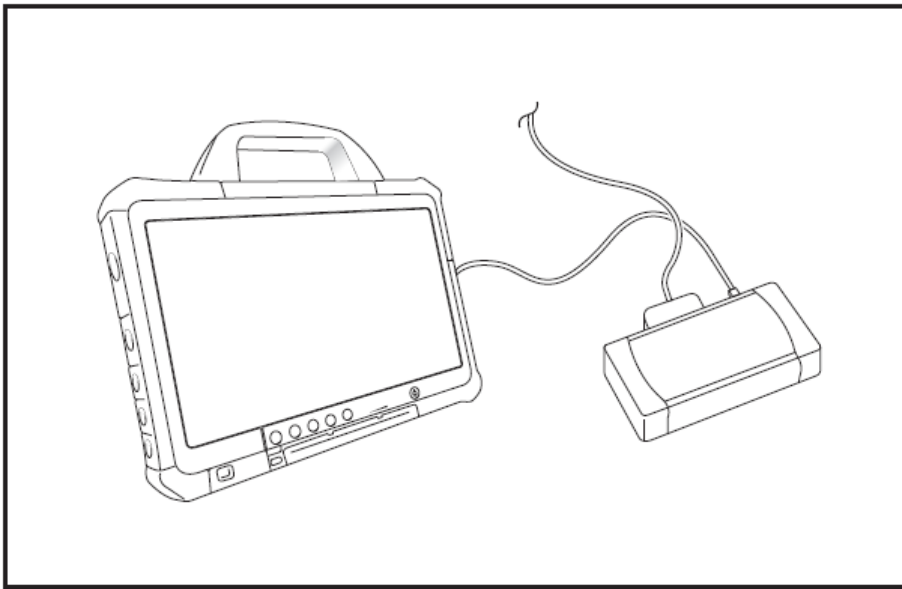
2. If a P0500 is the only DTC present, follow the procedure below to diagnose this concern.

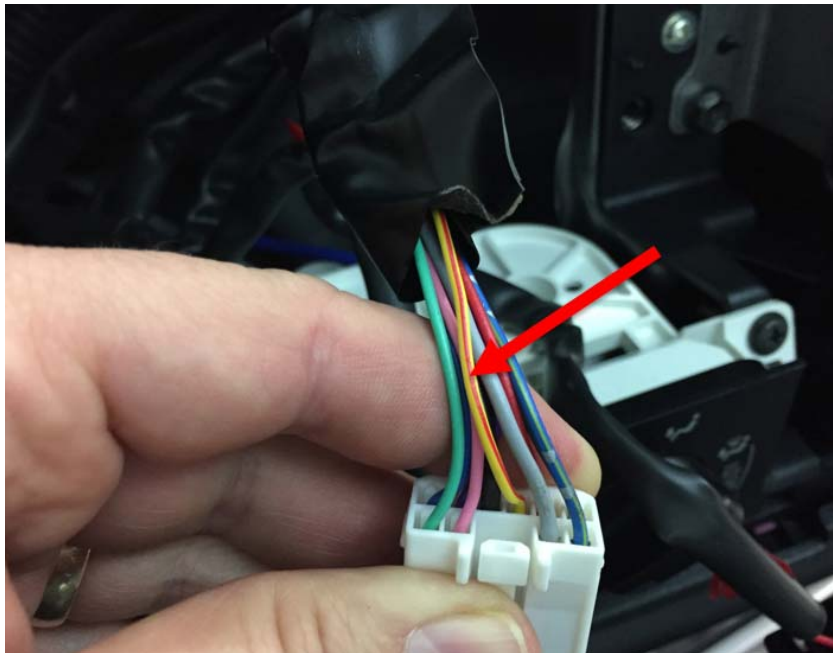
5. Inspect the yellow wire with the red tracer. If the wire was removed and tied back in the harness or used to connect to the device installed by the customer, this can be a concern. Disconnect the vehicle speed circuit from the aftermarket radio and tape the end of the wire. Secure the wire to the harness. If there is no aftermarket radio installed, remove the wire from the meter end and see if the wire is shorted. Repair if necessary.
