**ComfortPro APU Kubota Diesel Engine Shutting Down for Overheating****This replaces TSB-535 Rev A and TSB-538 Rev A**

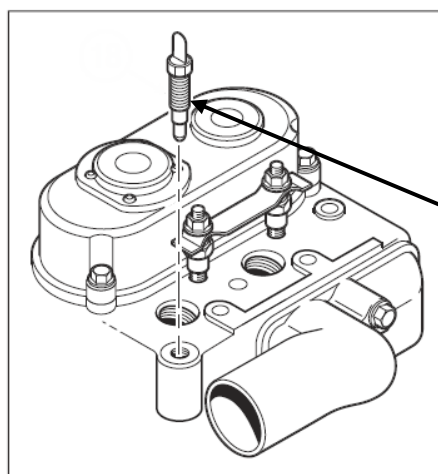
Overheat Sensor

The overheat sensor should open at 245°F (118°C) indicating an overheating condition. If the system shuts down for an overheat condition, using a suitable infrared thermometer, measure the temperature of the cylinder head near the overheat sensor. If the reading is below 245°F, replace the sensor. Typical sensor failures will indicate an overheat condition with the cylinder head temperature in the 150°F to 185°F (65°C to 82°C) range.

When installing the replacement sensor the torque spec is 5 to 8 Ft/Lbs ON a COOLED down engine. If the engine is warm, the switch installation depth will be too low and will increase the likelihood of damaging the switch.

**Do not exceed the torque spec.**

**Overtightening the sensor may result in damage to the sensor.**

**If the unit returns with a second failed overheat sensor it will be necessary to replace the complete cylinder head and the sensor.**
