## Updated Software (APU & DCP) for the ComfortPro APU

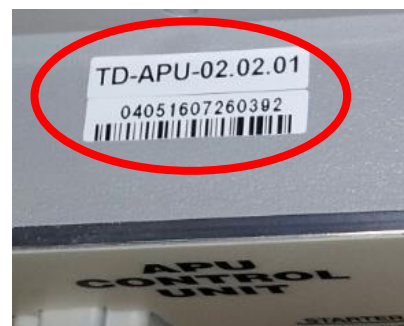
If controllers have the label "TD-APU-02.02.01", this means the controller already has been preloaded with updated / new software.

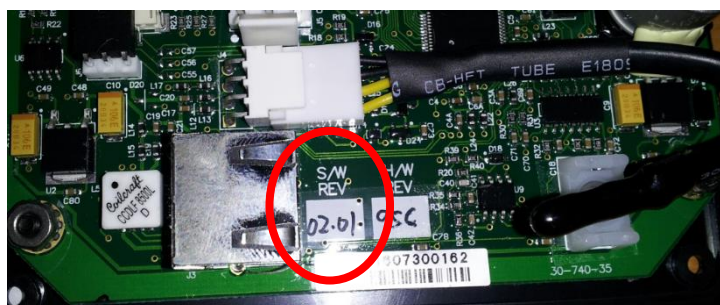
If controller has the S/W label with "02-01", this means the controller already has been preloaded with updated / new software.
