### ComfortPro APU Kubota Diesel Engine Shutting Down for Overheating

**This replaces TSB-538 Rev A and TSB-538 Rev B**

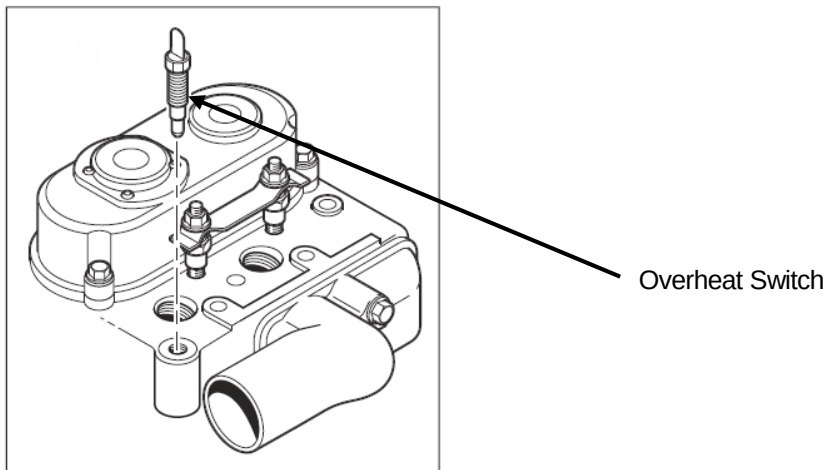
Diagnostics may indicate that the system has detected an overheating condition.

If after verifying that there are no issues with the cooling system, check the operation of the current overheat switch part number 30-266-02K.

The overheat switch should open at 230°F (110°C) indicating an overheating condition. If the system shuts down for an overheat condition, using a suitable infrared thermometer, measure the temperature of the cylinder head near the overheat switch. If the reading is below 230°F, replace the switch. Typical switch failures will indicate an overheat condition with the cylinder head temperature in the 150°F to 185°F (65°C to 82°C) range.

When installing the replacement switch, the torque spec is 5 to 8 Ft/Lbs ON a **COOLED** down engine. If the engine is warm, the switch installation depth will be too low and will increase the likelihood of damaging the switch.

**Use hand tools only. Do not exceed the torque spec.**

**Overtightening the switch may result in damage to the switch.**

**If the unit returns with a second failed overheat switch, a Over Heat Switch Retrofit Kit (30-G22-62K) is available to relocate the switch to a different location.**
