Commercial Vehicle Technology
Axle and Transmission Systems for Buses and
Coaches

Potential quality defect in the wheel bearing assembly of ZF axles of the type A/AV/AVN

ZF Quality issue - wheel bearing assembly

Checking of slotted nut-hub bolt connection on A 132, AV 110/132/133, AVN 132

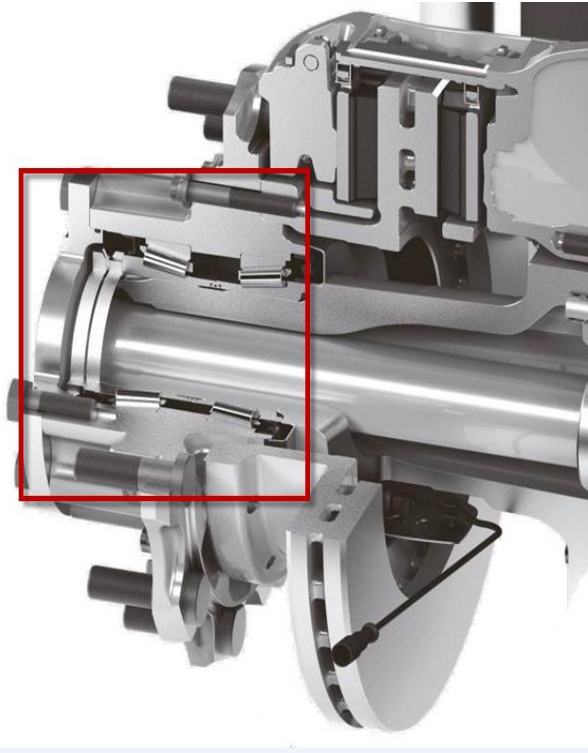
Sectional view wheel head

- The wheel heads of the rear axles A/AVN/AV are locked by a system of two slotted nuts and a tab washer. The inner slotted nut is tightened with 850 Nm and the outer nut with 1200 Nm. The tab washer between both nuts is used as locking device additionally to the countering of the two nuts
- Within an evaluation of screwing data of the wheel bearing assembly in October 2016 a high variation of the screwing angles of the slotted nuts has been detected. Because of this an intense root cause analysis and elimination process has been started.
- The investigations revealed that on some axles a settlement in the bearing assembly had occurred which could result in a loss of tightening torques of the threaded connections during operation and also a damage to the locking plate. This has also been verified by checks on axles in the field which had been selected by suspect screwing angles.

- Hubs were delivered with a surface roughness of bearing seat of wheel bearing at upper level of tolerance, starting at beginning of 2016 until March 2017.

- Disassembly of the wheel head threaded connection (slotted nuts), replacement of locking plate and re-assembly of the slotted nuts. Details see ZF service bulletin 80-17.
