# UPDATE Technical Bulletin

## 37K7 UPDATE – TCM Software Update (NVLW)

This update has been proactively released to address a Software update needed for smoothing the shift operation, driveshaft protection and transmission emergency mode for the AQ450 transmission.

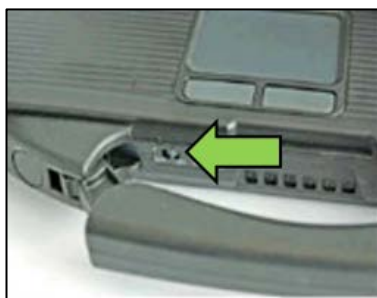
**VAS 6150 & VAS 6150A**  
(Front panel behind handle)

- ✓ **The Bluetooth function of the scan tool is physically switched off <see pictures below>.**

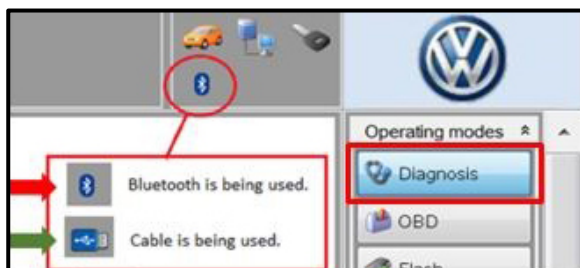
- Confirm that scan tool is communicating with the diagnostic head by USB <Green Arrow>.
- If the Bluetooth symbol is shown <Red Arrow> then disconnect the diagnostic head from the vehicle and reconnect the USB cable to the diagnostic head and then reattach to the vehicle.
- Upon ODIS startup, verify the "Diagnosis" operating mode is selected <as shown>.

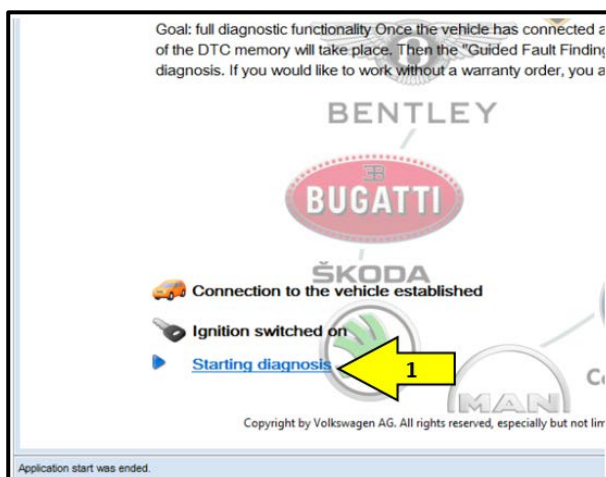
- Select "Starting Diagnosis" <1> and perform a GFF scan of the vehicle.

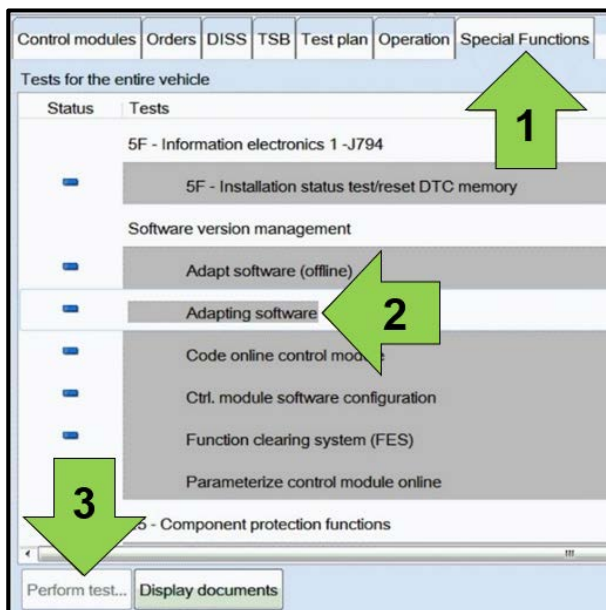
- Select "Special functions" <arrow 1>, then "Adapting software" <arrow 2>, then select "Perform test" <arrow 3>.

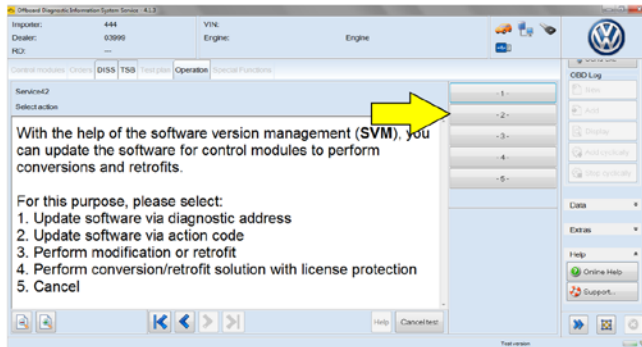
- Select the appropriate option to “Update software via action code” <arrow>.

Read this screen carefully. The option to update software via action code is **NOT** always selection #2 on this screen.

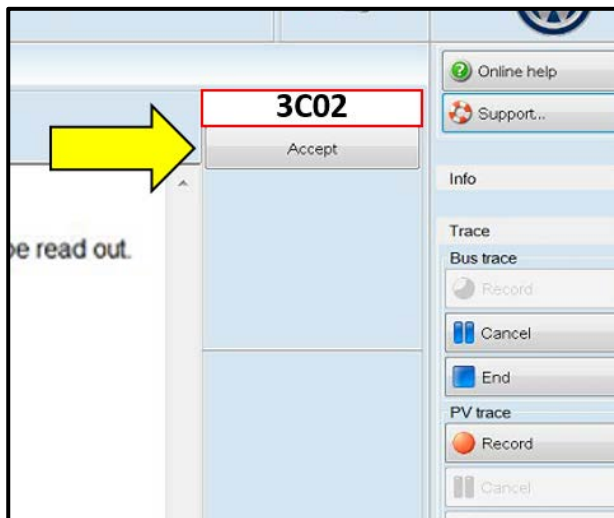
- Enter “3C02” <as shown>.
- Select “Accept” <arrow>.

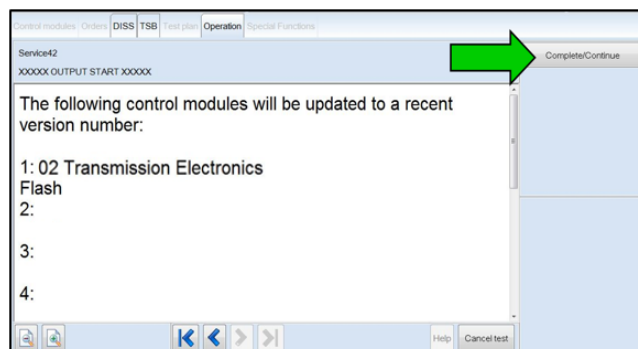
- Select “Complete/Continue” <arrow> to begin the software update process.
  - o If the response indicates that the control modules are current **Flash Process is Complete, proceed to Section C.**
  - o If the response indicates new software versions are available <as shown>, Select “Complete/Continue” and follow the on-screen prompts to **complete the test plan.**

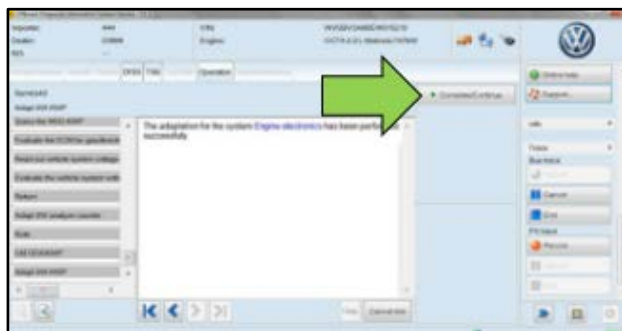
- When the SVM update is complete a confirmation message is displayed <as shown>.
- Select “Complete/Continue” <arrow>.

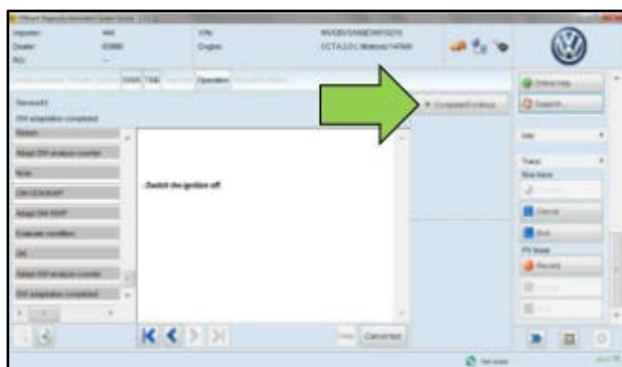
- Switch the ignition off, then select “Complete/Continue” <arrow>.

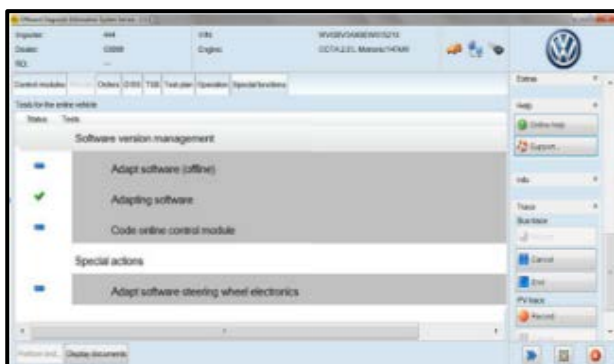
- The green check mark indicates the test plan was successfully carried out.
- Click on the Control Module tab.
- Right click on Address Word 0002 (TCM).
- Select Guided Functions.
- Select Basic Setting.
- Complete the Basic Setting test plan for the TCM.
- After the Basic Setting test plan is complete, exit ODIS.
- When prompted, send the Diagnostic log online to GFF Paperless.
- Remove the battery charger.
