Technical Tip

| Topic | 01-15-03TT – DTC P0171 and P2177 – Gasoline Engines Only | | |

DTC P0171 and P2177- Gasoline Engines Only

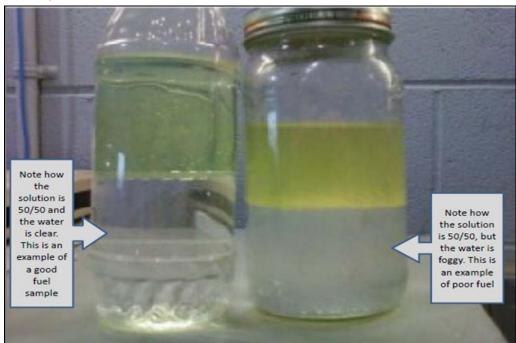
Figure 1

- 1) In a clear graduated container, mix a 50/50 solution of gasoline from the car and water.
- 2) Shake the container for 30 seconds and allow the solution to settle.
- 3) If the solution settles to a 30/70 (gas/water) mixture and not a 50/50 mixture (see figures 1 and 2), the fuel quality is in question.
- 4) Check the water portion in the solution for clarity. If the water (bottom) portion is foggy, the fuel quality is in question for alcohol contamination (see figures 1 and 2).

If excessive ethanol is found, it will be necessary to remove the existing fuel in the tank and replace the fuel using a Top Tier gasoline retailer in your area. Note that on saddle style tanks, fuel on both sides of the fuel tank must be removed. Removing the rear seat will provide access to both the passenger and driver side.
