Technical Bulletin

24 17 08 August 7, 2017 **2045138** Supersedes Technical Bulletin 24-17-04 (V241704) dated June 29, 2017 for information regarding the Top Tier Fuel Brochure.

MIL ON DTCs P2004, P2014 and or P2015 Stored in ECM Fault Memory

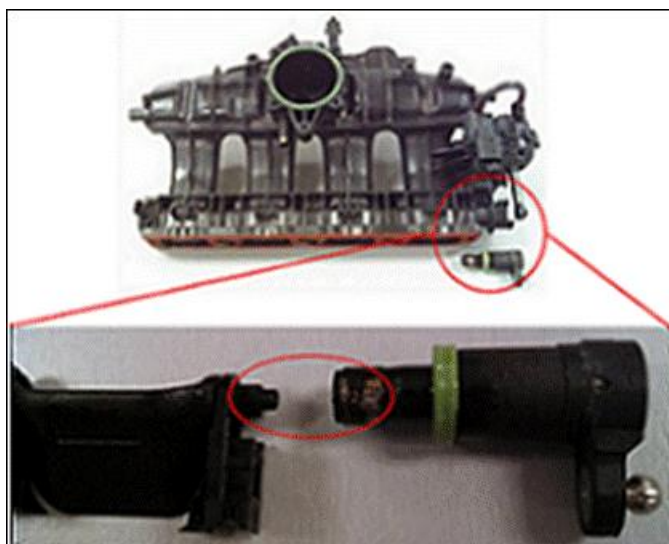
The intake manifold flap can separate internally and will not operate correctly with the regulator valve. See Figure 1. and Figure 2. for an example of a damaged flap disassembled.

If the carrier plate can be pulled out, the flap has separated and the intake manifold must be replaced. See Repair Group 24 Multiport Fuel Injection in Elsa.

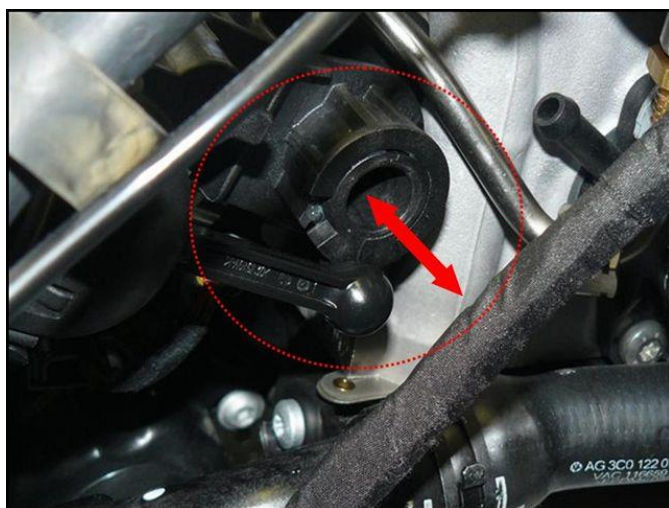
Figure 3.

- Remove the engine cover. See Repair Group 10 Engine Assembly in Elsa.
- Move the carrier plate by hand in an axial direction (Figure 3, red arrow) to check if the carrier plate can be pulled out.

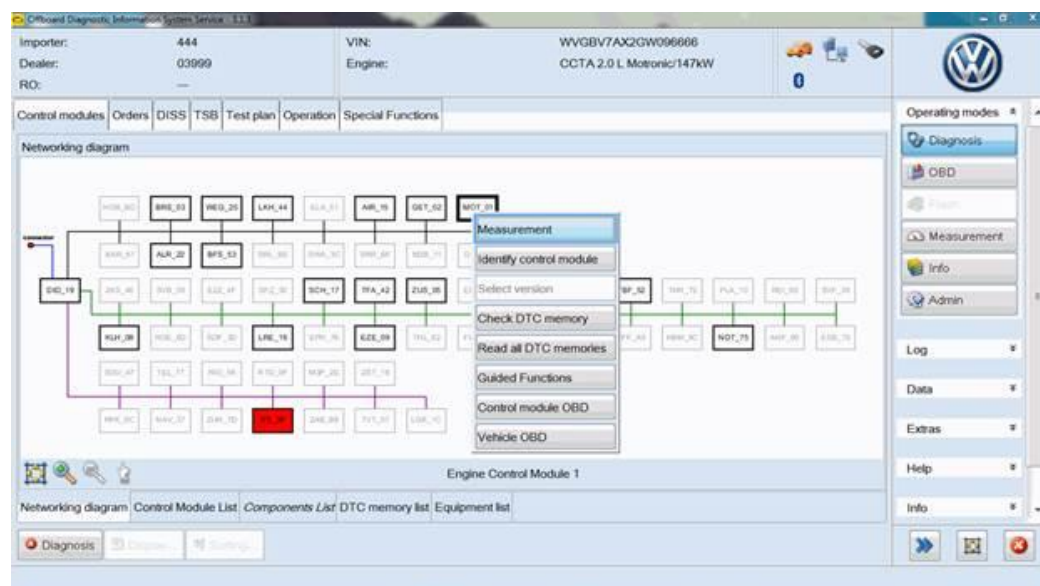
Figure 4

- Check the diagnostic limits of the flap with the ODIS tester.
- Under Motor, select Guided Functions (Figure 4).

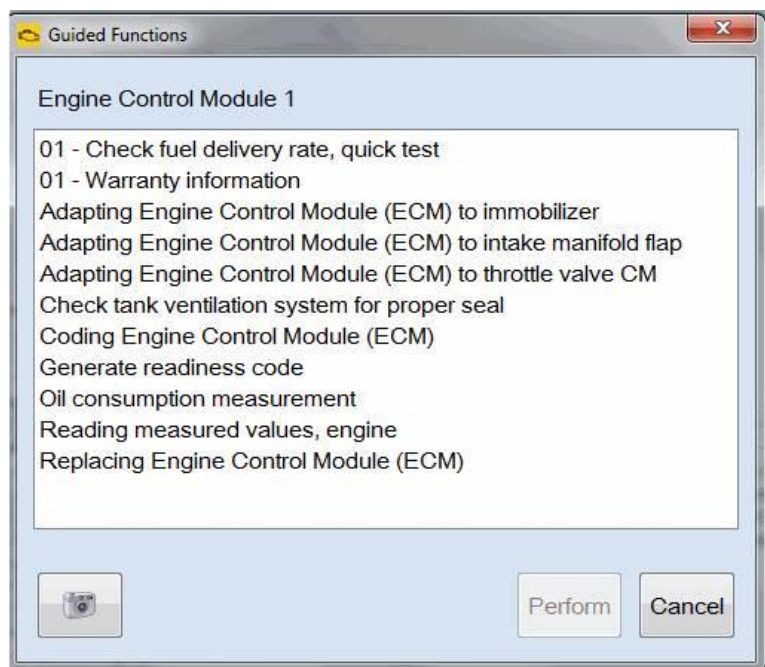
Figure 5

- Select Adapting Engine Control Module (ECM) to intake manifold flap (Figure 5).

If the adaptation is not successful, the flap stop is worn internally, the intake manifold also has to be replaced. See Repair Group 24 Multiport Fuel Injection in Elsa.

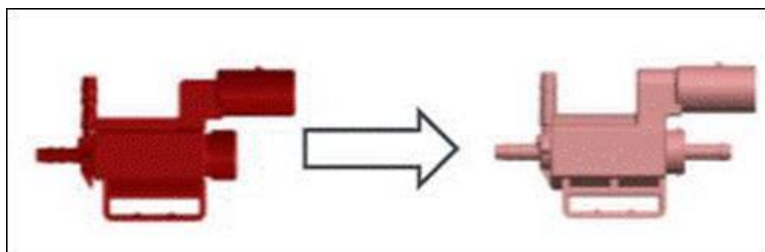
The new intake manifold will come with a new style Solenoid Valve for Intake Manifold Flap -N316-. Please reference TB 2047363 for installation of Clean Air Line.
