Emissions Recall

Code: 24CV

Subject	Inlet Air Box Housing Snow Flap Replacement & Oxygen Sensor Inspection/Replacement
Release Date	August 15, 2017
Revision Summary	Updated work procedure and claiming instructions. Included new ODIS test plans, and 2009 MY work and claiming instructions.
Important Repair Information!	CAMPAIGN 24CV MUST BE COMPLETED BEFORE BEGINNING THE 23U3 CAMPAIGN! Over the next few weeks there will be updates made to ODIS and the campaign circular. Do not retain any hard copies of campaign circulars – only refer to the electronic copies posted to Elsa and ServiceNet.
Affected Vehicles	U.S.A. : 2009-2014 MY Volkswagen 2.0L TDI Engine Vehicles (Generation 1)

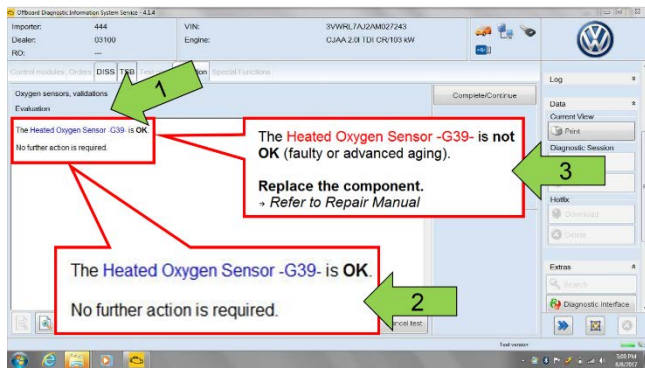
- The Heated Oxygen Sensor -G39- test plan will perform its check and give a result <arrow 1>. The possible results are:
 - “The Heated Oxygen Sensor -G39- is **OK**. No further action is required.” <arrow 2>
 - **Proceed to Section C** and replace the Snow Flap.
 - “The **Heated Oxygen Sensor -G39- is not OK** (faulty or advanced aging). **Replace the component**. Refer to Repair Manual.” <arrow 3>
 - **Proceed to the next step.**

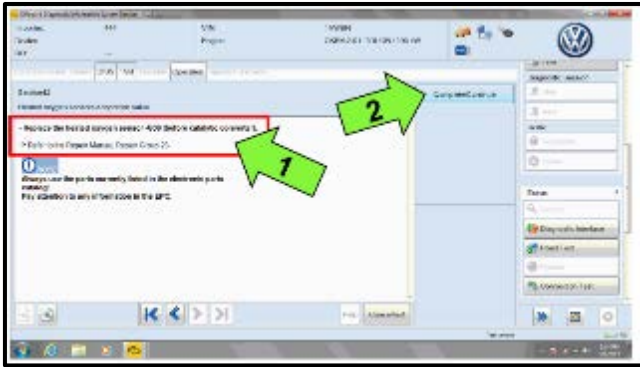
If the Heated Oxygen Sensor -G39- was checked, found bad, and replaced under this action, you **MAY** still receive the following message “**Replace the heated oxygen sensor -G39- (before catalytic converter), Refer to the Repair Manual, Repair Group 23**” <arrow 1> when performing the flash procedure during Campaign 23U3. It does not indicate a failed sensor, or improperly reset adaptation values.

It is normal to receive this message while performing the flash operation during Campaign 23U3 if the Heated Oxygen Sensor -G39- was found to be bad, and replaced. Appearance of this message does not indicate a new, failed sensor.

The new sensor requires adaptation to the new ECM software in order for the 23U3 flash self-check routine to “pass” the new sensor.

Disregard this message if it is received after sensor replacement. Select “Complete/continue” <arrow 2> to bypass.
