# Emissions Recall

## Code: 24CV

**Subject** Inlet Air Box Housing Snow Flap Replacement & Oxygen Sensor Inspection/Replacement

**Release Date** August 14, 2017

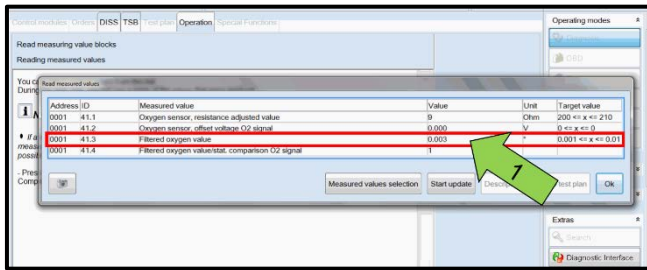
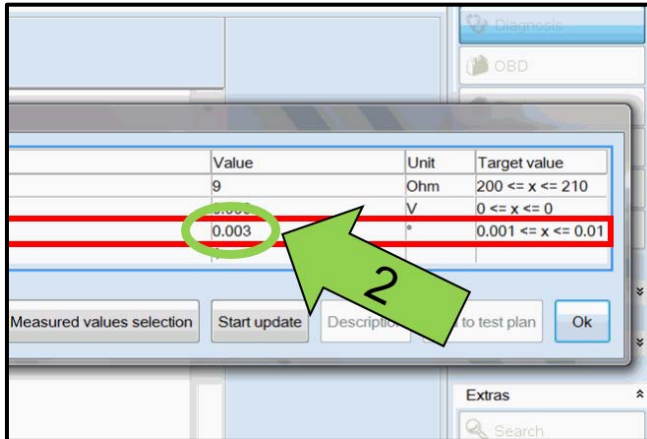
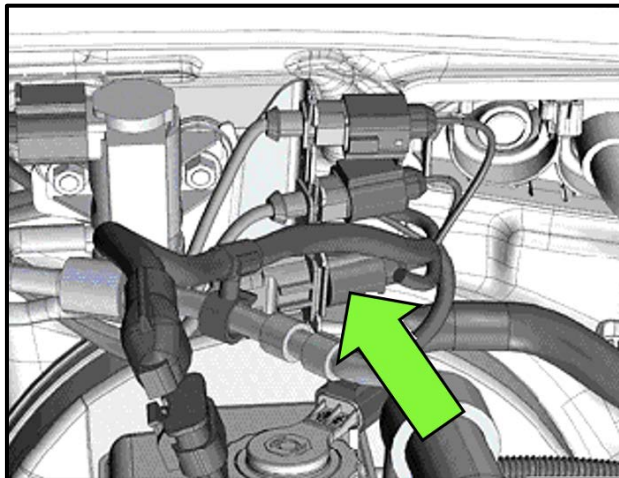
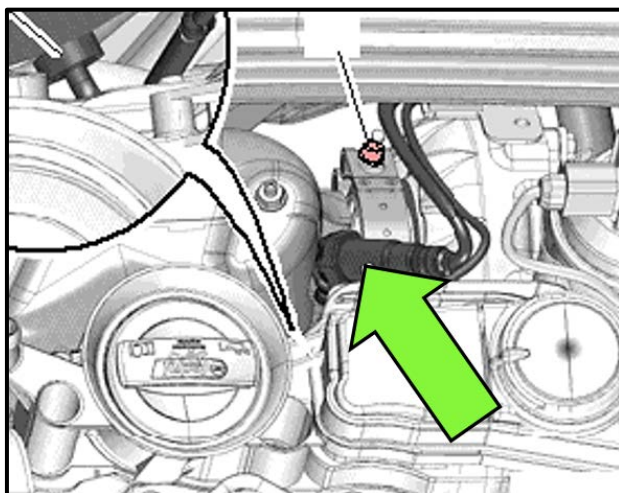
- Using the search function, locate measuring value block **41.3** for “Filtered oxygen value” <arrow 1>.
- Read the measuring value block **41.3** for “Filtered oxygen value” <arrow 1>. Check the measuring value against the following specification:
  - **BAD** = Greater than: **0.0195**
  - **GOOD** = Less than: **0.0195**
- If the Filtered oxygen measuring value listed is **BELOW** the value **0.0195**, the sensor is **GOOD** and does **NOT** require replacement.
  - **Proceed to Section C** and replace the Snow Flap.
- If the Filtered oxygen measuring value <arrow 2> listed is **ABOVE** the value **0.0195**, the sensor is **BAD** and **WILL** require replacement.
  - Proceed to the next step to replace the Heated Oxygen Sensor -G39-.

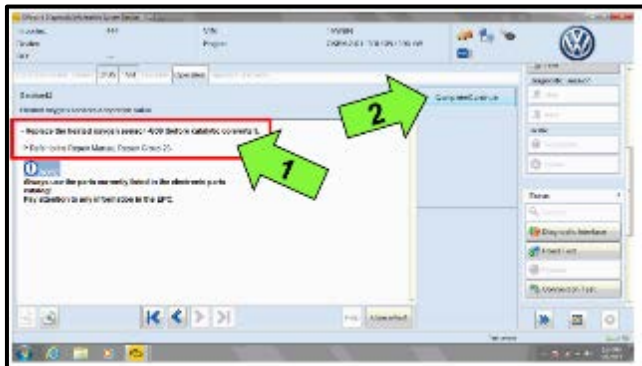
If the Heated Oxygen Sensor -G39- was checked, found bad, and replaced under this action, you **MAY** still receive the following message **“Replace the heated oxygen sensor -G39- (before catalytic converter), Refer to the Repair Manual, Repair Group 23”** <arrow 1> when performing the flash procedure during Campaign 23U3. It does not indicate a failed sensor, or improperly reset adaptation values.

It is normal to receive this message while performing the flash operation during Campaign 23U3 if the Heated Oxygen Sensor -G39- was found to be bad, and replaced. Appearance of this message does not indicate a new, failed sensor.

The new sensor requires adaptation to the new ECM software in order for the 23U3 flash self-check routine to “pass” the new sensor.

Disregard this message if it is received after sensor replacement. Select “Complete/continue” <arrow 2> to bypass.

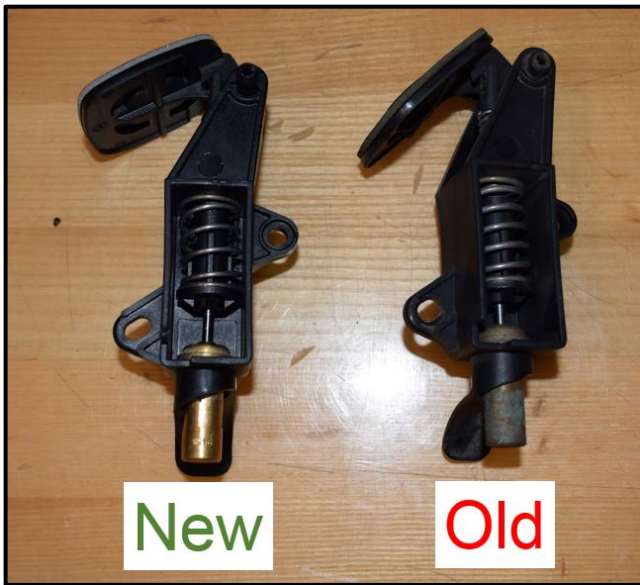
The new snow flap when at rest and at normal room temperature (70 F or 21 C) may appear to be extended in the closed position further than the old flap. This condition is normal.
