Emissions Recall

Code: 24CV

Subject	Inlet Air Box Housing Snow Flap Replacement & Oxygen Sensor Inspection/Replacement														
Release Date	August 11, 2017														
Important Repair Information!	<i>CAMPAIGN 24CV MUST BE COMPLETED BEFORE BEGINNING THE 23U3 CAMPAIGN!</i> <i>Over the next few weeks there will be updates made to ODIS and the campaign circular. Do not retain any hard copies of campaign circulars – only refer to the electronic copies posted to Elsa and ServiceNet.</i>														
Affected Vehicles	U.S.A. : 2009-2014 MY Volkswagen 2.0L TDI Engine Vehicles (Generation 1)

**Subject: Emissions Recall 24CV - Inlet Air Box Housing Snow Flap
2009-2014 MY Volkswagen 2.0L TDI Engine Vehicles (Generation 1)**

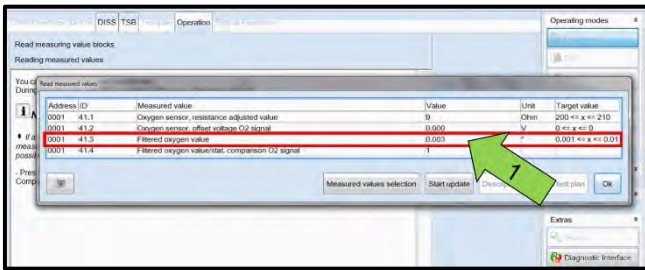
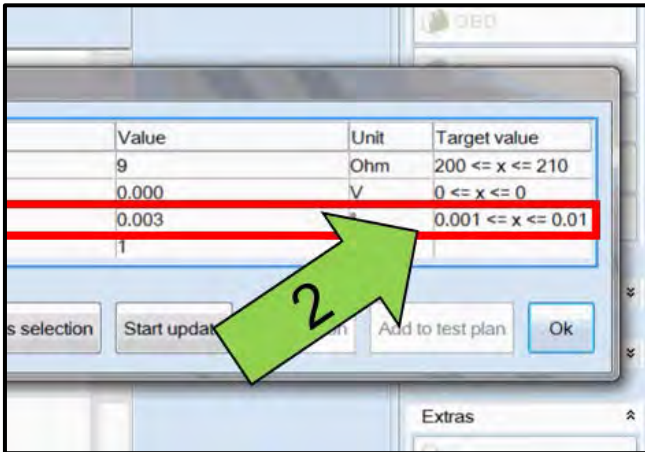
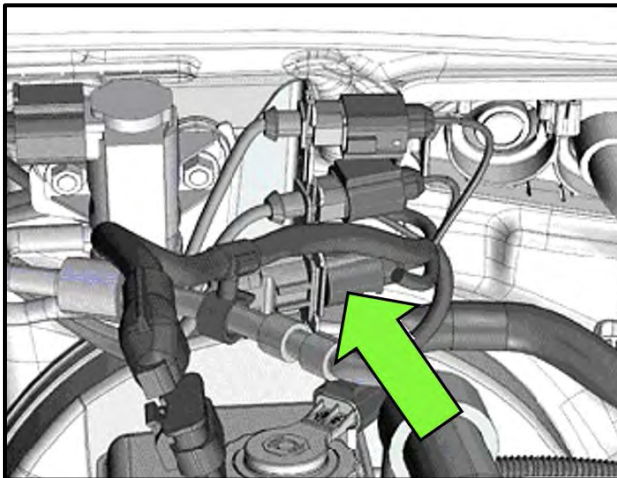
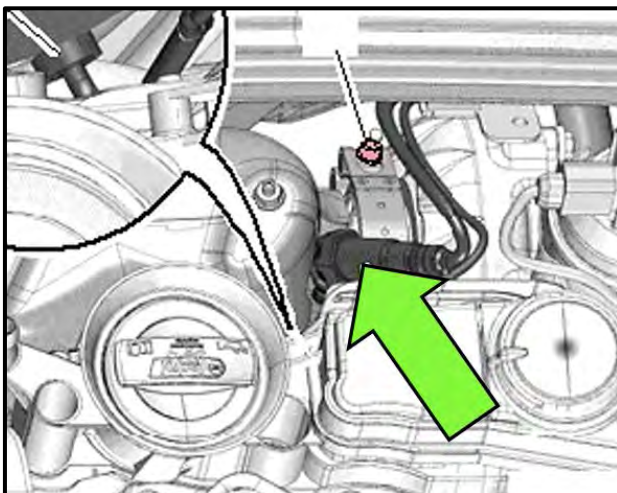
- Using the search function, locate measuring value block **41.3** for “Filtered oxygen value” <arrow 1>.
- Read measuring value block **41.3** for “Filtered oxygen value” <arrow 1>. The measured value for a **GOOD** Heated Oxygen Sensor -G39- will read within the following range:
 - **Greater than: 0.0019**
 - **Less than: 0.0100**
- If the Filtered oxygen value <arrow 2> listed is **WITHIN** this range, the sensor is **OK** and does not require replacement.
 - **Proceed to Section C** and replace the Snow Flap.
- If the Filtered oxygen value listed is **ABOVE**, or **BELOW** this range, the sensor is **BAD** and requires replacement.
 - Proceed to the next step.

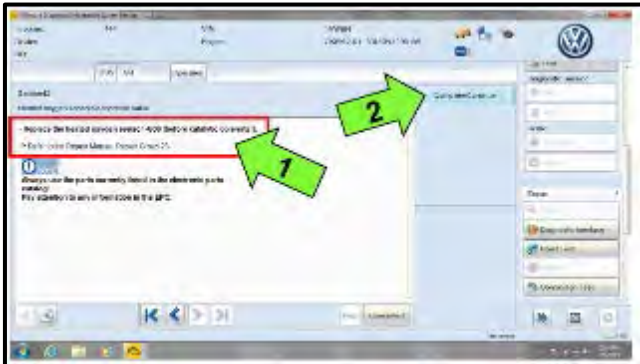
If the Heated Oxygen Sensor -G39- was checked, found bad, and replaced under this action, you **MAY** still receive the following message **“Replace the heated oxygen sensor -G39- (before catalytic converter), Refer to the Repair Manual, Repair Group 23”** <arrow 1> when performing the flash procedure during Campaign 23U3. It does not indicate a failed sensor, or improperly reset adaptation values.

It is normal to receive this message while performing the flash operation during Campaign 23U3 if the Heated Oxygen Sensor -G39- was found to be bad, and replaced. Appearance of this message does not indicate a new, failed sensor.

The new sensor requires adaptation to the new ECM software in order for the 23U3 flash self-check routine to “pass” the new sensor.

Disregard this message if it is received after sensor replacement. Select “Complete/continue” <arrow 2> to bypass.

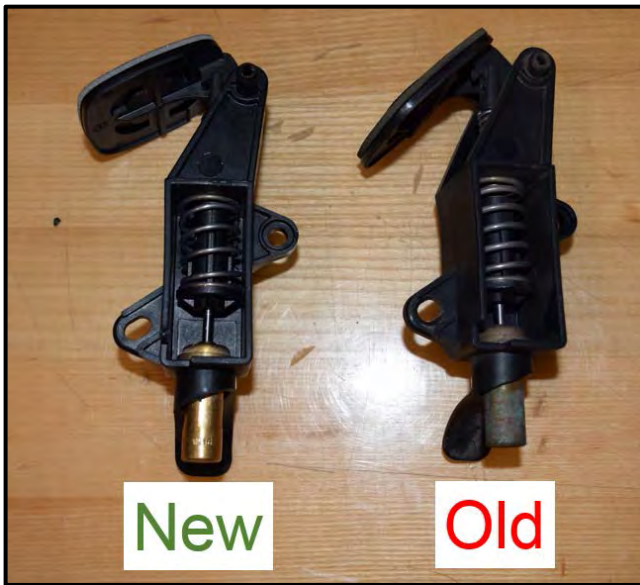
The new snow flap when at rest and at normal room temperature (70 F or 21 C) may appear to be extended in the closed position further than the old flap. This condition is normal.
