SERVICE BULLETIN

APPLICABILITY: 2015-2017MY Legacy

NUMBER: 12-226-17R

SUBJECT: Fuel Door Sticking Closed in Cold Weather

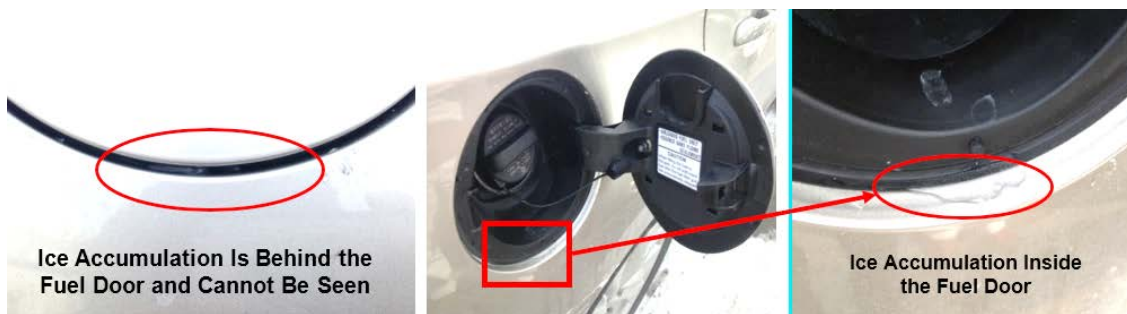
This bulletin provides part number and design change information regarding the fuel door (saucer) assembly which may not open properly due to ice accumulation in sub-freezing conditions.

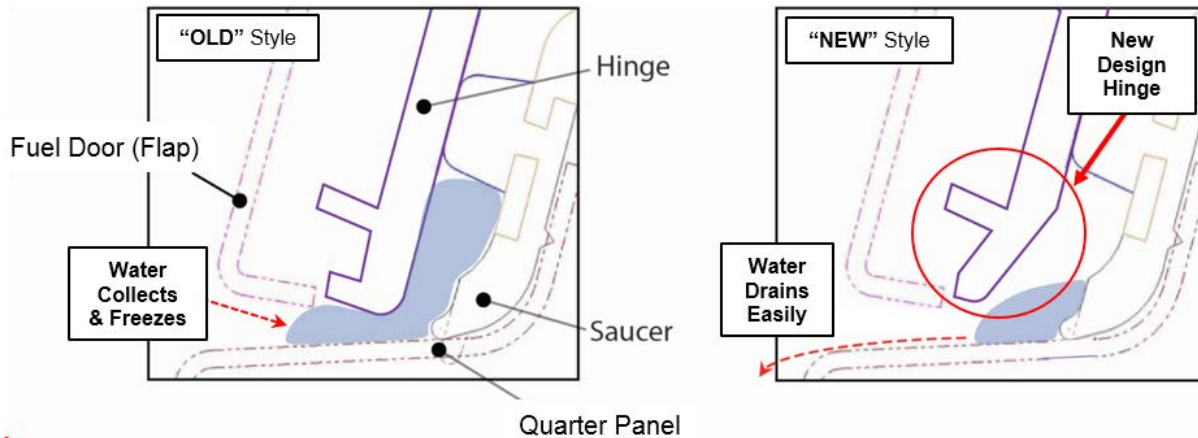
The illustrations below provide a comparison between the “NEW” and “OLD” -style parts. The change involves a change made to the base of the hinge portion to improve drainage and prevent water accumulation. In sub-freezing temperatures, ice can form causing the fuel door to not open properly.

When replacement of the saucer assembly is required, follow the repair procedure outlined in the applicable Service Manual.

NOTE: Always confirm the surface is clean and dry before applying the fuel label to the new part.
