SERVICE BULLETIN

APPLICABILITY: XV Crosstrek Hybrid (HEV)

NUMBER: 16-108-17R

SUBJECT: New Service Procedure for Repair of DTC P172A and P0B0B

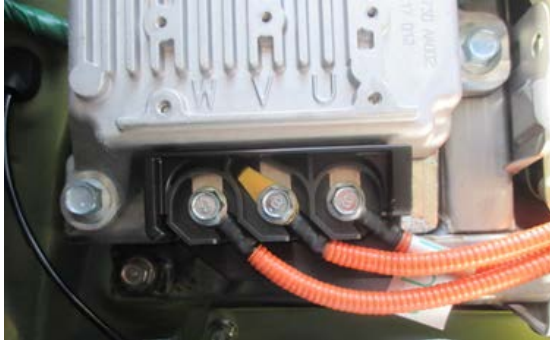
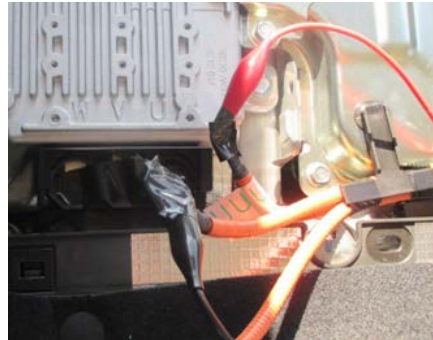
- Remove the TORX screws and necessary trim clips securing the aluminum battery cover.
- **ONE AT A TIME**, remove the 3 bolts securing the orange “W”, “V”, and “U” cables to the electric oil pump inverter. As each cable is removed, cover each terminal end with one of the strips of electrical tape to insulate it. Connect the RED (+) test lead from the DVOM to the “U” cable end and BLACK (-) lead to the “V” cable end as shown. Confirm the “W” cable end is wrapped with insulating tape.

- **IF THE DVOM SHOWS 0.5V OR MORE:** The relief valve o-rings are damaged. Replace the relief valve following the new procedure supplied below.
- **IF THE DVOM SHOWS LESS THAN 0.5V:** the root cause of the DTC is elsewhere. Continue diagnosing the DTC using the applicable Service Manual procedure.

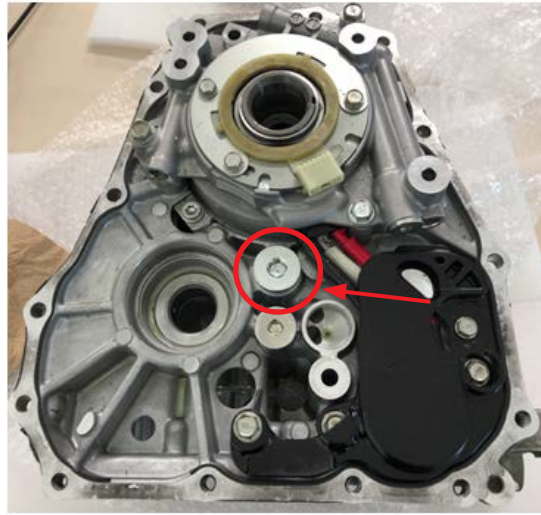
- Remove the CVT assembly following the procedure in the applicable Service Manual.
- Remove the drive motor / case assembly from the CVT and place it on the workbench as shown below. Remove the plug circled in the photo below to gain access to the relief valve.

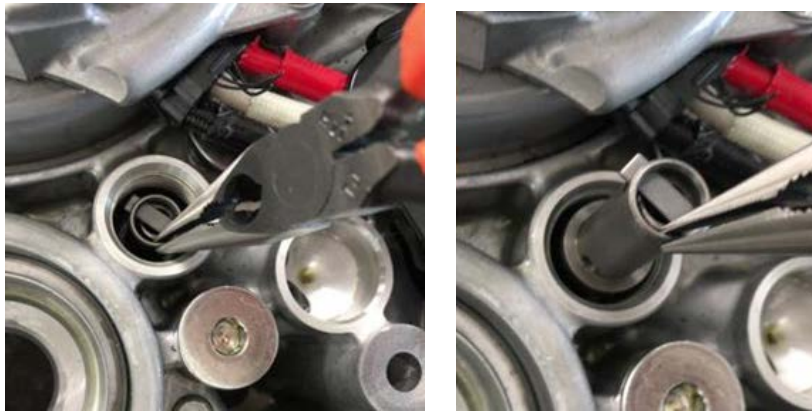
- Use a pair of needle-nosed pliers to CAREFULLY remove the relief valve from the case.

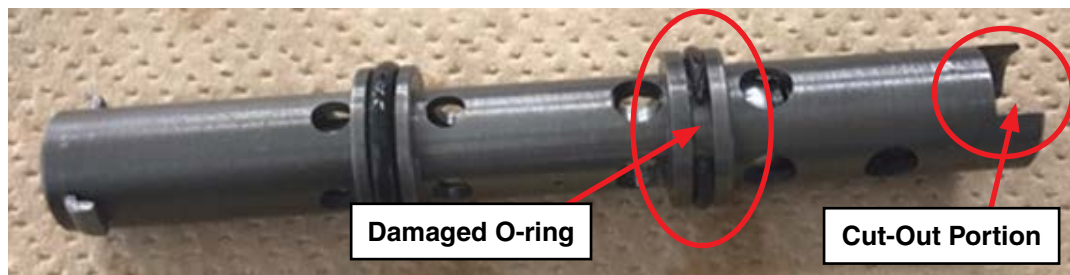
- Inspect the o-rings on the relief valve for any damage.

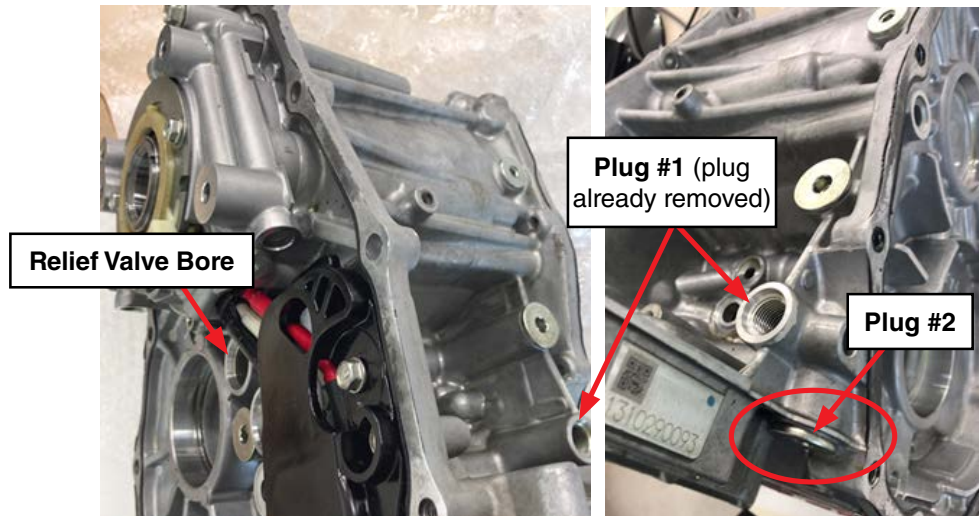
- Remove **Plug #1** and **Plug #2** as shown in the photos below and allow any remaining CVTF to drain.

- REMINDER:** Always wear eye protection for this step: Thoroughly clean the bores with spray parts cleaner then blow dry with compressed air. Always direct the spray away from other people and vehicles. Re-inspect closely for any remaining contamination.
- Install **new** o-rings on both plugs, lubricate with CVTF and re-install. Torque these 2 plugs to 50 Nm (37 ft. lbs.).
- Lubricate the o-rings with CVTF then **CAREFULLY** install the new relief valve assembly (cut-out portion in first) until it is fully seated in its bore. Use caution to avoid damaging the new o-rings on the plug threads. The valve can be installed in any rotational position.
