Customer Satisfaction Program

17105 Incorrect Idler Pulley Installed

Reference Number: N162081320

Make	Model	Model Year		RPO	Description
		From	To		
Chevrolet	Silverado HD	2017	2017	L5P/KHB	Diesel Engine /Dual Generators
GMC	Sierra HD

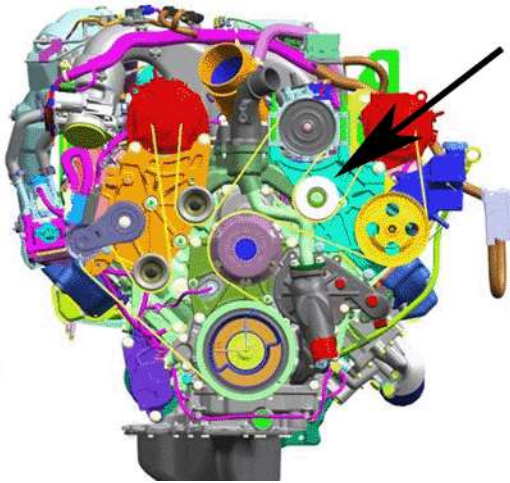
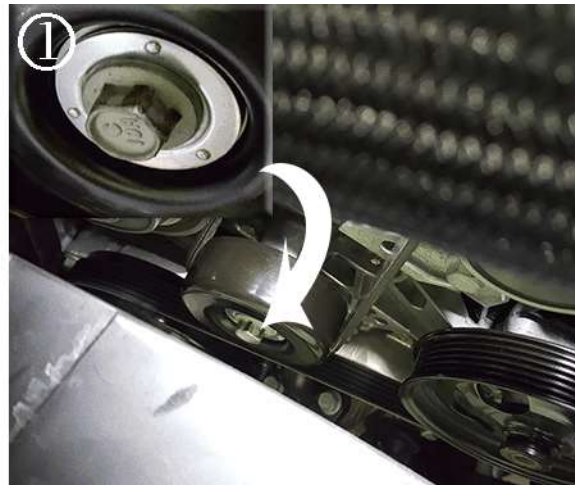
4734678

Condition	Certain 2017 model year Chevrolet Silverado and GMC Sierra vehicles, equipped with a DuraMax Diesel Engine (L5P) and Dual Generators (KHB), may have been built with an accessory drive belt idler pulley intended for other applications. The pulley's centerline and capacity differs from the design intent pulley. This difference in alignment and durability may cause the accessory drive belt at some point to come off the accessory drive system. Without an accessory drive belt, the vehicle will lose engine cooling, battery charging, power steering, power brakes, and air conditioning operation. All other systems will function normally.
Correction	Inspect the idler pulley and the drive belt replacing either or both if required.

1. Inspect the idler pulley for 3 visible “dots” (1) on the front of the pulley.
2. If the pulley has the 3 visible “dots”, no further action is required.
3. If the pulley DOES NOT have the 3 visible dots, replace the pulley:
 - 3.1 Remove the tension from the drive belt by rotating the tensioner counterclockwise. The drive belt does not need to be fully removed to replace just the idler pulley.
 - 3.2 Remove and replace the idler pulley. Torque to 58 Nm (43 lb ft).
 - 3.3 Inspect the drive belt for any damage. Replace the drive belt only if there are any visible signs of damage. Refer to Drive Belt Replacement (Dual Generators) in SI.
 - 3.4 Route the drive belt around all the drive pulleys except for the tensioner.
 - 3.5 Rotate the tensioner counterclockwise.
 - 3.6 Install the belt around the tensioner and slowly release the tension on the tensioner.
